CORONERS COURT OF QUEENSLAND

FINDINGS OF INVESTIGATION

CITATION: **Non-inquest findings into the death of PJR**

CATCHWORDS: CORONERS: Work-related death; forklift; unloading shipping containers; semi-trailer axle stacking configuration; loose load; unstable movement; entrapment; safe work procedure

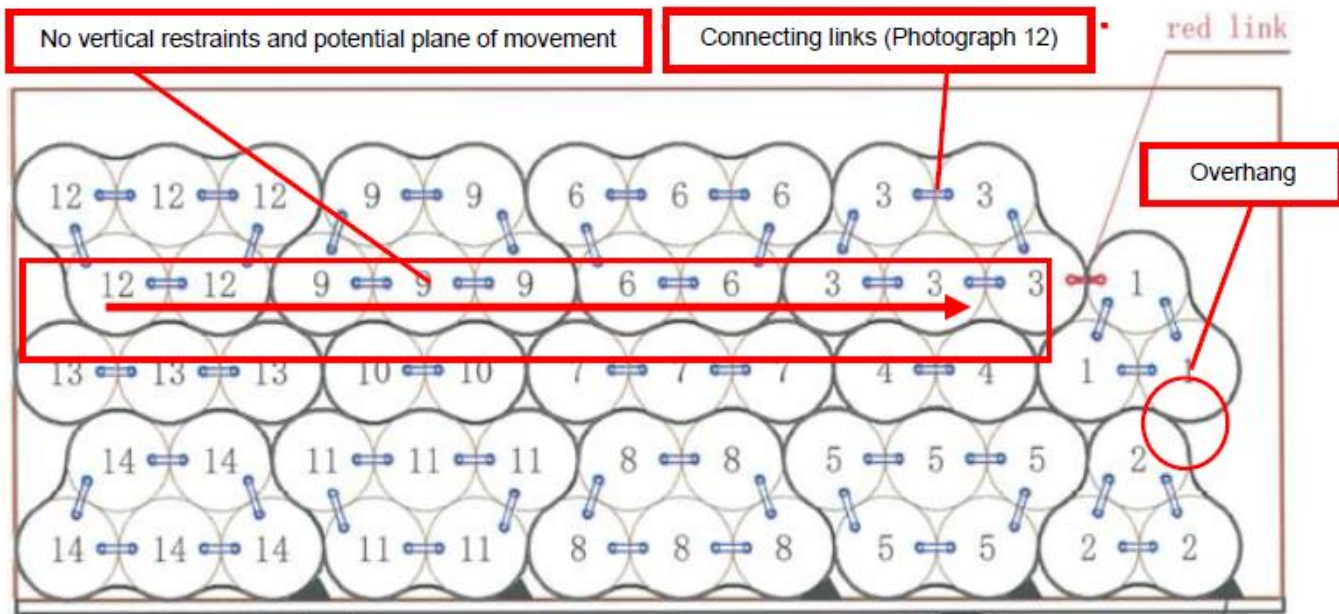
- An unloading diagram of how the axles were stacked was found on the floor within the incident container. This diagram came with the container and showed the configuration of the stacking and a numbering system to assist in the unloading process. The axles were bundled in different configurations (eight sets of five linked top and bottom, two sets of two linked in the centre and four sets of three of which two sets were in the centre and two were at the front near the door of the container. The two sets of three linked at the front of the container were arranged in a pyramid formation, the bottom of the top pyramid was placed on the top of the bottom pyramid and was connected to the adjacent set by four red alloy links connected to drum studs on each side of the axles. The red links were looped over the drum studs and a wheel nut placed over.

- There were two red links on the floor on the right-hand side of the container just behind the fallen axle 3-pack. These links were used to connect the axle 3-pack to another axle pack and hold the axle 3-pack within the container and stop them from falling. Due to its position, the axle 3-pack would have been the last bundle to be packed, and the red links were likely attached to the relevant axle packs at completion of loading the shipping container holding the last stowed axle pack to another axle pack.
