CORONERS COURT OF QUEENSLAND

FINDINGS OF INVESTIGATION

CITATION: **Non-inquest findings into the death of Peter Raymond Thistleton**

CATCHWORDS: CORONERS: Heavy Vehicles, Prime Mover and Two Trailers, Crash in context of Driver Fatigue, Failure to Wear Seat Belt, Speeding and Drug Driving.

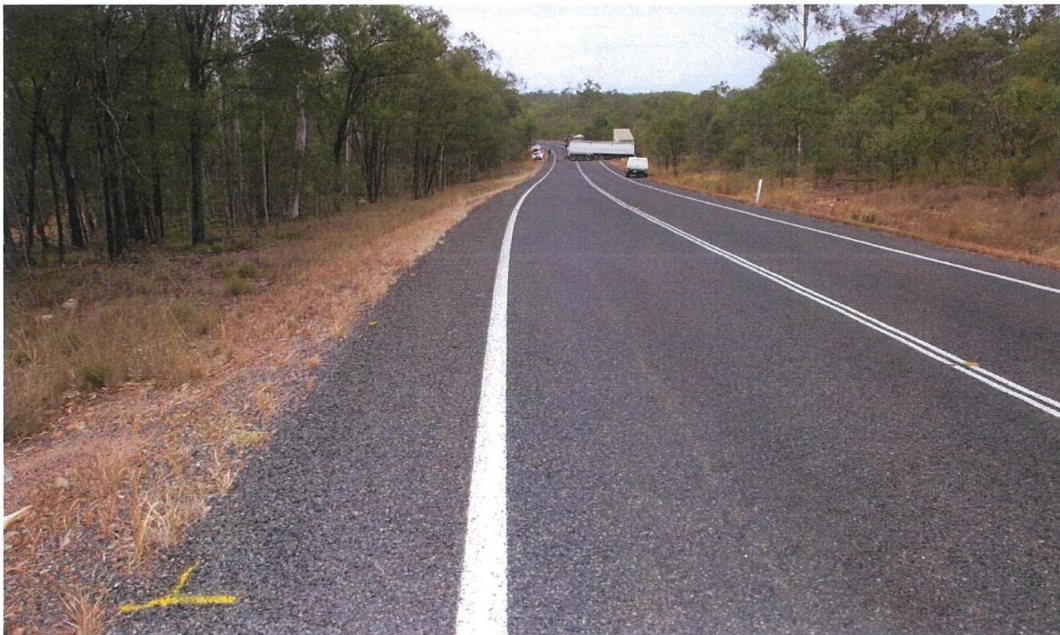
5. The incident location was on the Burnett Highway between Malmoe and Grosvenor Queensland, approximate GPS -25.442920, 151.196085.
6. The PM was travelling south from Monto when it negotiated a slight right bend at the top of a hill descent, when it appears to have partially left the sealed road surface with evidence of left-hand tyres on the grassed and dirt verge sloping down away from the sealed road. It then appears to have attempted to correct itself and returned to the sealed road surface.

Crash scene from top of decline facing South.

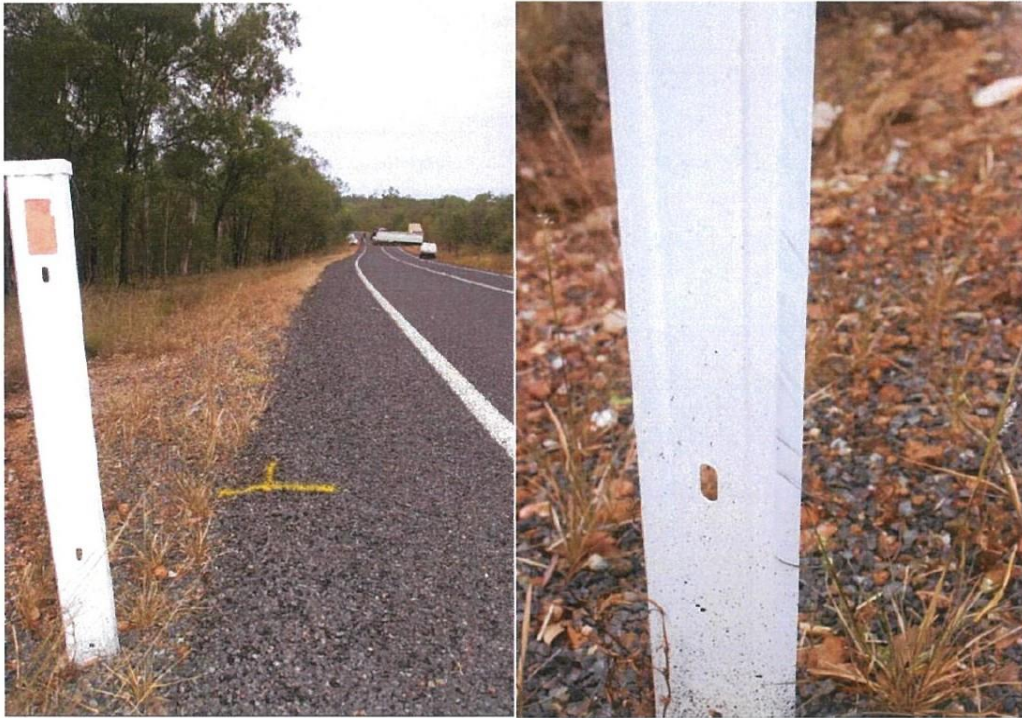
14. Transfer from a tyre contacting the reflector post immediately prior to damage to the edge of sealed surface was observed with disturbance in the grass along the edge of the inclined verge several metres prior to the first observations of wheel tracks present in the grassed verge.

Scuff indicating first observed point of contact on roadside reflector post.

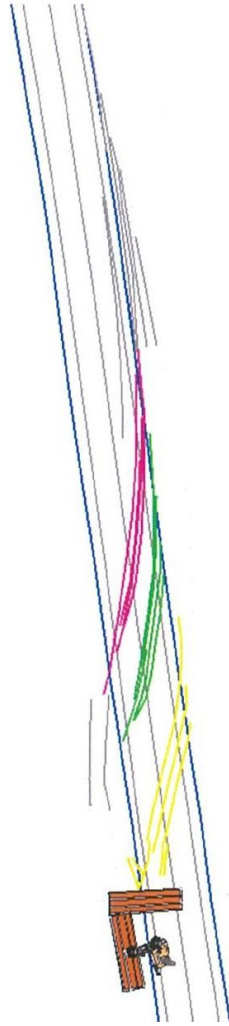
Forensic scene map and overview breakdown.

21. The road is approximately 10 metres wide from edge of pavement (EP) to EP with two standard 3.5-metre-wide lanes. Fog line (FL) to EP varies from approximately 1.0-1.5 metres (1.25 metres avg). The distance measured of tyre marks from where PM left the eastern EP until re-entered EP approximately 40 metres.
22. Distance measured from where the PM left the EP until Trailer B re-entered the EP is approximately 82 metres.

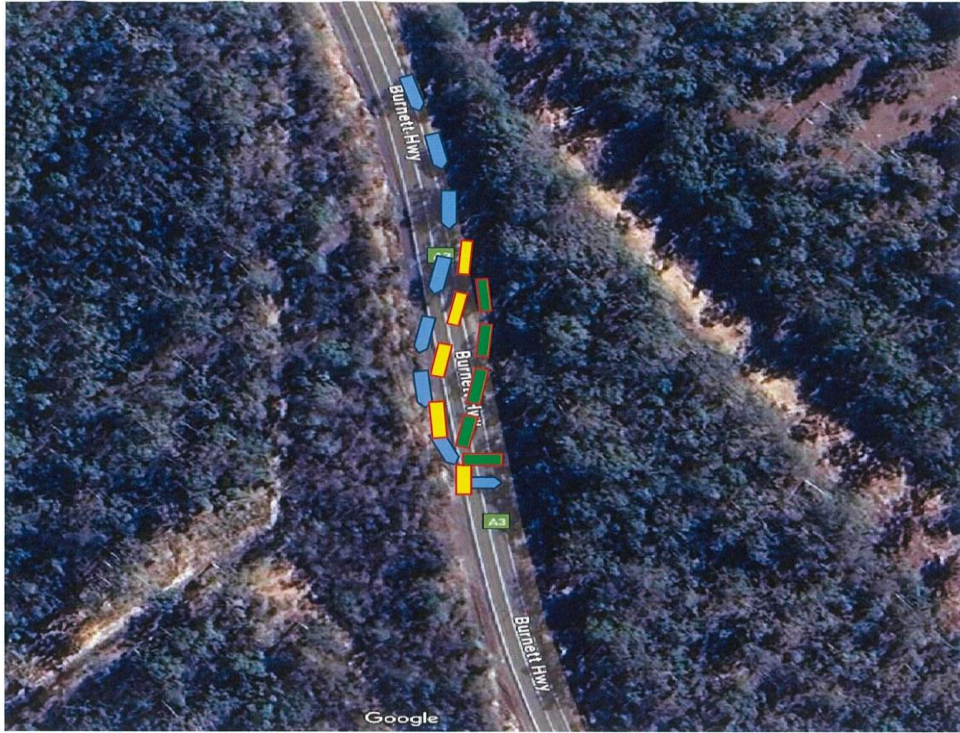
Track of prime mover through tyre marks
-

Track of A trailer through tyre marks
-

Track of B trailer through tyre marks

- q. The tyre tracks observed are consistent with the left-hand wheel track of the steers and Trailer A and B following the angle of exit of the PM off the sealed bitumen with slightly increasing margins down the embankment, as would be expected to be seen in a series of vehicles with tow in this manner.

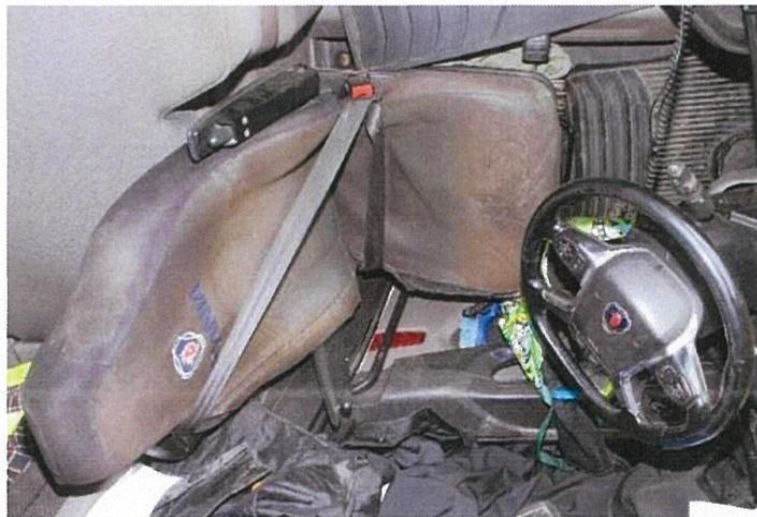
Peter was located unresponsive with his upper body protruding out of the driver's side window of the PM and his lower body pinned under the PM. His seat belt had been fastened behind him so to negate the activation of any seatbelt sensors during operation. With the seat belt remaining fastened and Peter having been ejected from the cab, Police formed the view that he was not wearing a seatbelt at the time of the crash. Peter was pronounced deceased by the attending QAS paramedics at 05:47 hours.

Cab driver's seat belt.

28. The driver's seat belt was plugged in and tight across the seat indicating it was not worn.
 29. A search of the cab revealed a homemade water pipe (bong) and a small quantity of cannabis in a tobacco tin.

- z. It is the opinion of the investigating FCU officer that had Peter been wearing his seat belt he would not have been ejected from the window and would likely have survived.

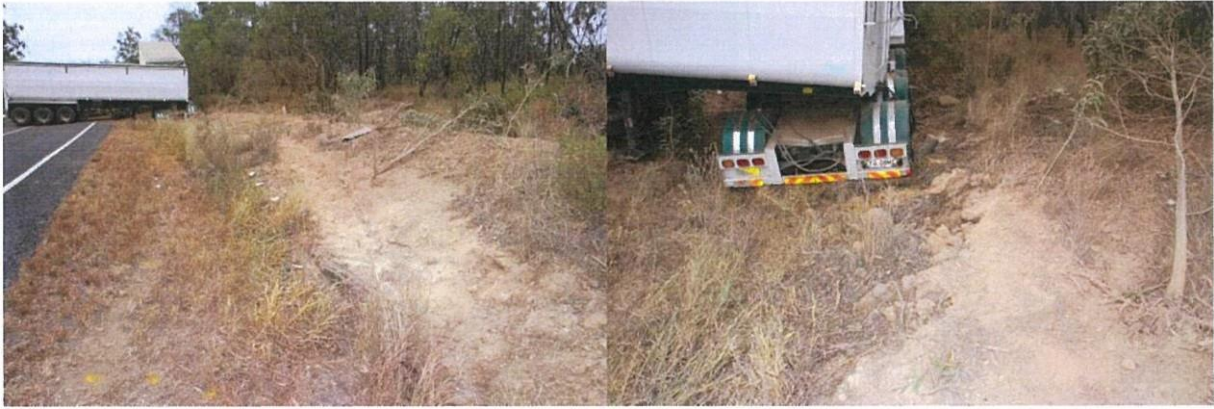
Image showing the western edge roadside drainage and wheel marks through vegetation with tree damage leading to drainage ditch roadside bottom of decline western side.

- i. Despite the PM impacting several small trees, the PM had begun angling back toward the sealed road as the ground surface deteriorated into a rocky depression (ditch) at the base of the decline.

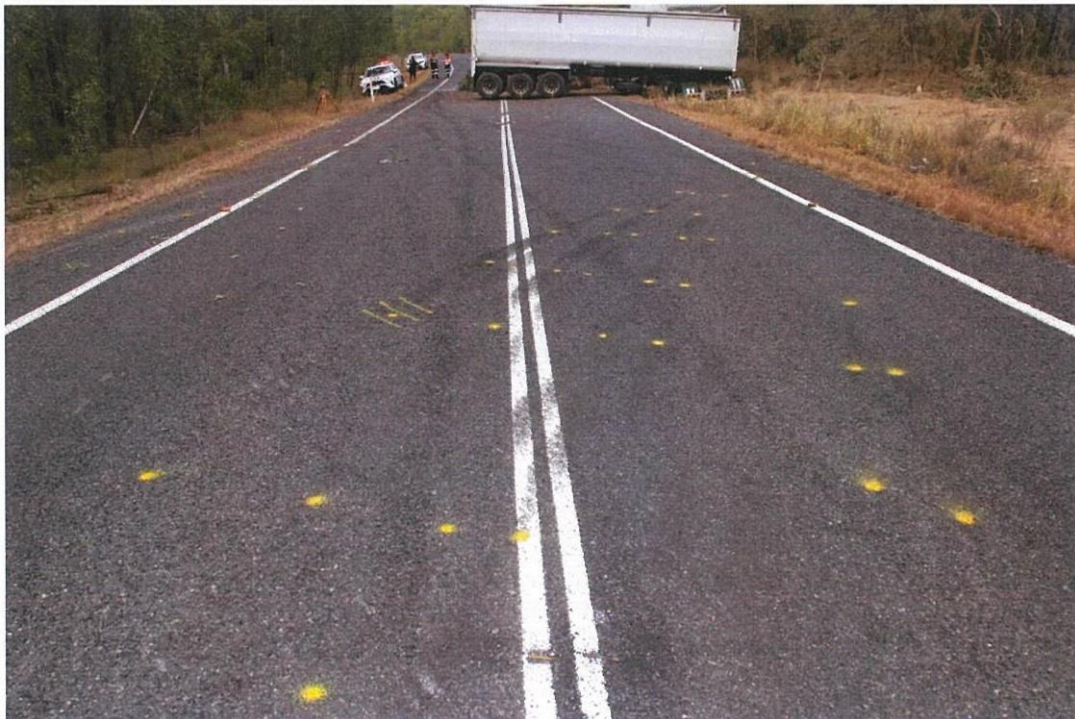
17. Multiple tyre marks consistent with dual double rear axles of the trailers and PM were observed from this point which tracked up to the point of termination where the axles of the PM and A Trailer left the sealed surface on the western edge, and the B Trailer remained in situ across the roadway.

*Wheel tracks crossing bitumen east to west close up.
Right to left – PM, Trailer A, Trailer B.*

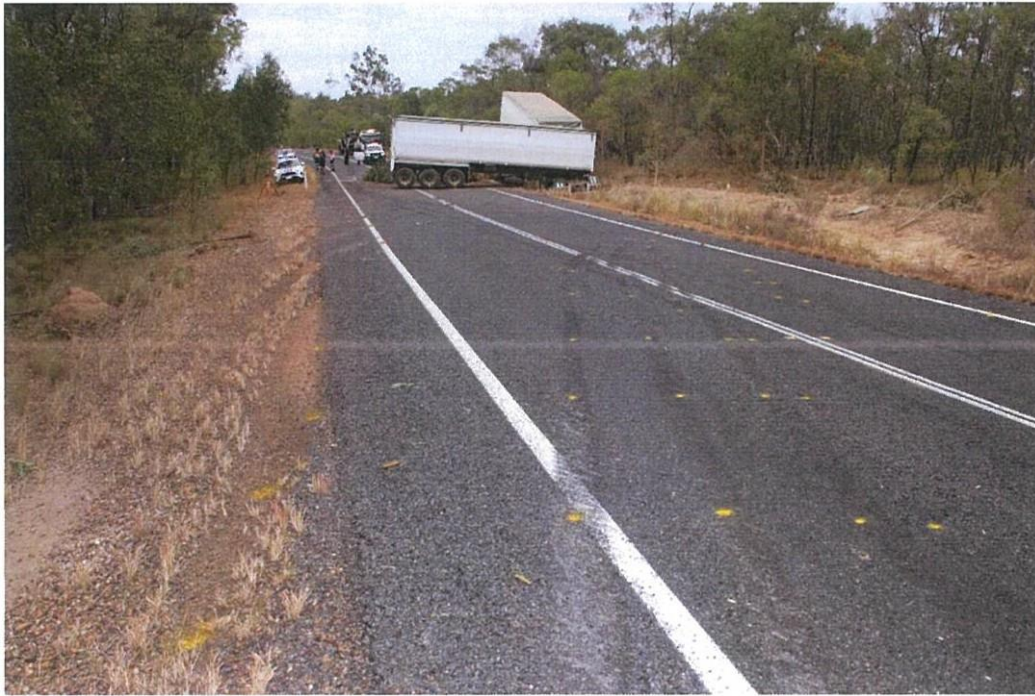
16. A clear point of re-entry to the sealed road surface was identified further down the incline. This was evidenced by significant gouging on the edge of sealed surface and was consistent with tyre marks from the vegetation lining up with tyre marks on the road at this point.

*Wheel tracks re-entering bitumen close up.
Right to left – Trailer A, Trailer B.*

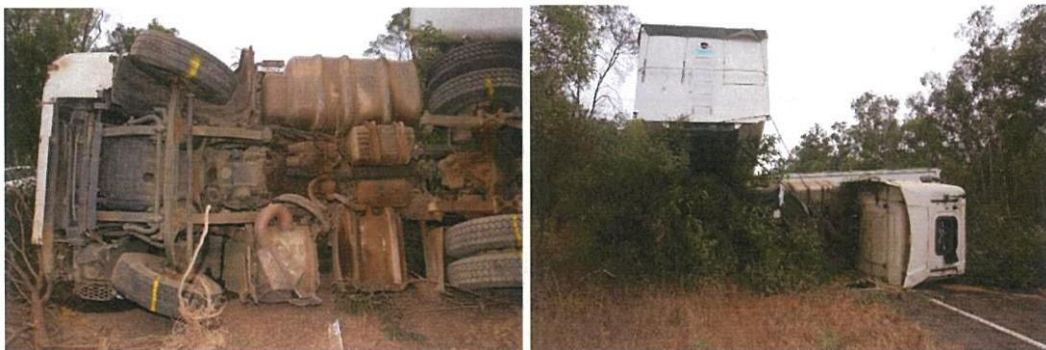
23. The PM exhibited minor damage to the lower front end, with scrapes and impact damage seen on the front right corner spreading from the headlight assembly towards the number plate. This damage bore the transfer of red dirt and dust and would be consistent with an impact such would be expected when the truck impacted the dirt hillside and subsequent ditch of the western side of the road.
24. The undercarriage appeared free of any substantive damage with the front wheels and steering assembly appearing damaged but intact. The windscreen and roof displayed damage consistent with the impact of a rollover.
25. Some areas of scrapes and transfer were seen on the undercarriage of the PM consistent with low points making contact with hard surfaces.

Image showing scrapes and damaged undercarriage of PM from contact & Image showing A Trailer free of coupling resting on rear left of PM.

26. The rear axle seemed to have slightly rotated out of true to the right along the horizontal axis which would be consistent with the weight and forces expected from Trailer A breaking its coupling and rolling forward over the rear of the PM to finish suspended at the front with
