CORONERS COURT OF QUEENSLAND

FINDINGS OF INVESTIGATION

CITATION: **Non-inquest findings into the death of Pedro Miguel Ventura Enes**

CATCHWORDS: Coroners: Heavy Vehicles; Dual Tyres; High Velocity Rock Projectile into Windscreen; Regulatory Oversight; Industry Wide Risk Mitigation

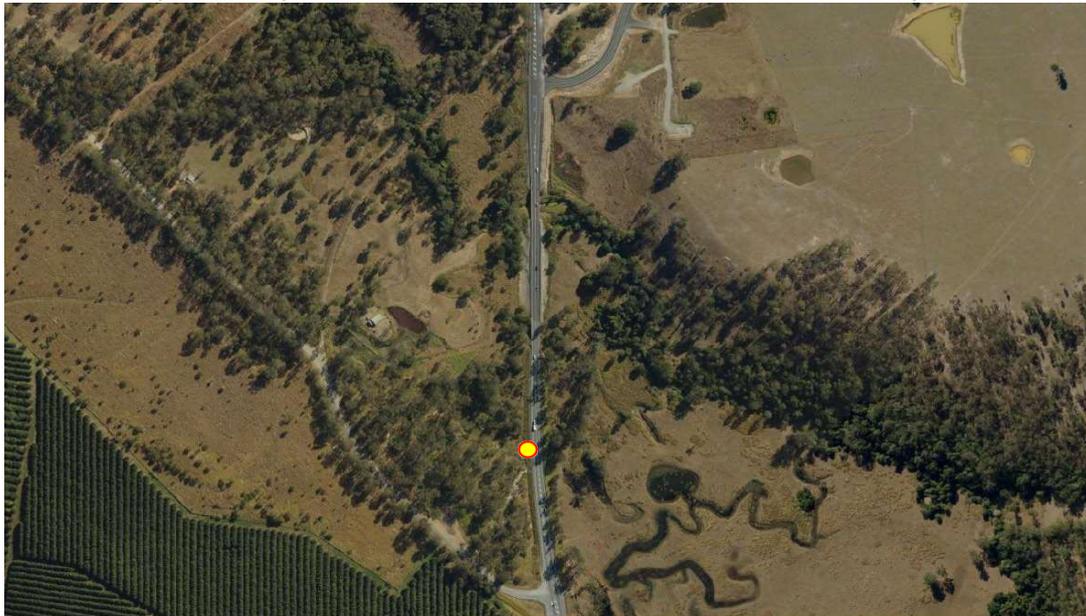
3. The scene covers an extensive distance, with Unit 2 approximately 50 to 60 metres North of Deveron Road against the guard rail (-25.883813, 152.596958). The entire site extends approximately 550 metres South of Deveron Road to immediately North of the merge of the Northern overtaking lane where the Southern end of the Southern Gootchie overflow bridge is located (-25.888415, 152.596988), which is where the first trace evidence was located. The assumed point of impact is calculated to be 50 to 75 metres South of this point.

Aerial view of estimated point of impact and crash location Bruce Highway

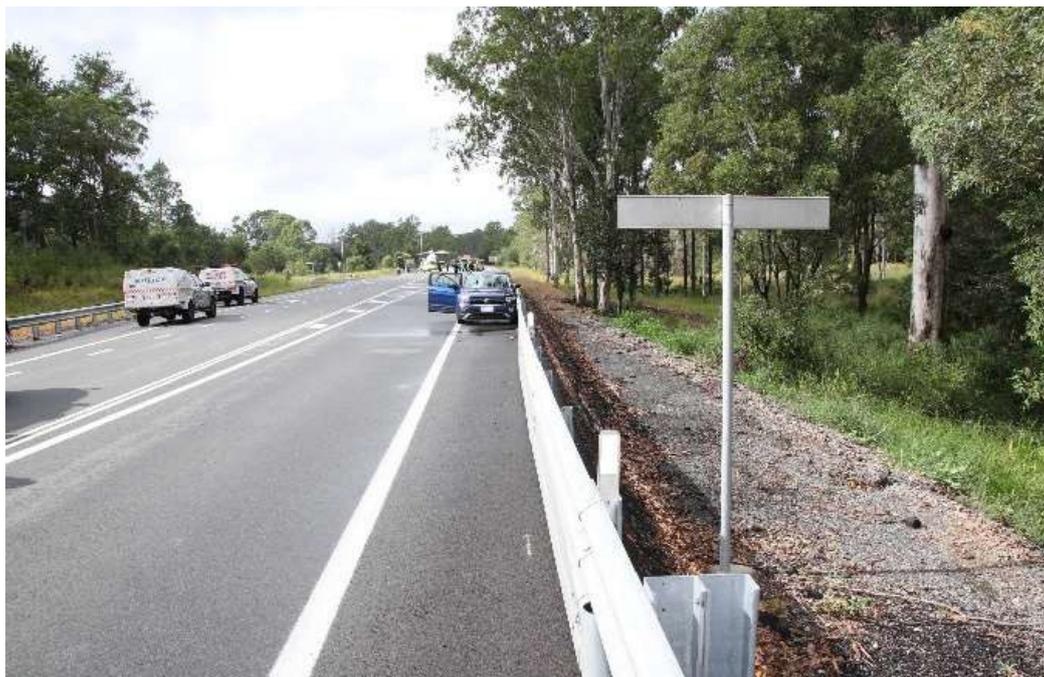
Vehicle against guard rail

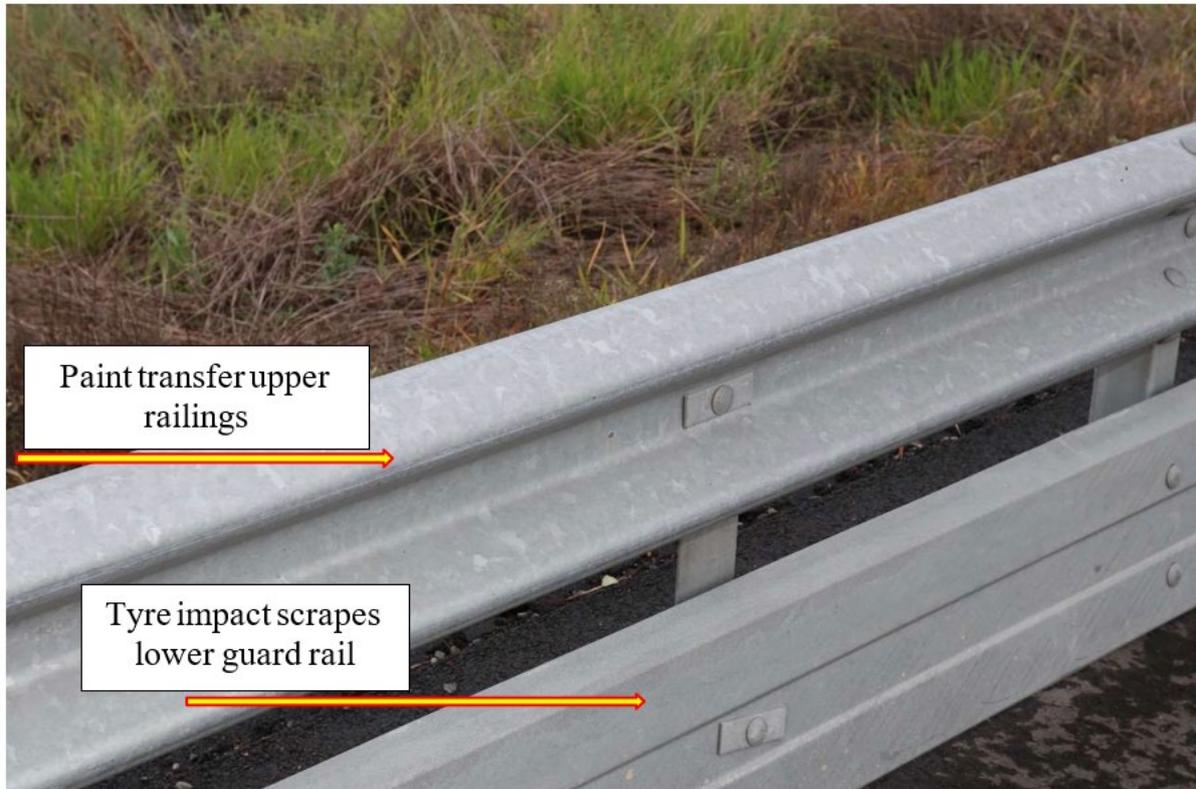
6. Race contact from the left side of the vehicle in the form of blue paint from the vehicle's body and grey plastic from the wheel arch and side skirts was observed intermittently for approximately 340 metres along the Armco and bridge railings.
7. Circular rubber tyre transfer impact scrapes were observed on the lower rail with a heavy paint transfer on the upper rail indicative of a primary point of contact / impact at speed.

Guard rails close up paint and rubber impact transfer

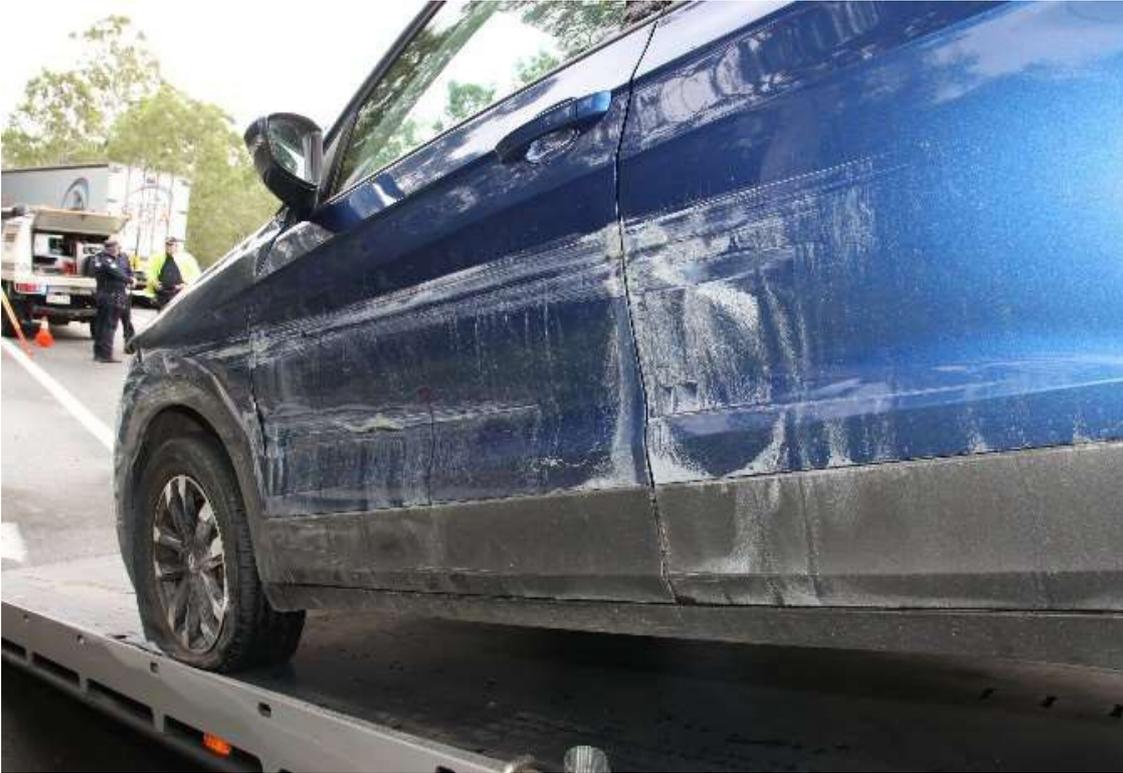
Damage to Unit 2 vehicle left hand side

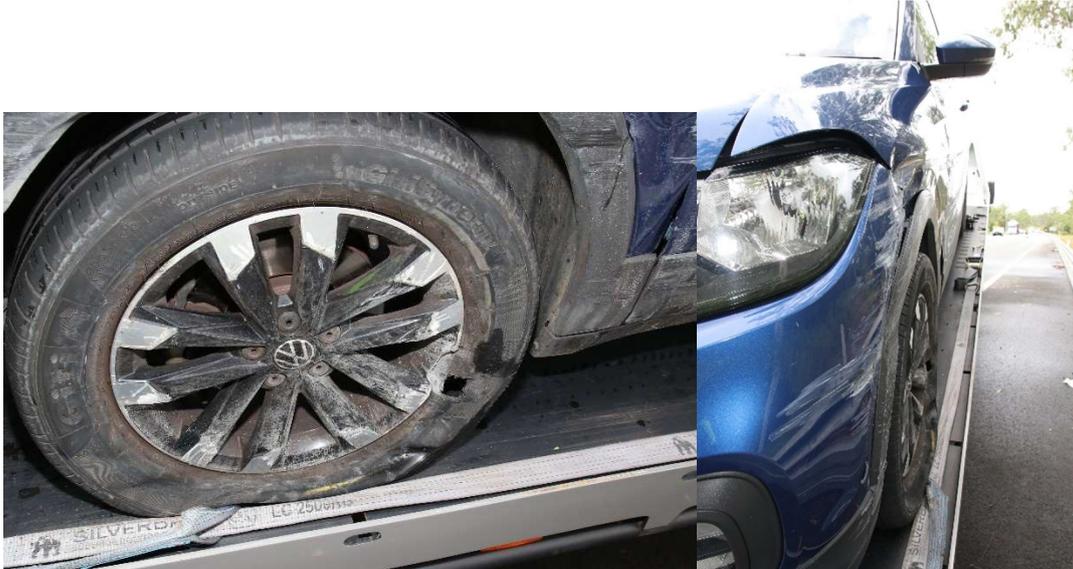
12. Scrapes and gouges consistent with extensive contact with the roadside railings were observed on the left side of the vehicle at heights consistent with the railings. The directionality is consistent with the vehicle's left side dragging along the railings in a forward motion as the vehicle came to rest.
13. The vehicle's front left tyre had deflated and there was damage to the front left fender and wheel rim consistent with a substantive impact of minimal angle in nature, at speed with the lower vertical section of the guard rail.

T-Cross damaged front left wheel and transfer from guard rail left side

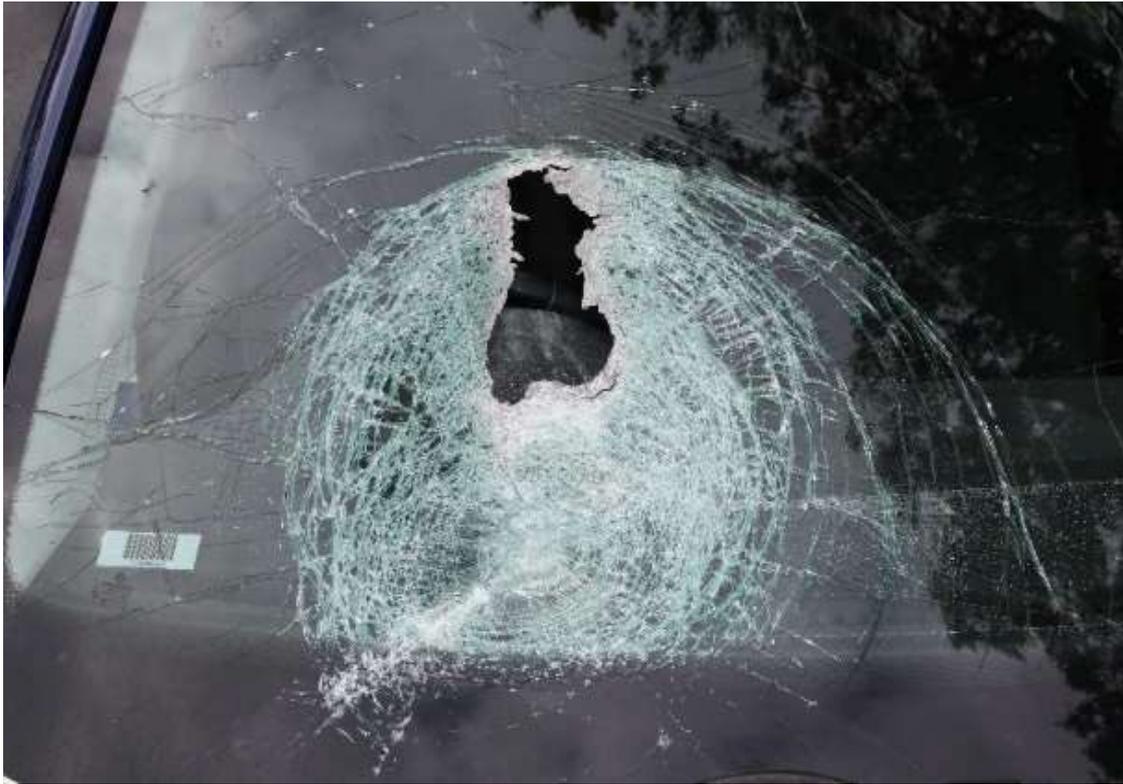
14. The windshield of Unit 2 was observed to have a large, depressed fracture directly in line with the driver's seat and steering wheel between 20 to 60 centimetres from the base of the windshield. The depression exhibited a radial fracture from a low centre point, about 15 centimetres above where a 20 centimetres long vertical and 10 centimetres wide void is observed with glass curling inward, indicative of a significant mass entering through the glass at speed.
15. Gouge marks are observed on the raised portion of dash directly in front of the steering wheel. The gouges continue in line onto the steering wheel.

External front view of windshield gouges visible on dash

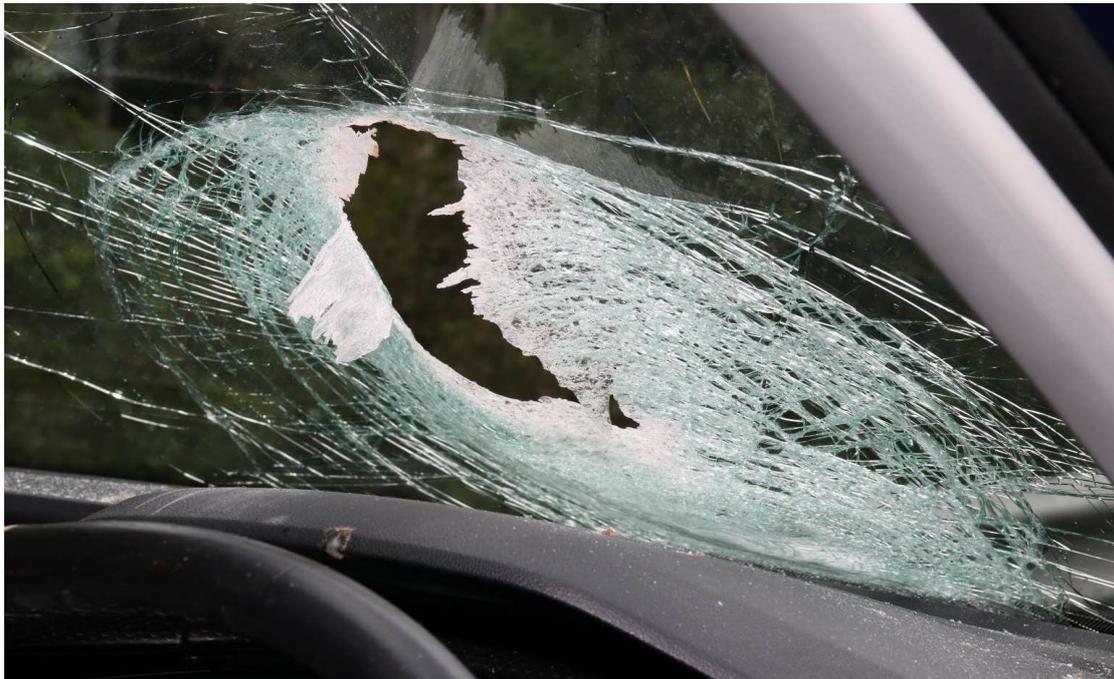
Internal view of windshield

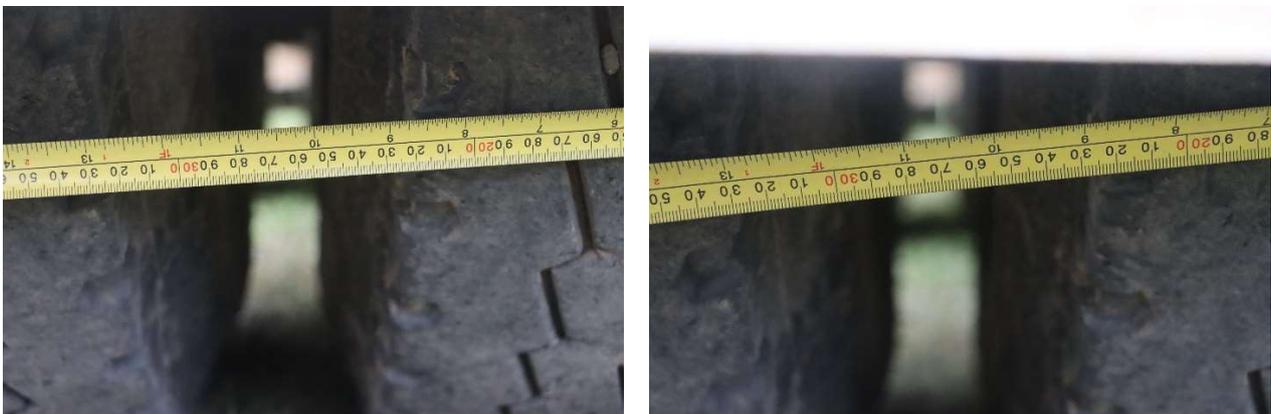
27. The spacing between the tyre walls of the duals was measured consistently at approximately 100 millimetres.
28. Tyres were standard HIFLY 295/80 HH308 11R22.5.

Spacings consistent between dual tyres on the drive and slave axles RHS

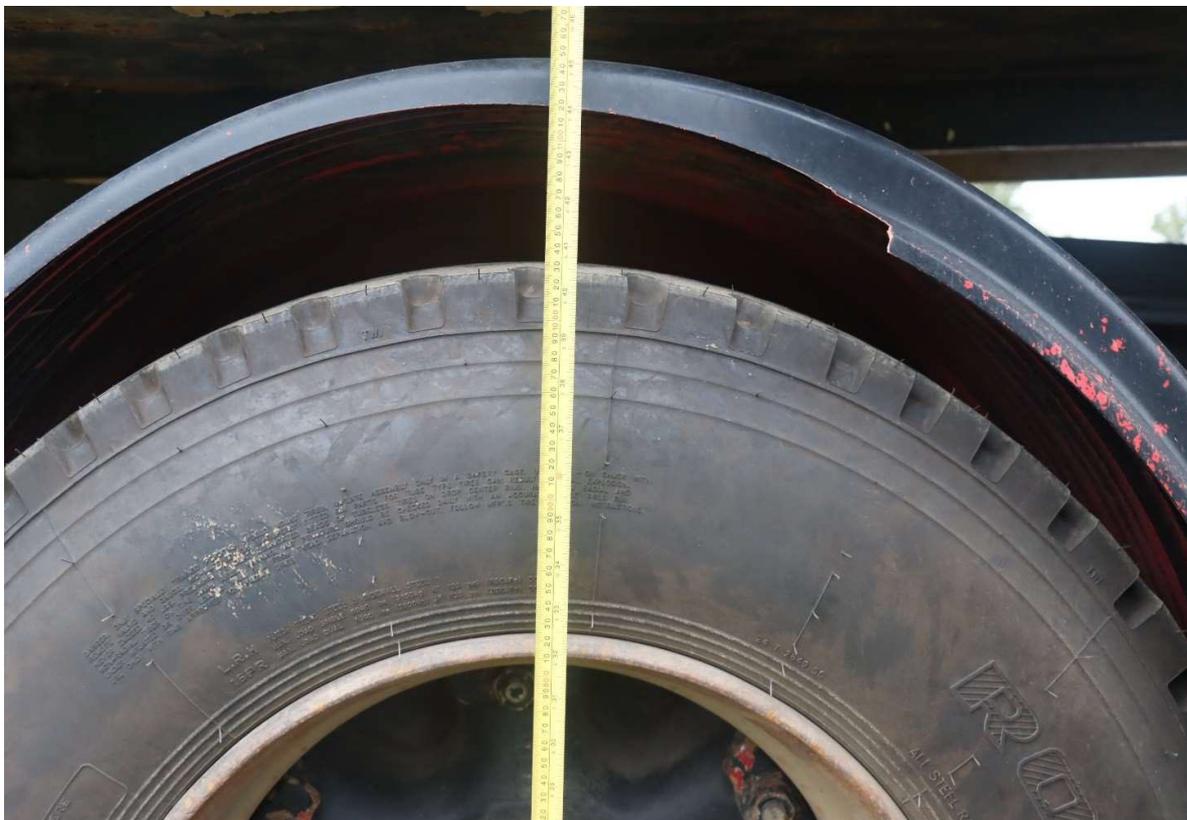
Rear RHS slave axle wheel guard spacing height from tyre (+/-90mm)

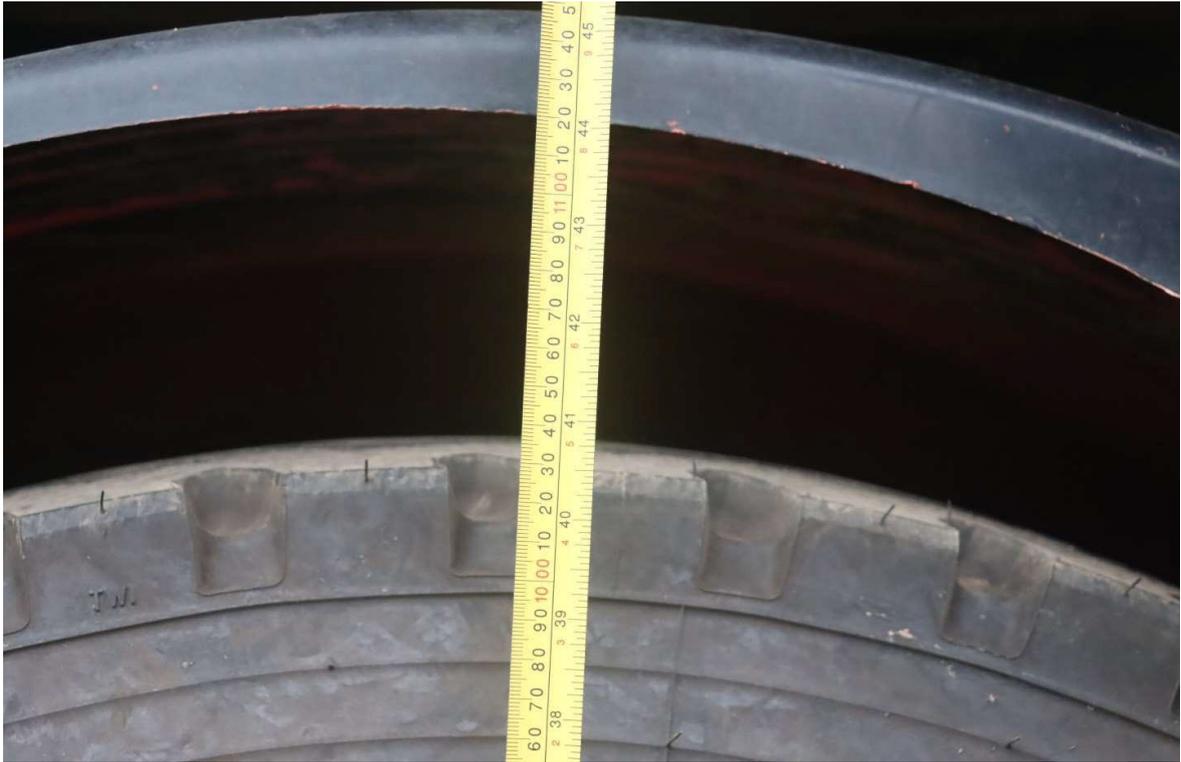
Rear RHS drive axle wheel guard spacing height from tyre (+/-90mm)

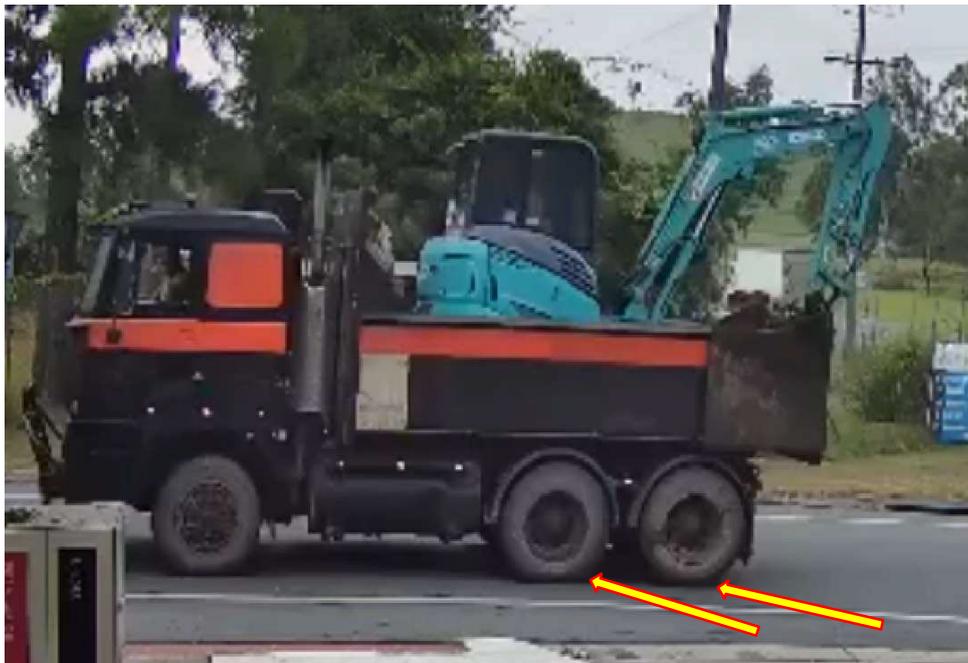
41. He stated that in his opinion as an experienced truck tyre fitter, elements such as the rain, the cold tyre pressure increasing from the truck accelerating, and the amount of tyre deflection (the amount of 'bulge' the tyre lowers under load as the weight or torque is applied to the tyre by the equipment axle) present from the load being carried by the truck could all have contributed to the rock being dislodged in the circumstances present on the morning of the incident.

Tyre deflection of Unit 1 rear tyres under load immediately after incident

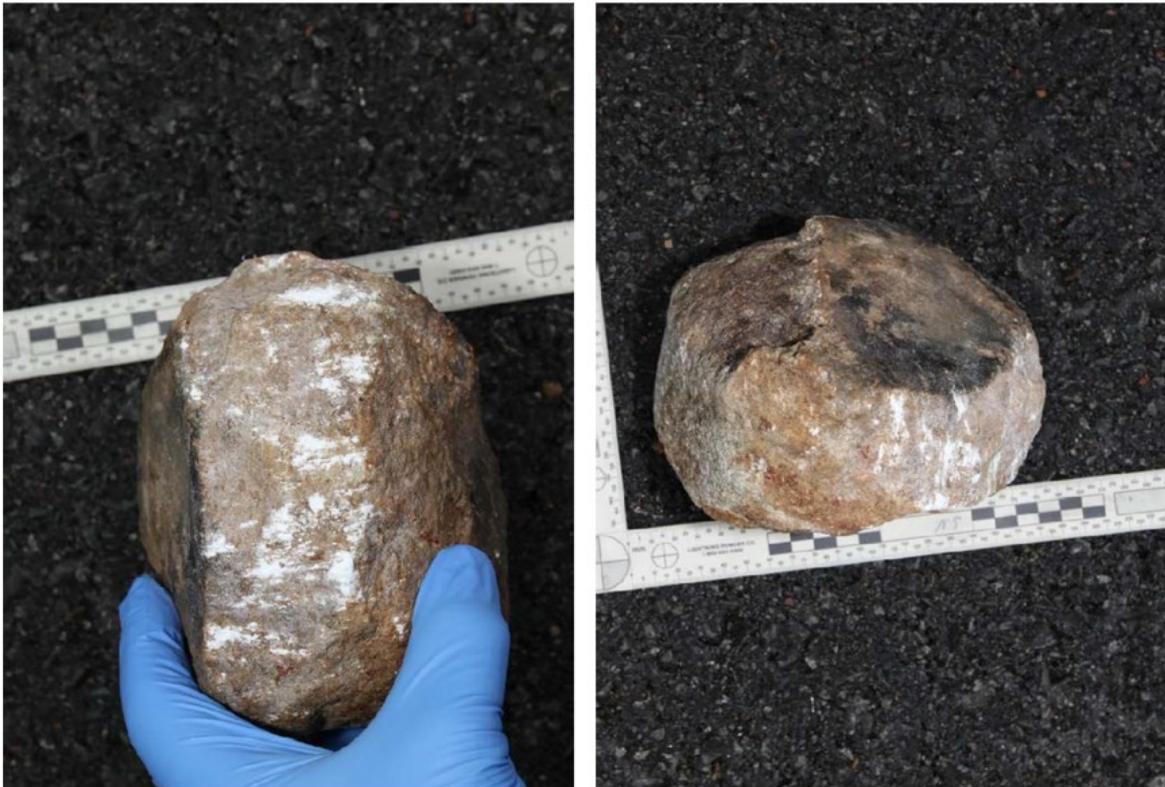
Images showing powdered glass from impact, and rubber friction burns on either side of the wedge shaped rock from its assumed orientation during its position lodged between the dual tyres.

42. The rock was recovered at the scene in the rear of Unit 2. It measured approximately 190mm long, 160mm wide and 100mm tall. There is evidence of rubber deposits on two opposing flat faces consistent with being wedged in the 100-millimetre gap between the dual tyres on the truck.

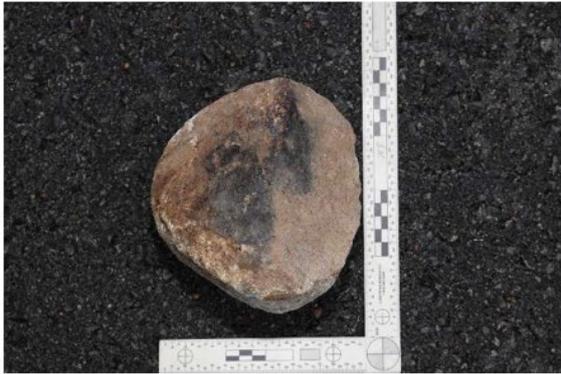
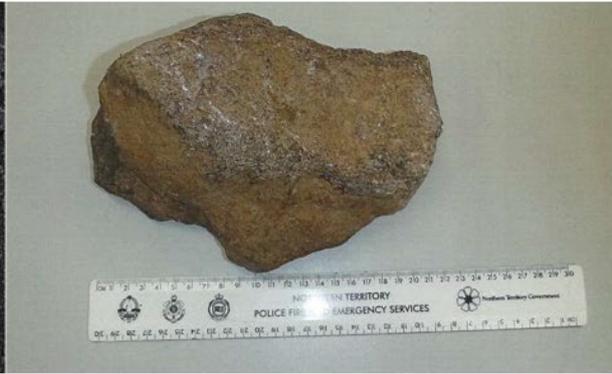
53. The O'Neill rock displayed similar characteristics including the presence of dark rubber transfer on opposing sides of the irregularly 'wedged' shaped object which was determined to be consistent with being lodged between the dual tyres before being deposited at the location.

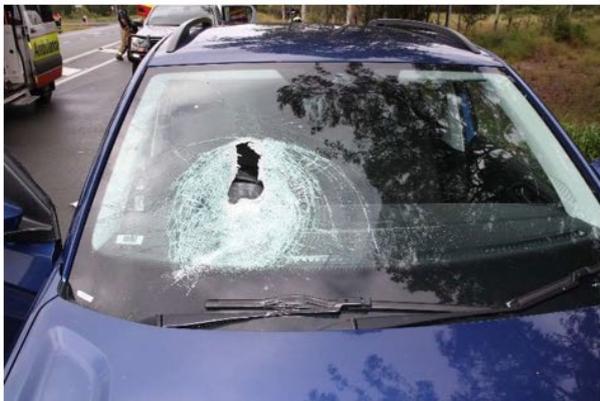
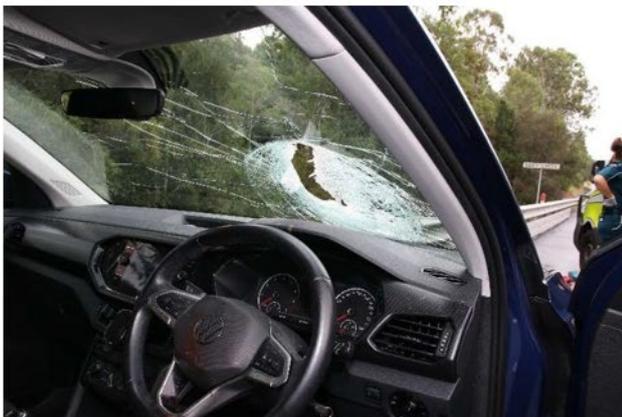
52. The damage to the windshield shows great similarities to Pedro's vehicle, with an initial area of impact, and a penetration above within the fracture area showing the glass 'tearing' inwards in the shape of the rock profile as is observed in Pedro's case.

- i. Once the laminate was significantly damaged, the rock was able to pierce the damaged section above the initial strike point due to the vehicle's own continued momentum acting against that of the rock.

- j. Potentially, if the laminate was reinforced, the structure of the damaged (delaminated and fractured) section of glass may be capable of diverting such a significantly large rock from continuing its path towards the occupants within the vehicle.

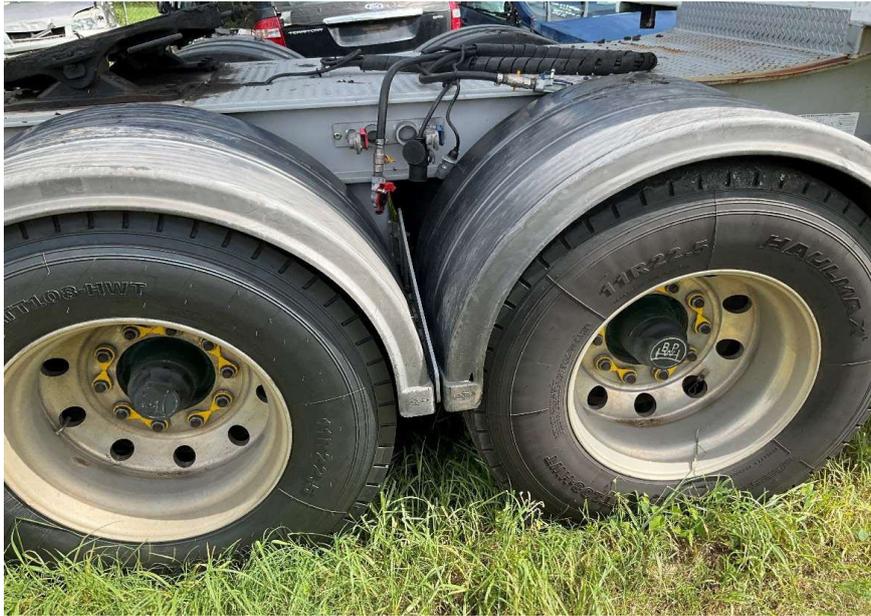
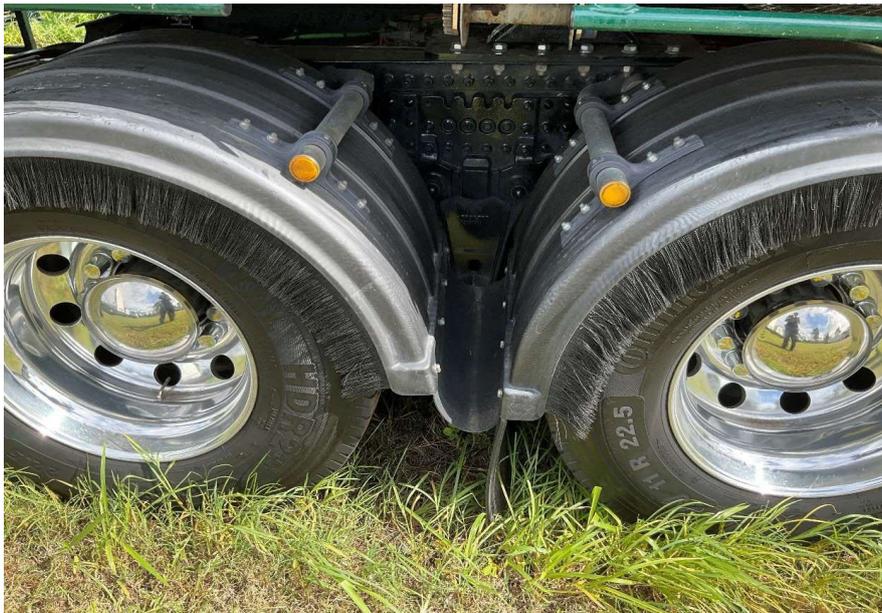
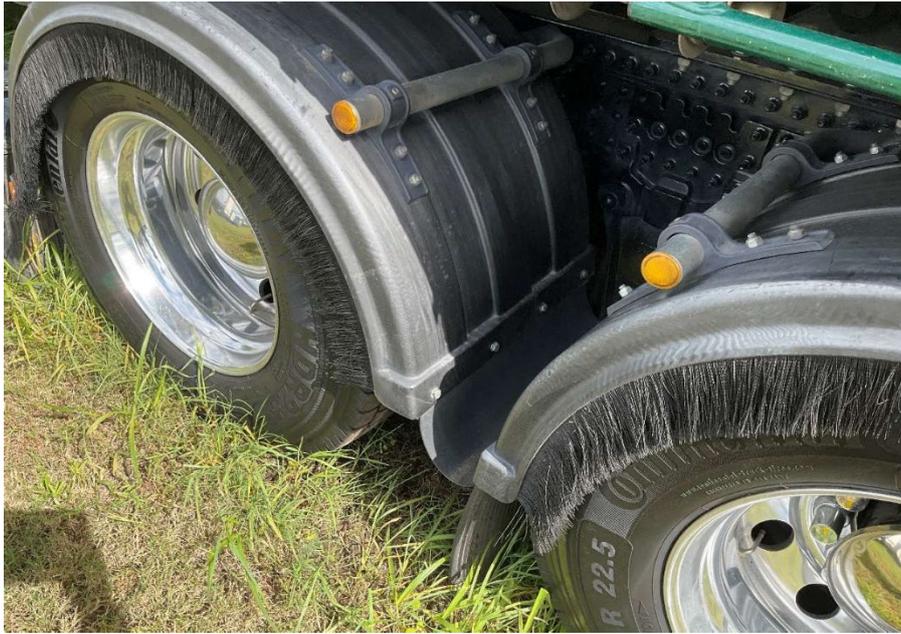
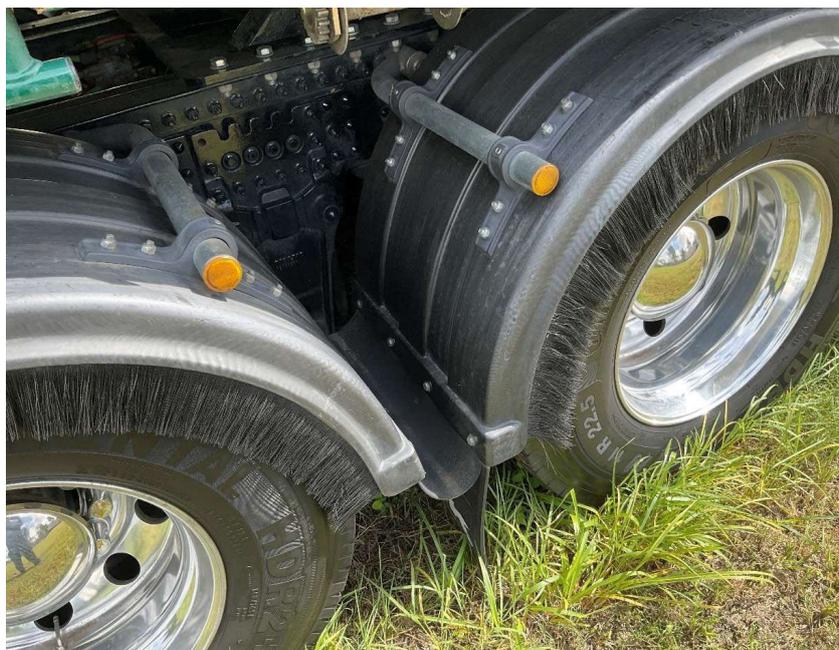
Side view example of new model prime mover fitted with extended mud flaps on both axles, sturdier metal wheel arch guards, heavy duty rubber joiner, and side spray brushes

- p. It is recommended that fitting design improvements like these above (pictured on new model trucks) to older vehicles in use, would reduce the probability of any similar rock or projectile related accident resulting in the unnecessary and tragic loss of life occurring again.
