# **CORONERS COURT OF QUEENSLAND**

## **FINDINGS OF INVESTIGATION**

**CITATION:** **Non-inquest findings into the deaths of Pilot 1 and Pilot 2**

**CATCHWORDS:** CORONERS – Aviation – Recreational Flying – Plane crash – Touch-and-go manoeuvre – Insufficient thrust to maintain a climb

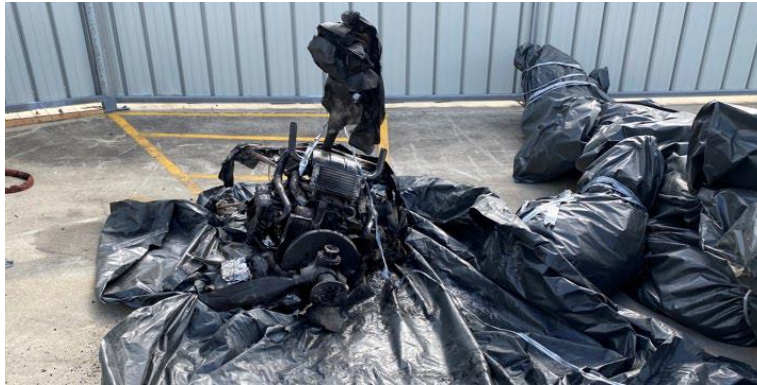
72. The engine was recovered from the wreckage and, other than post impact fire damage, was essentially intact. A full engine disassembly and inspection did not reveal any evidence of mechanical or lubrication failure. Due to fire damage, some systems within the engine such as electronic components, injectors, throttle body, airbox assembly and sensors could not be tested.

Figure 21: Engine wreckage (Source: RAAus consultant)

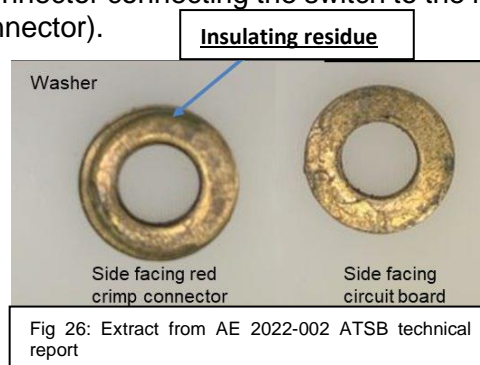
78. The ATSB also identified a possible electrical connection issue within the propeller system:
- a. A functionality check of the switch revealed an electrical discontinuity between the coarse switch circuit board (and adjacent brass washer) and the red crimp connector connecting the switch to the motor (and its adjacent green crimp connector).

- b. The manufacturer, Airmaster, was consulted about the effect of the connection issue on propeller function. The response indicated that if the electrical connection issue was present before the engine started, the three red indicator lights would flash and the propeller would not respond. The

recommended pre-start check could therefore not have been completed. If the electrical connection issue developed in flight the three red indicator lights would flash and the propeller would not respond.

- c. ATSB could not determine how or when the residue deposited, or when the electrical connection was interrupted, and that it was possible the post-crash fire may have caused the electrical connection issue to develop.
