FINDINGS OF INQUEST

CITATION: Inquest into the death of Jordan Robert Crocker

CATCHWORDS: Coroners: inquest; work related death; electrocution; electrician; restricted domestic roof space; ducted air conditioner system; indoor unit; fault finding; communication error; residual current device (safety switch); risk assessment; safe system of work; product design, installation and safety warnings

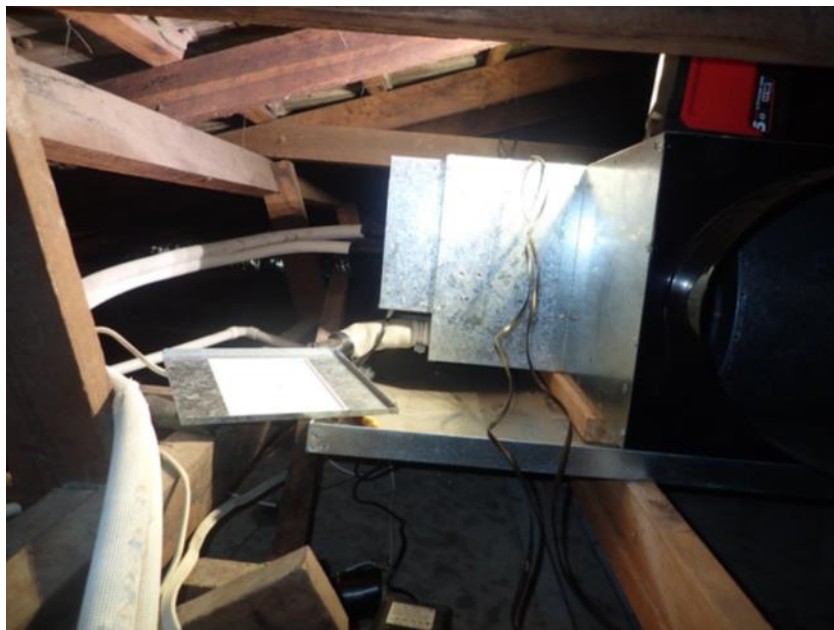
12. The indoor unit was installed in the roof space approximately 1850mm from the manhole entry in an easterly direction. Its orientation was such that the control box faced north, away from the manhole entry (Figure 1). The unit was mounted above a sheet metal drip tray.

Figure 1: The environment within which Jordan was working (showing the perspective from the manhole entry)

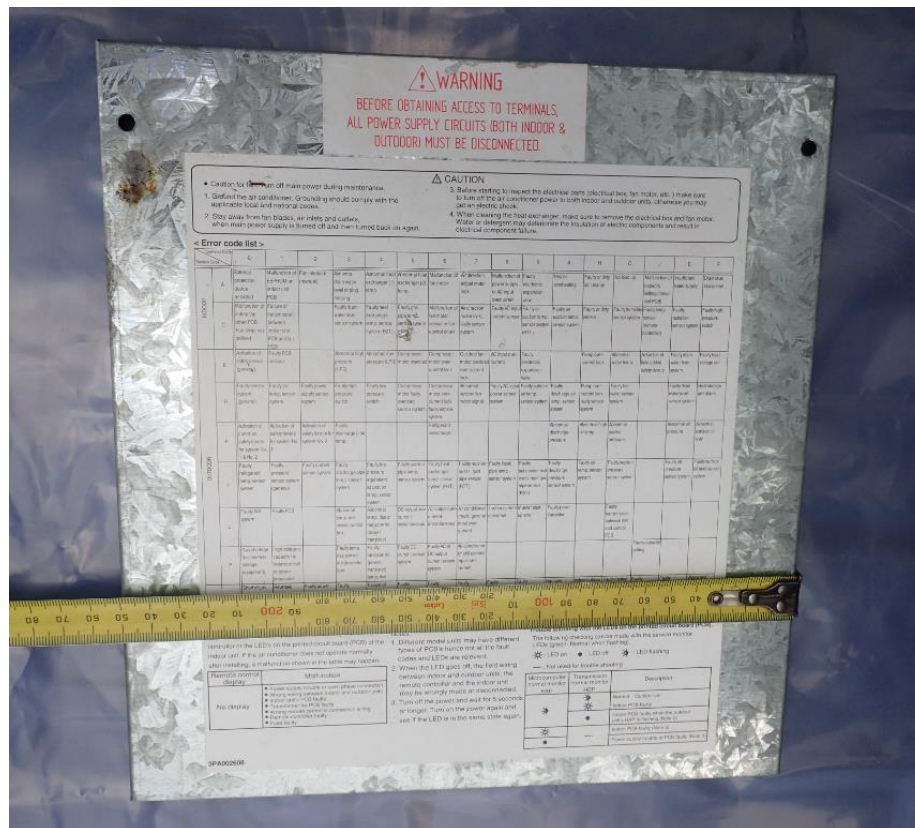
13. The indoor unit's control box measured 260mm high x 250mm wide x 100mm deep. It had a metal cover. There were "warning" and "caution" stickers on the front of the cover (Figure 2).
14. A warning in large red type to disconnect all power supply circuits (both indoor and outdoor) was directed to the task of obtaining access to the terminals.

15. Beneath this warning were cautions in smaller black type including “Before starting to inspect the electrical parts (electrical box, fan motor, etc) make sure to turn off the air conditioner power to both indoor and outdoor unit, otherwise you may get an electric shock”.

Figure 2: Indoor unit control box cover

16. The orientation of the control box facing north meant these stickers were not within direct line of sight from the manhole entry while the metal cover was in place. Whether Jordan could have visualised the warning and cautions from the manhole entry and his position with the roof space is discussed later.
17. The control box componentry and its layout are generally typical of that for ducted system indoor units. The size, position and construction of the terminal box containing two low voltage live terminals within the control box are key elements in how the electrical shock path was established (Figure 3).

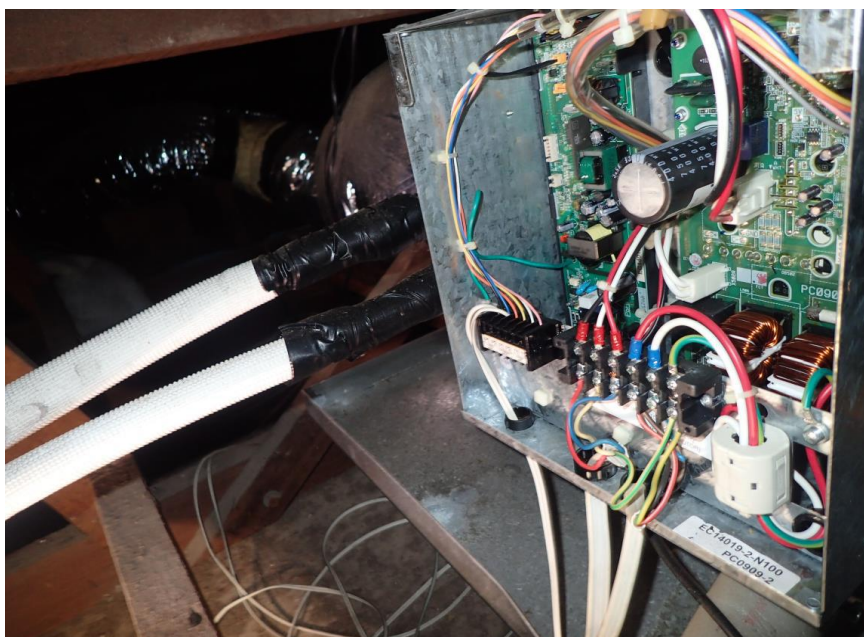
Figure 3: The inside of the indoor unit control box enclosure

39. While handling the metal cover, the edge or corner contacted the exposed live terminals in the terminal block inside the control box causing Jordan's left hand to contract, effectively squeezing the cover. Electrical continuity tests subsequently confirmed continuity between the air conditioner circuit breaker and the terminals of the red interconnect conductors at the control box, indicating the terminals were energised when the air conditioner system was running. This was the entry point for the electric shock.
