CORONERS COURT OF QUEENSLAND

FINDINGS OF INQUEST

CITATION: Inquest into the deaths of:
Wayne Joseph GANTER
Mark Robert RAWLINGS
Henry Phillip ROEBIG
Wayne Anthony BRISCHKE
Stuart Henry Russell WEAVELL
(“Lockhart River Plane Crash No. 2”)

DELIVERED ON: 30 August 2023

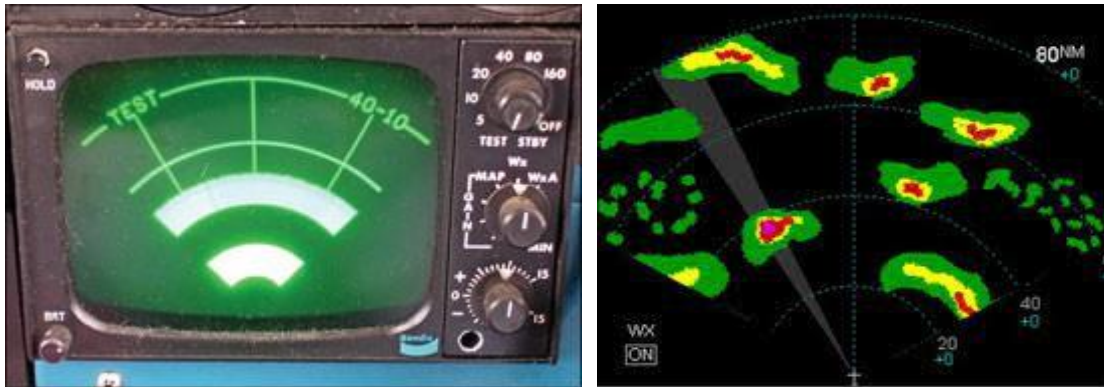
OZO had a weather radar, as it was required to. However, this was an old monochrome model that displayed weather "returns" (areas of moisture detected by the radar) in a single colour. Modern radar displays show rain in colours ranging from white (light rain) to green, yellow, red and black (each indicating higher amounts of precipitation). This enables the pilot to discern a light shower from a dangerous storm cell. This distinction is much harder to make on the type fitted in OZO. Example images included below.

I will continue to assert that we need modern equipment in these aircraft. We can and should improve pilot training and proficiency - but human error will never be eliminated. Aviation, at higher levels, is upheld as an example of an industry that has multiple layers of defences or 'redundancy'. No single point of failure should be enough to cause catastrophe.
