# **CORONERS COURT OF QUEENSLAND**

## **FINDINGS OF INVESTIGATION**

**CITATION:** **Non-inquest findings into the death of a pilot**

**CATCHWORDS:** CORONERS: Aviation- Recreational Flying- Drifters- Low Level Flying- Alcohol and Drugs- Non-Compliance with Regulatory Framework.

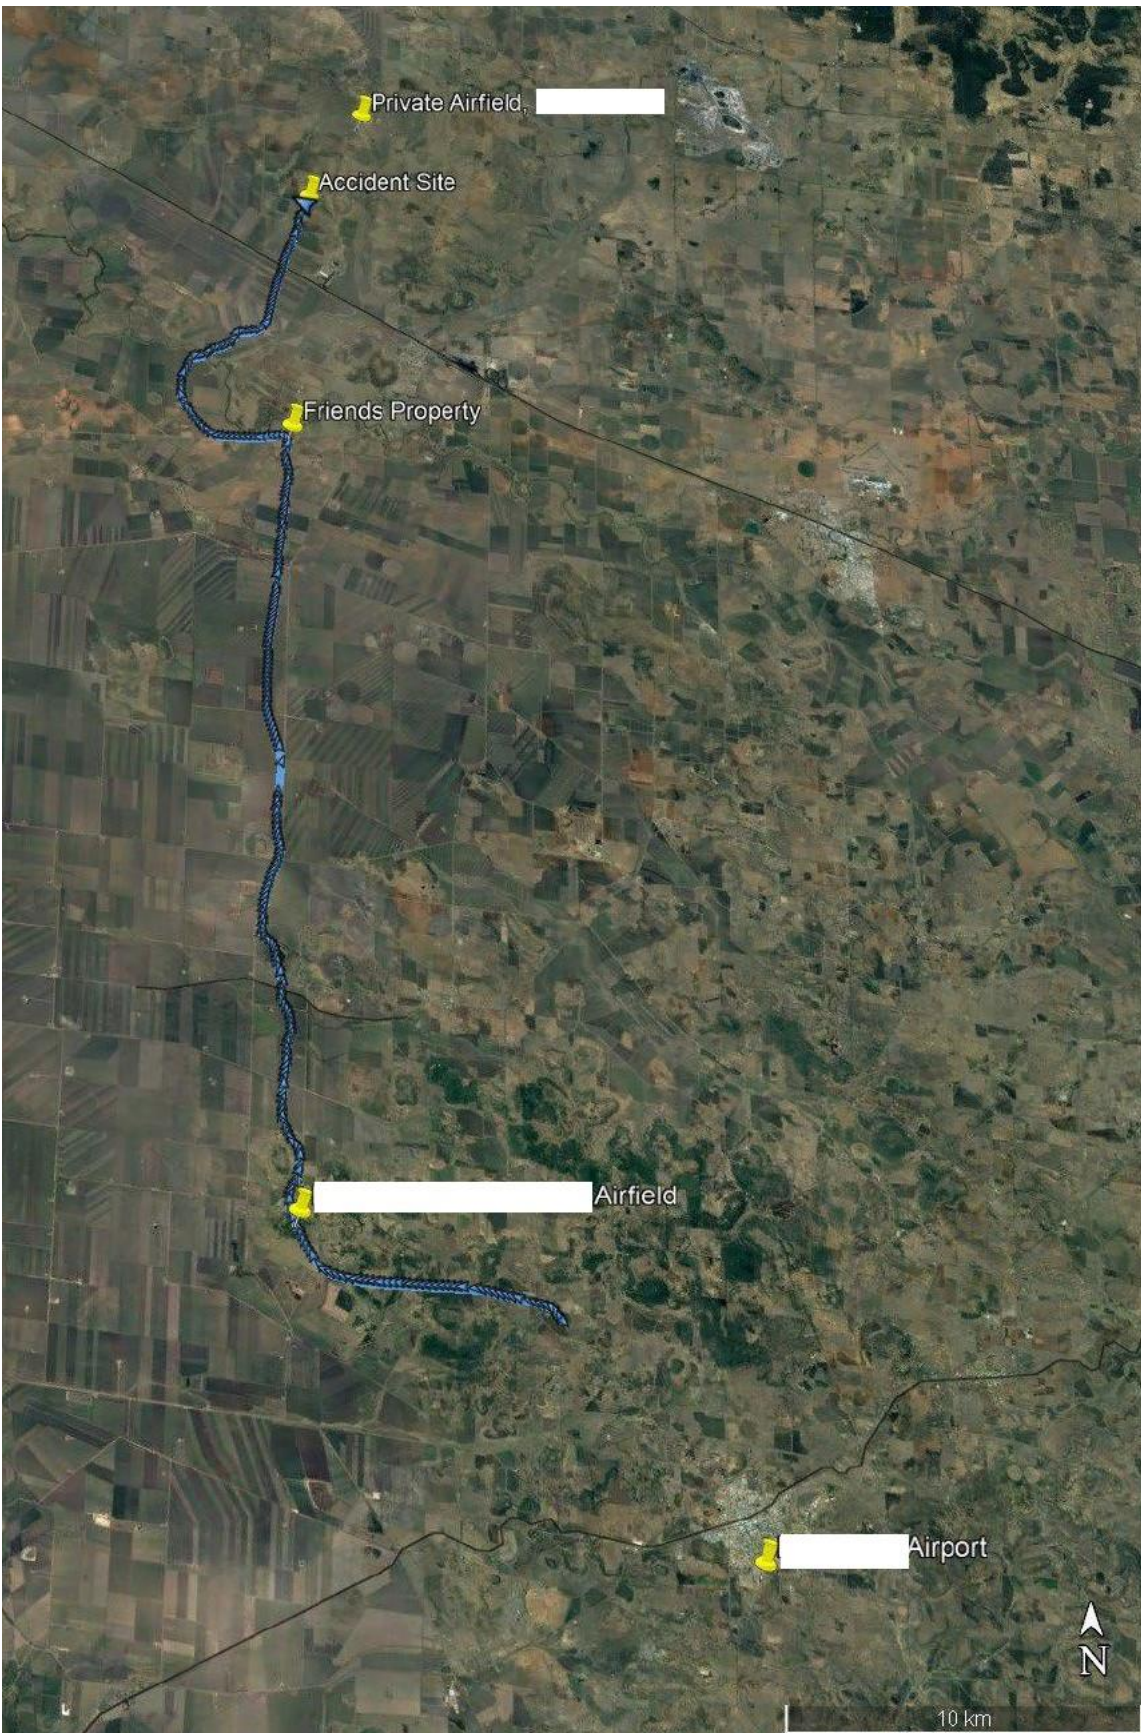
4. The pilot departed first and his flight data re-commenced tracking at 13:48 hours, approximately 5 nautical miles north-west of the airfield. The Drifter initially climbed to an altitude of approximately 1100ft AGL tracking towards a nearby accommodation venue which has an airfield. As the Drifter approached the venue it descended below 500ft AGL, passing overhead the airfield at approximately 80ft AGL. The Drifter then tracked towards a property owned by another friend of the pilot's, who witnessed the Drifter fly overhead at an estimated height of 10-15m above the ground. This is consistent with flight data which shows the Drifter passed overhead the property at 60ft (18m). Shortly after, the Drifter was observed operating at low levels by a local farmer who reported paying more attention as the Drifter was flying a lot lower than expected. The farmer then observed the aircraft collide with powerlines and subsequently impact terrain at 14:13 hours. The incident site was located approximately 2 nautical miles south-west of the private airfield. **[Image 1]**.

Image 1: Flight path flown from the departing town's airfield to the accident site (image source: OzRunways track data overlaid on Google Earth).

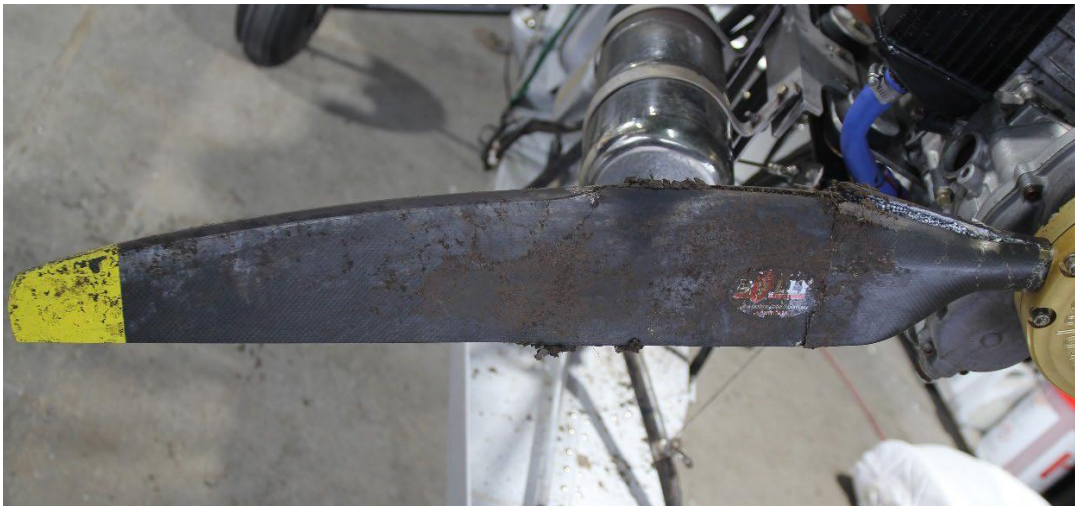
11. RAAus did not attend the incident scene. However, it assessed witness statements and viewed scene photographs obtained by Police from the incident site.
12. An RAAus investigator, accompanied by an RAAus Chief Flying Instructor, undertook an inspection and assessment of the Drifter wreckage in a holding yard at a regional town on 5 July 2022. Several components of the flight and control systems were examined. Several items were seized for further examination by experts within RAAus and ATSB. Components of the engine were inspected with no signs of mechanical failure prior to impact with terrain. The propeller blades were correctly assembled and primarily intact, with one blade showing clear impact damage. Markings on all three blades were considered consistent with an impact at slow rotation speed. **[Image 3].**

*Image 3: Propeller blade (Image source: Police Supplied).*

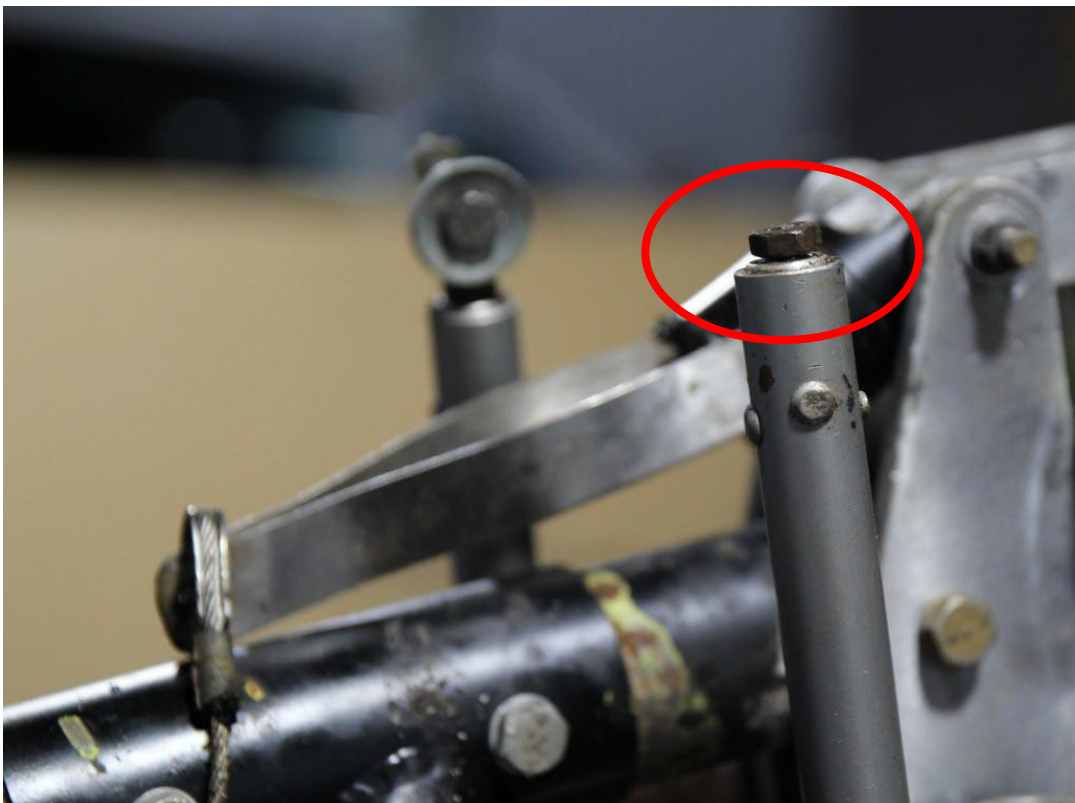
13. Inspection of the wreckage confirmed that all primary control functions were operational and normal for elevator, rudder, and throttle. The elevator trim system was functional and found with slight forward trim, consistent with level cruise flight for this aircraft.
14. The right-hand aileron push rod was identified to have fractured at the male rod end connecting thread. Based on the information available, including witness statements of the aircraft path prior to the incident, it is considered most likely that this fracture occurred as a result of the wire strike and subsequent impact with terrain. **[Image 4].**

*Image 4: Aileron push rod (Image source: Police supplied).*

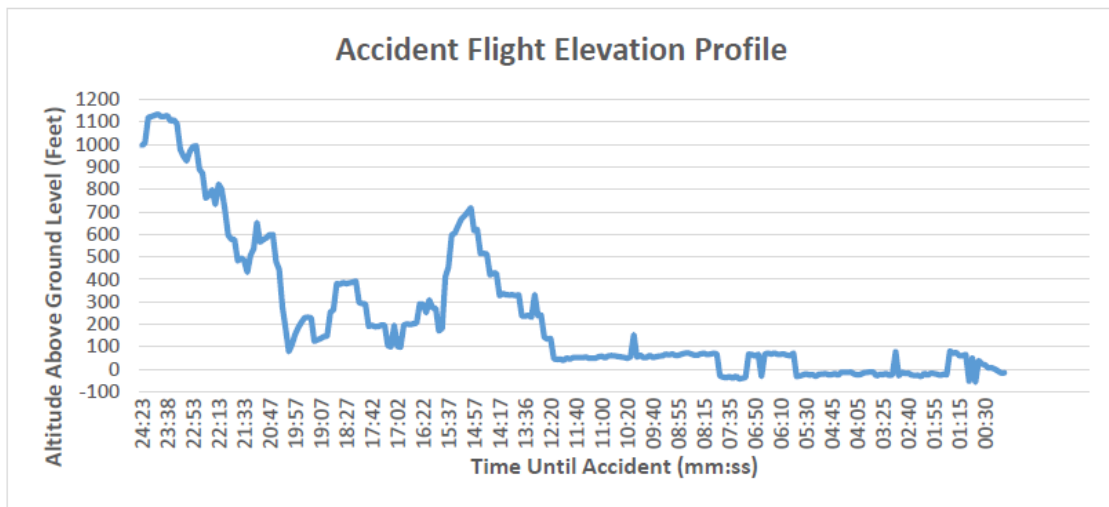
some data points showing an altitude below ground level during the final 8 minutes of the flight. Despite this, the data provides valuable information with respect to an overview of the general flight profile of the Drifter prior to the incident and is consistent with witness statements reporting the aircraft flying at very low altitude prior to the incident. [Image 5].

Image 5: Accident Flight Elevation Profile (Source: OzRunways flight data).

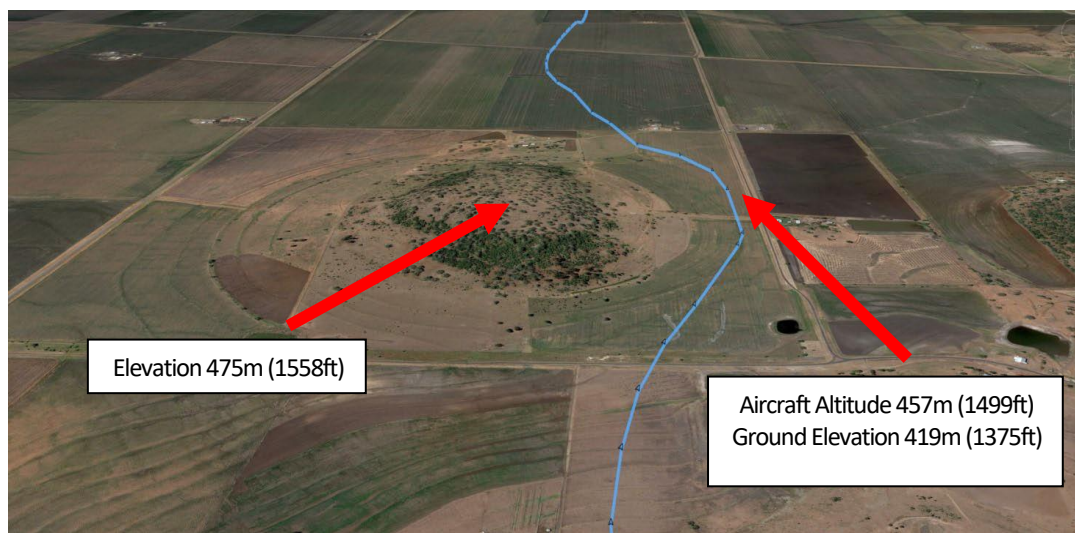
- c. In addition to the altitude data recorded, flight path data further indicates that the pilot conducted the flight at low level. The track flown by him is observed to navigate around low level terrain which would not be reasonably expected to result in flight path deviation if the Drifter was operating at a normal flight altitude.
- d. **Image 6** below shows the aircraft path deviating around a small hill which stands approximately 50m (164ft) higher than surrounding terrain. The Drifter flight data shows the aircraft to be operating 38m (125ft) AGL.

Image 6: Flight track showing navigation around low terrain. Measurements above sea level (Source: Google Maps).

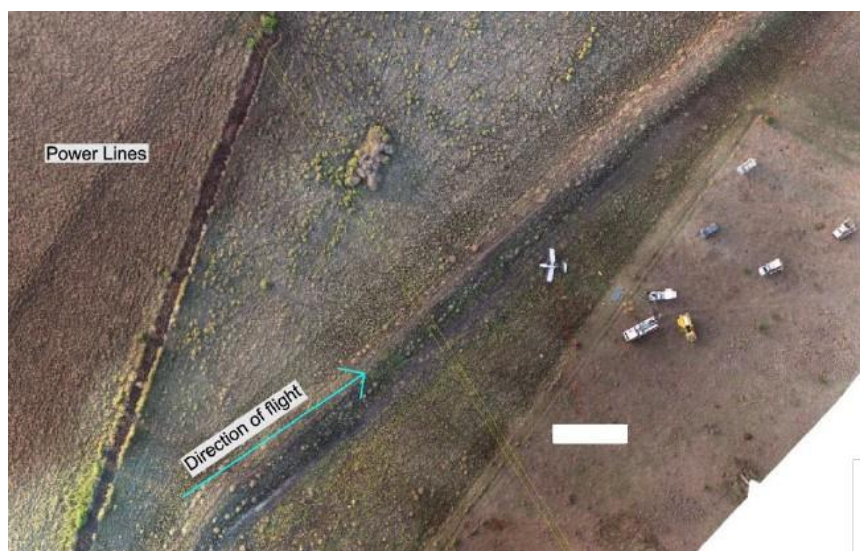
6. A power pole was observed near a road adjoining the incident location (to the east of the Drifter) and another towards the West. The flight path of the Drifter was generally east-north-east towards the private airfield which places the flight path roughly perpendicular to the power lines. **[Images 8 and 9].**

*Image 8: Overhead Drone photos taken at time of crash. Note yellow lines depicting location of powerlines relevant to Drifter.*

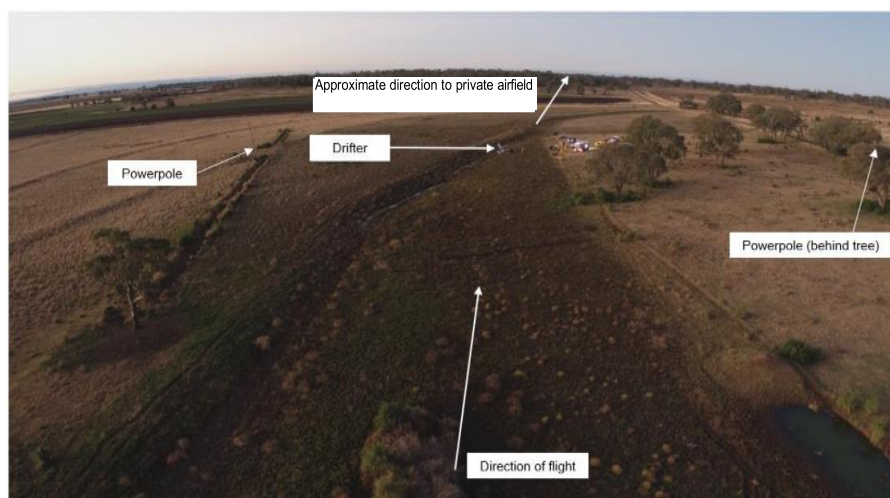
*Image 9: Drifter insitu looking in a northerly direction.*

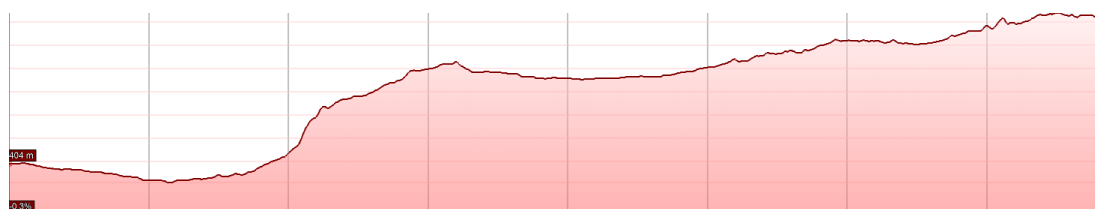
12. The private airfield is at approx. 450m ASL, and the crash location is approximately 400m ASL. Review of topography from crash location to the private airfield shows an inconsistent vertical grade increasing by 50m over approximately 4km with an average gradient of 1.25% or .71 degrees. **[Image 10].**

Image 10: Terrain profile from the crash site to the private airfield (Google Earth).

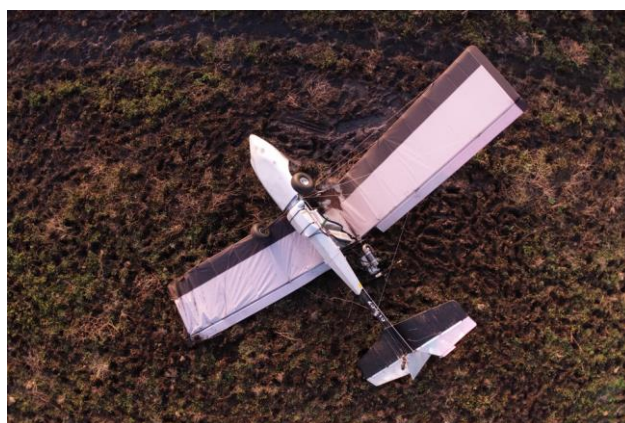
14. An examination of the Drifter was undertaken at the scene and found to have extensive structural damage. It had come to rest upside down with the left side of the fuselage resting on the ground. It was facing roughly south westerly. Whilst extensively damaged, the Drifter had not broken up. There was no debris field suggesting all damage was done on impact and there appeared to be no evidence of in-flight structural failure. **[Image 11].**

Image 11: Drifter A-503 # post impact.

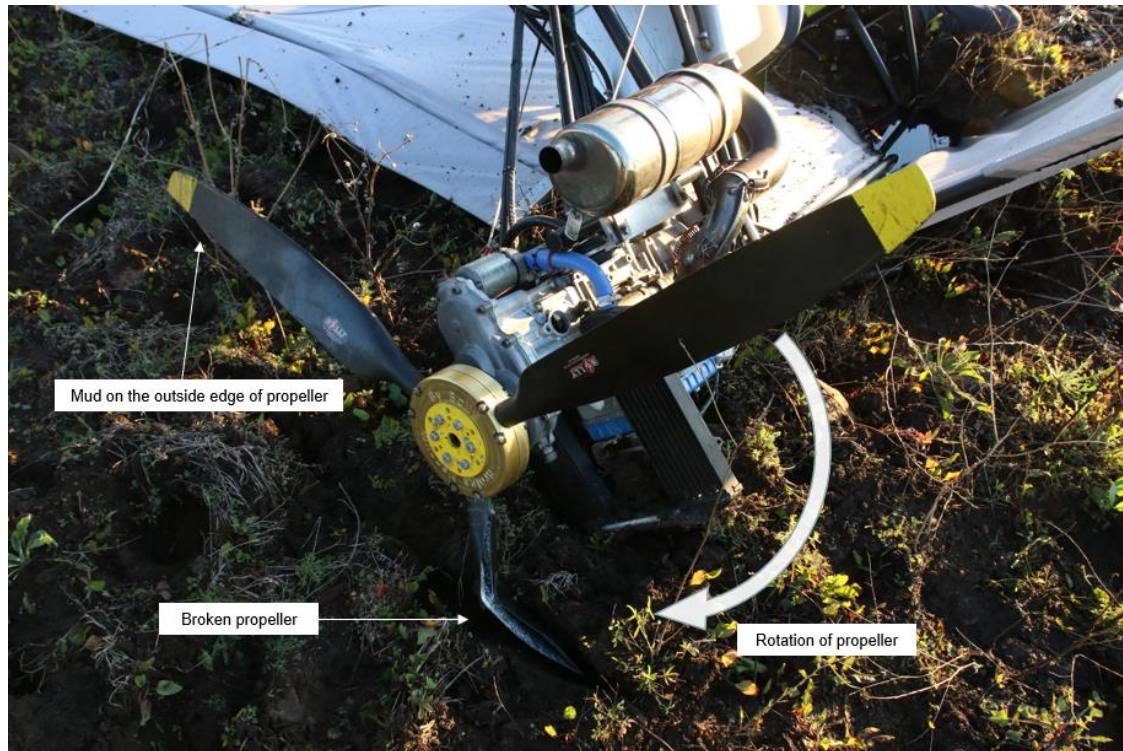
*Image 12: Propeller showing damage and mud transfer with direction of rotation.*

18. Examination of the propeller and ground nearby was completed. One blade had fractured mid-way along and was partially submerged in the soft ground. The second appeared undamaged, and the third had a light film of mud along the outer edges. This mud transfer appears to have come from the propeller carving a groove through the mud during impact. This damage and ground evidence indicates the propeller was rotating, and the engine was under power at the time of impact.

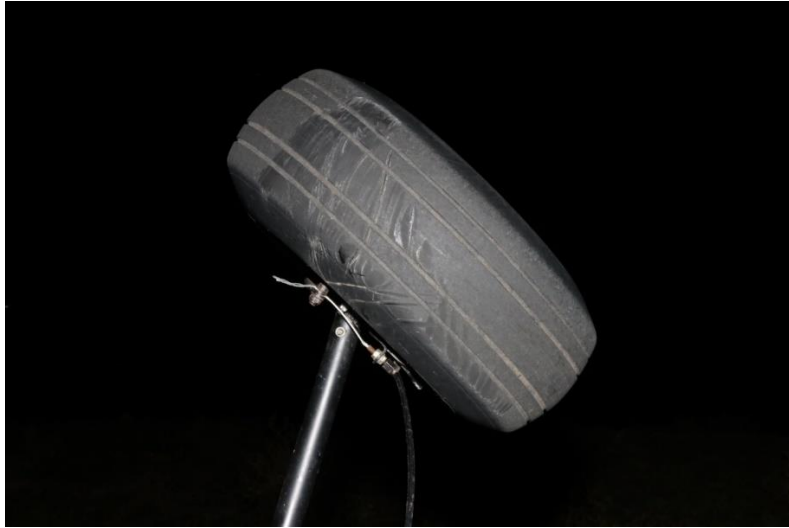
19. Closer inspection of the undercarriage located marks on both front tyres, wheel struts and undercarriage consistent with wire strike. Further inspection located points of possible arcing of electricity creating scorch marks. This evidence indicates the Drifter has struck the power lines with the front tyres, and the power lines have ridden up over the tyres becoming entangled on the wheel struts. **[Images 13, 14 and 15].**

*Image 13: Left front wheel showing impact marks of power lines.*

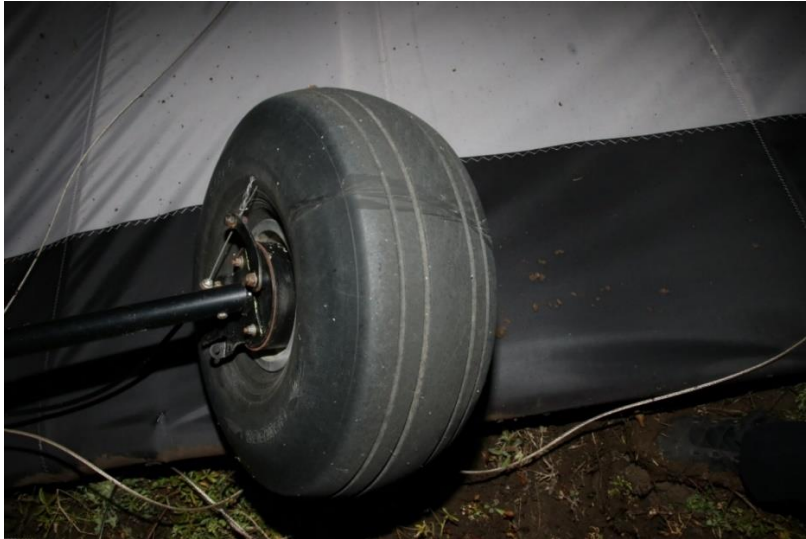
*Image 14: Right front wheel showing impact marks of power lines.*

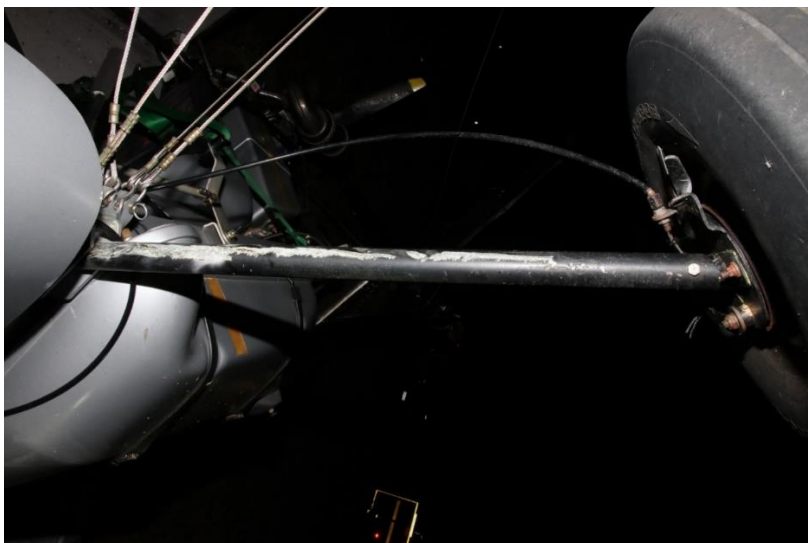
*Image 15: Left wheel strut showing damage from power line strike.*

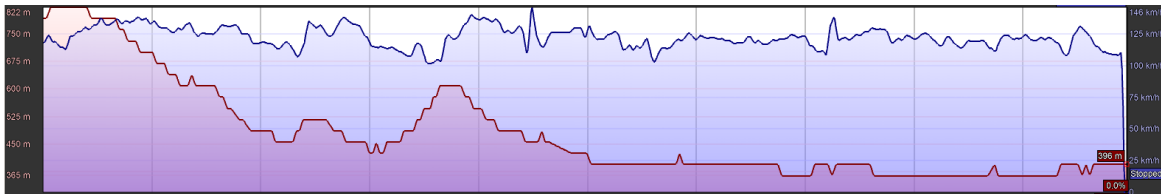
- Just prior to the crash, at 14:13 hours, the pilot was at 396m ASL travelling at 109km/hr. Topography data indicates the crash location is between 400m and 410m ASL.

- At 14:15 hours, data records the pilot speed at 0km/hr and height 396m ASL.

Image 18: Terrain/Speed profile for deceased's flight Pittsworth to 530 Malu Rd. Speed is top profile line and height is bottom profile line. Source: Runway Oz data imported into Google Earth.
