CORONERS COURT OF QUEENSLAND

FINDINGS OF INVESTIGATION

CITATION: **Non-inquest findings into the death of a 5-year-old boy**

CATCHWORDS: CORONERS: Non-Inquest findings- Fire- Rural property- Child- Modified motorcycle- Non-compliance with refuelling protocol.

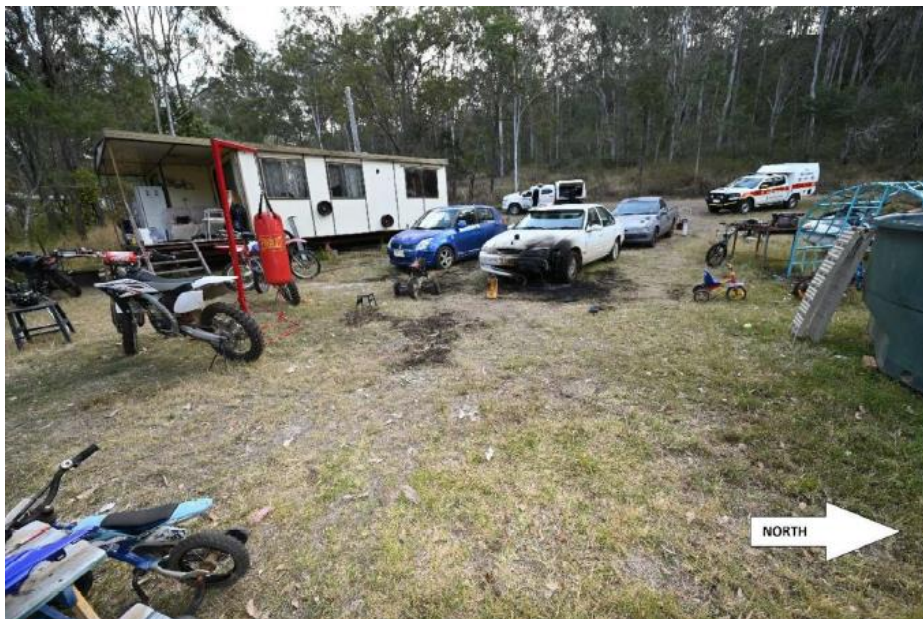
1. Scene examination revealed the following:
 - a. The incident location was a rural property with a long dirt driveway with a demountable style building used as a dwelling.
 - b. Parked outside the dwelling were several motorcycles and vehicles, including the subject motorcycle and the Ford sedan which were parked approximately 1.2 metres at the closest point.

Incident scene looking west.

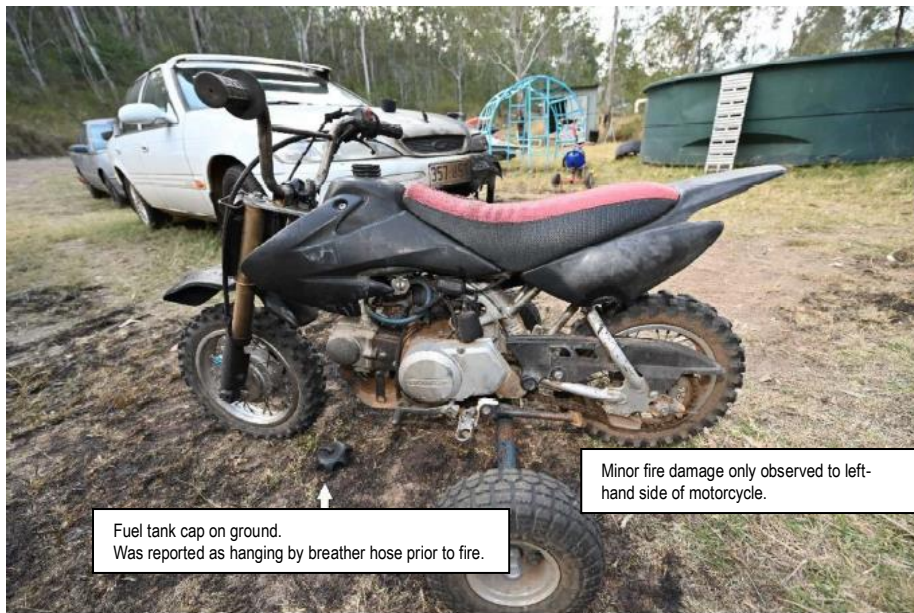
- c. The subject motorcycle:
 - i. Significant fire damage was observed to the right-hand side of the motorcycle (the exhaust side and front guards), closest to the Ford.
 - ii. The ignition switch was in the ON/RUN position and the fuel cap was on the ground on the left side of the motorcycle.
 - iii. No signs of fire damage were observed to the spark plug, lead or boot of the motorcycle.

Left-hand side of Honda

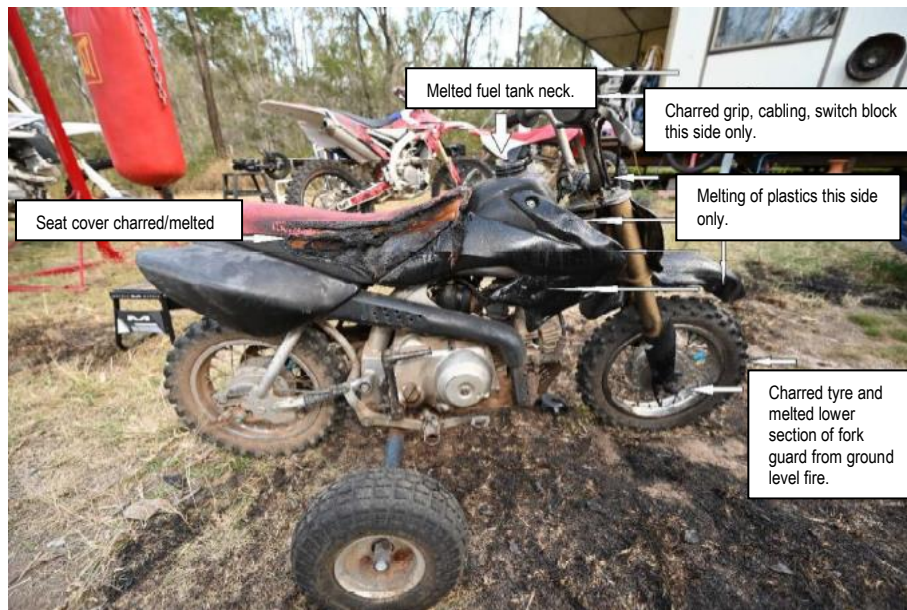
- iv. Melting, deformation and char was observed to the external plastic components including handlebar switch block, fuel tank, fairing, front mudguard, fork guard and vinyl seat cover, indicating exposure to intense heat. The most intense fire damage was observed to the upper section of the motorcycle.
- v. With the seat and fairings removed, isolated areas of minor melting and char of the inside surfaces of the seat and fairings, other plastic componentry and wiring insulation were observed, indicating short term exposure to heat and combustion gases.
- vi. The fire patterns displayed across the motorcycle indicates exposure to a fire developing across or near its right-hand side external surface.

Right-hand side of Honda

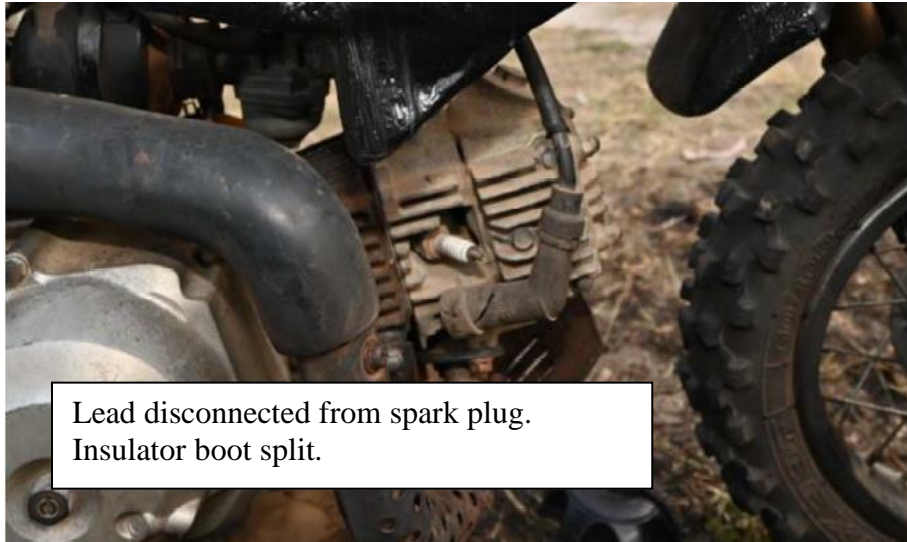
Spark plug and lead, right-hand side of Honda

- c. Electrical short circuit or arc- electrical arc from split in spark plug lead.
11. Because all 3 were considered as competent ignition sources, the cause of the fire is classified as 'undetermined'.

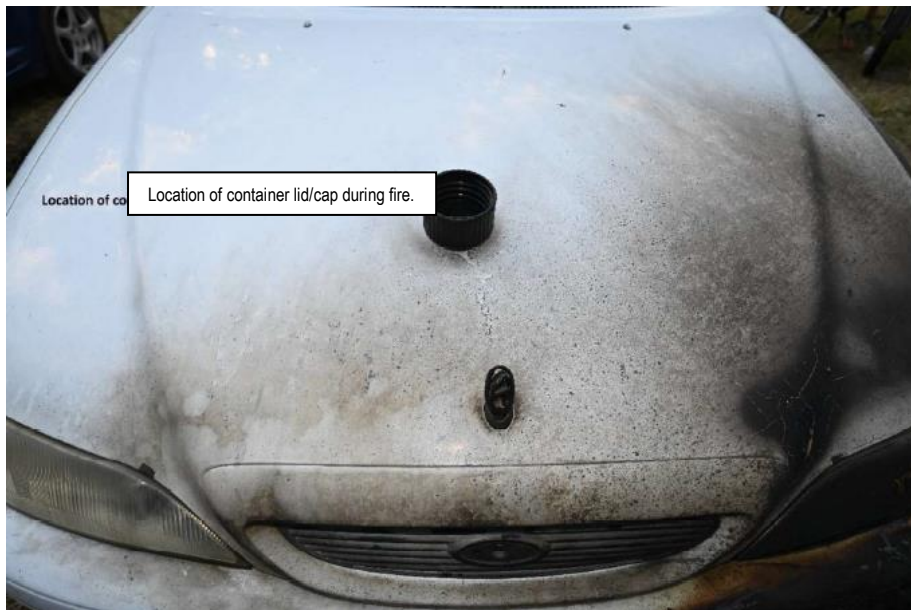
- d. On the ground between the motorcycle and Ford sedan was a yellow fuel container which was partially fire damaged, and the cap was on the bonnet of the sedan.

Lid/cap in-situ on Ford bonnet

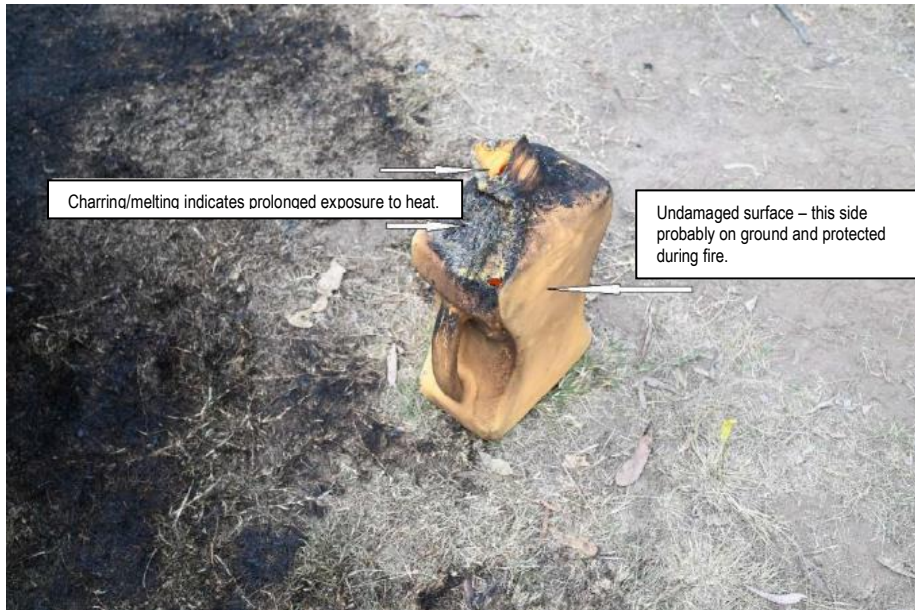
- e. The container was identified as a FAST FILL FUEL JUG manufactured by O NEAL, having a capacity of at least eight litres. The lid/cap on the Ford's bonnet was identified as a compatible manufacturers accessory for the fuel jug.
- f. The fuel jug was observed on the ground, on its base, adjacent to the area of most intense burning near the Ford. It is undetermined as to the exact location and position of the fuel jug during the development of the fire.
- g. Consumption, melting and char was observed to the top surface of the jug, including the threaded neck/orifice. Smoke staining was observed across three sides while the remaining side and base were free from fire damage.
- h. No liquid was present within the jug at the time of examination.

- i. The fire patterns displayed across the external surfaces of the fuel jug indicate prolonged exposure to intense heat and fire.

Fuel jug

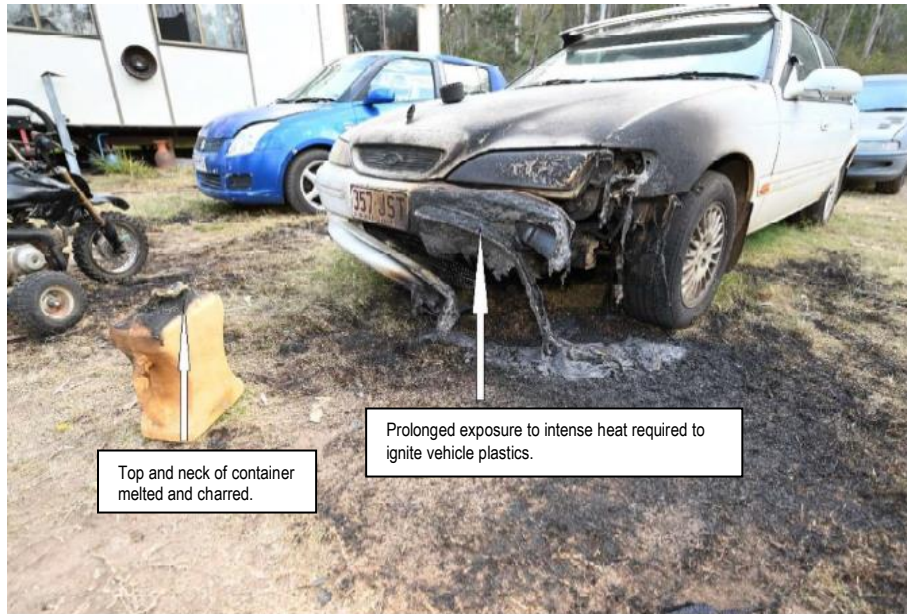
- j. The Ford:
 - i. The left-hand front corner of the Ford displayed signs of severe fire damage.
 - ii. Consumption, melting and char was observed to the lower section of the plastic bumper bar, indicating prolonged exposure to intense heat. The fire damage decreased in intensity with distance in all directions across the front section of the vehicle.
 - iii. Heavy smoke staining extended across the bonnet where the plastic lid/screw cap was located. A clean section of bonnet was observed under the lid/cap indicating it was in that location during the development of the fire.
 - iv. The fire patterns displayed across the Ford indicates exposure to an intense fire developing at or near to ground level adjacent to its left-hand side front corner external surface.

Intense burning to localised area of Ford
