FINDINGS OF INQUEST

CITATION: Inquest into the death of Maximilian Patrick MCDOWALL

CATCHWORDS: Coroners: Inquest, Cyclist deceased in road traffic crash with Brisbane City Council bus, simultaneous traffic light access to both cyclist and bus, Brisbane City Council Bus driver blind spots, failure of bus driver to observe cyclist, failure of cyclist to appreciate danger, improvements to traffic light signalling and bus driver awareness systems.

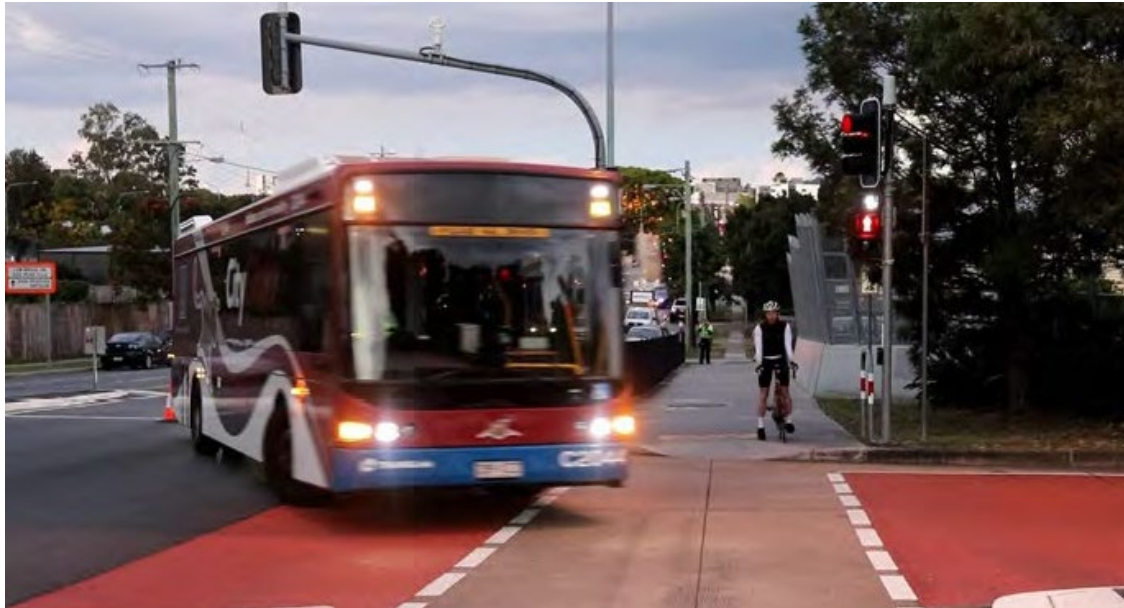
Image 2: Reconstruction photograph (orientated east) of the intersection of O'Keefe Street and the south-east busway, Woolloongabba. The cyclist is in the identical starting position of Max about to head west across pedestrian crossing and the bus is turning in a similar matter to the bus that struck him on his bicycle in the right foreground area of this photograph.

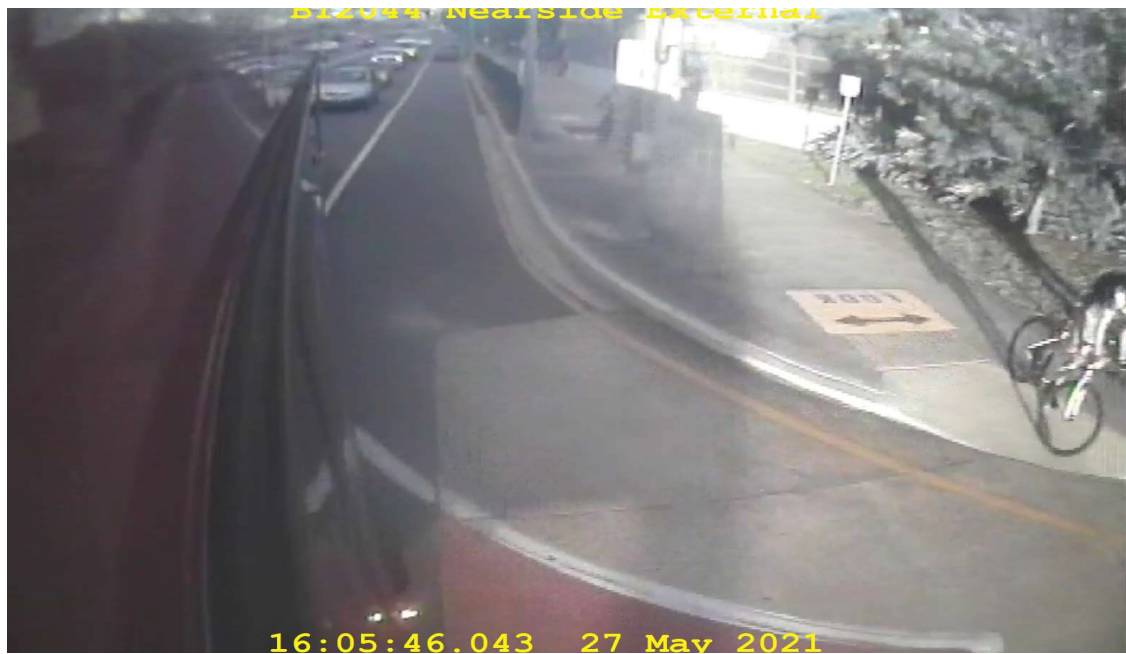
Image 3: CCTV Footage just prior to this road traffic crash

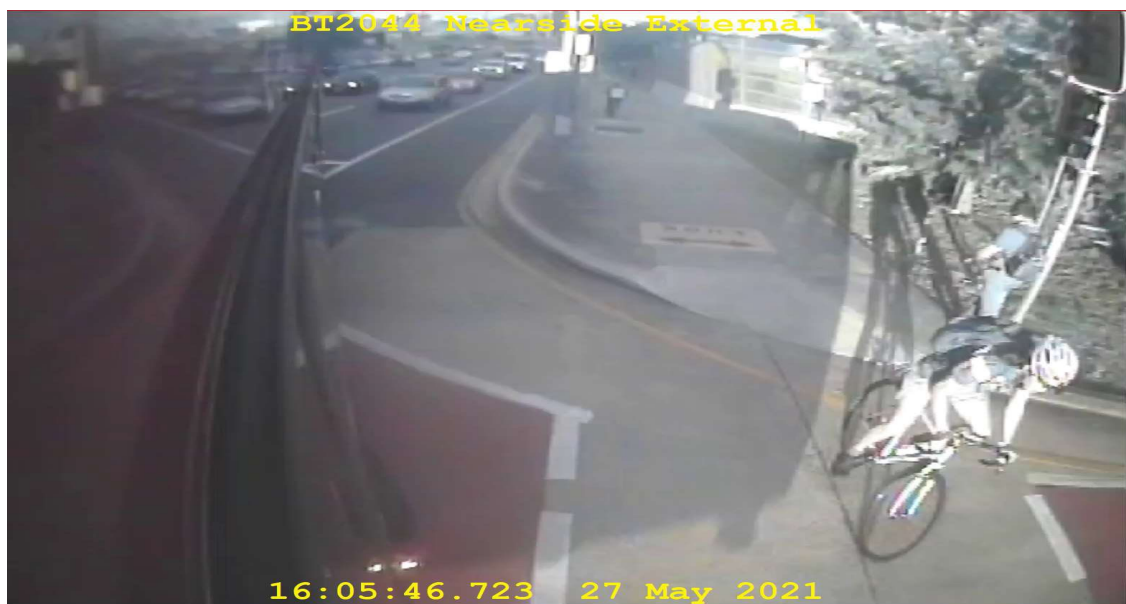
Image 4: CCTV Footage just prior to this road traffic crash

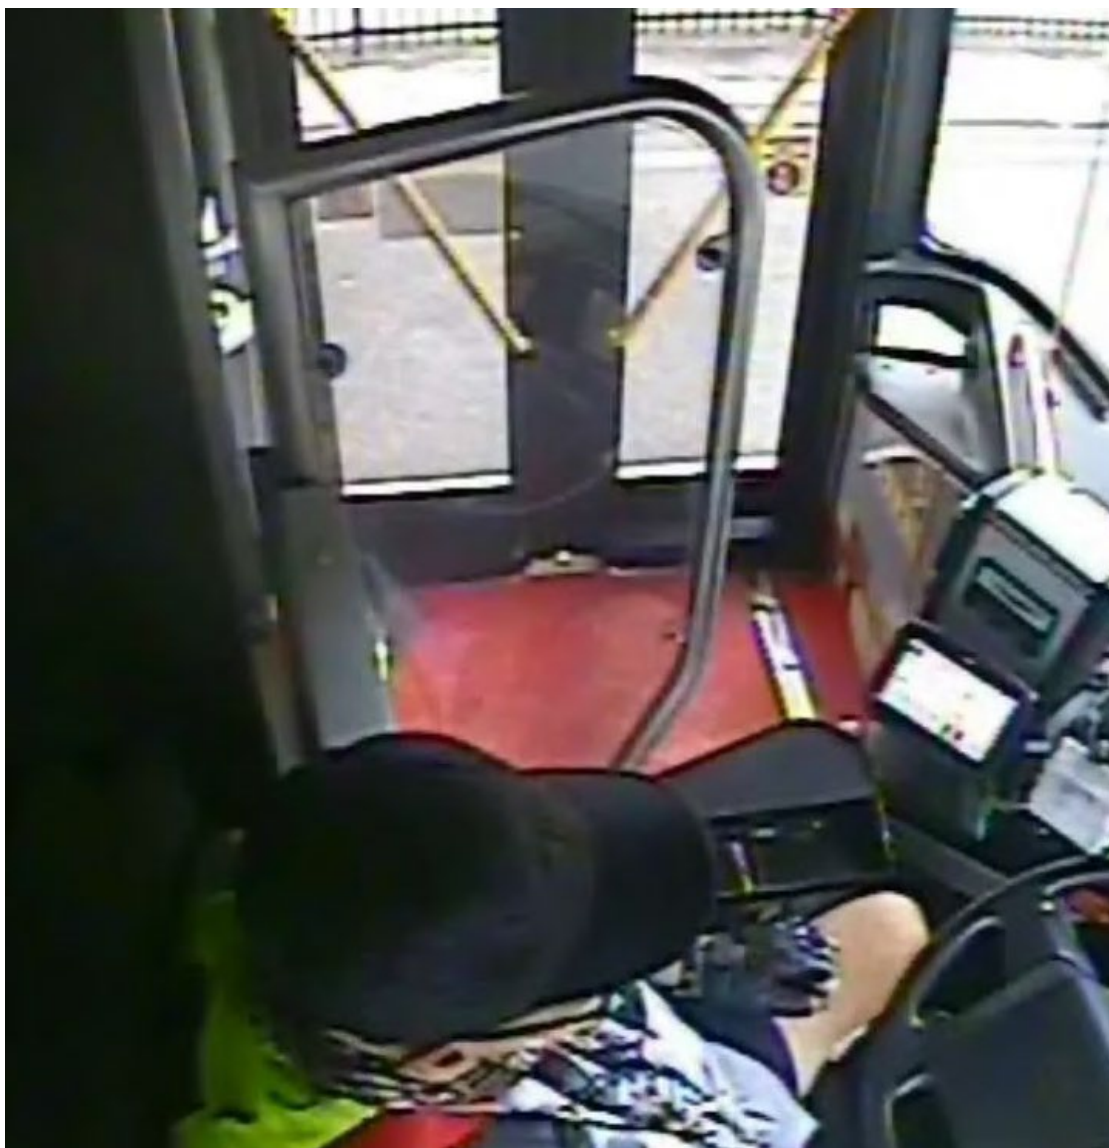
21. A still image from the bus CCTV shows Mr Rudnicki in his normal sitting position:

Image 3: A still image from the bus CCTV17 shows Mr Rudnicki in his normal sitting position

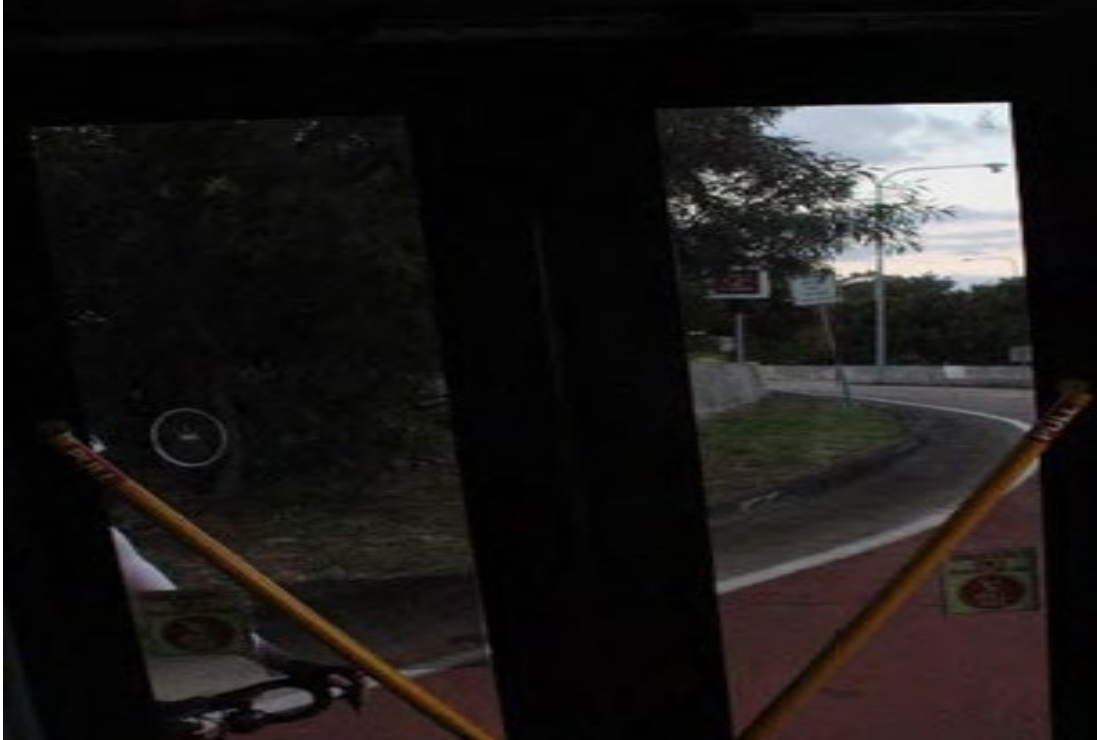
Image 4: Approximate position of Max from slightly in front of the bus driver's seat from the re-construction. Noting that this is an approximate impact position, based on the CCTV footage – see evidence SGT Cutler, Transcript Day 1; 1-14; lines 40-46.

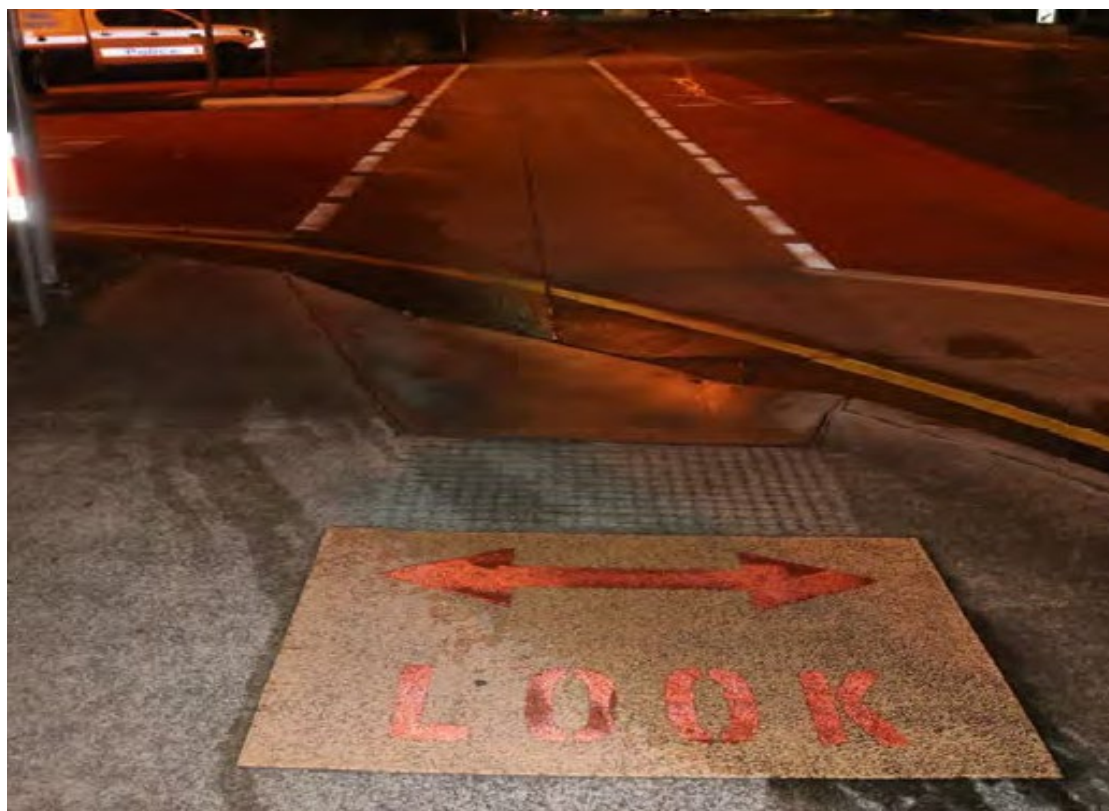
Image 6: Photograph taken at night hours after this road traffic crash (orientated west – the director of travel of Max across the pedestrian lane).

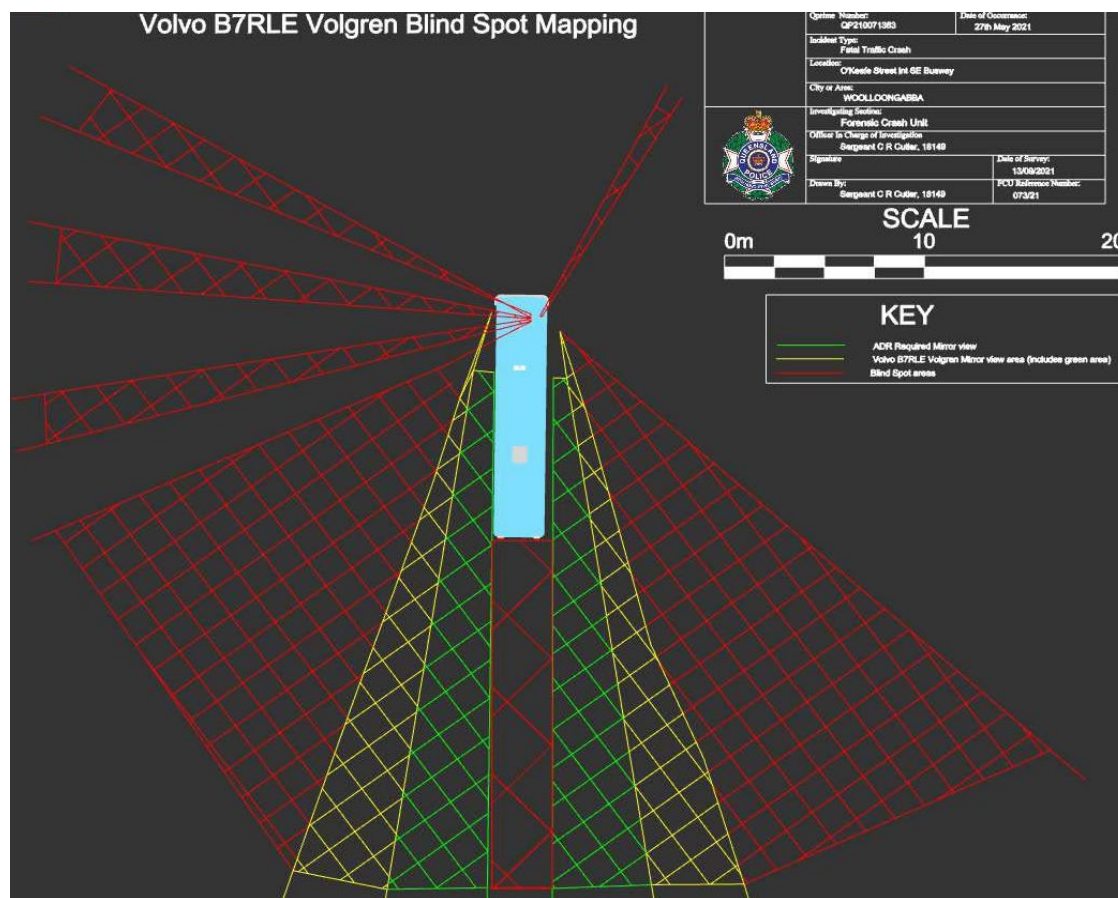
36. SGT Cutler considered there were blind spot issues with the bus, so as part of his investigation he arranged for the bus to be mapped so as to identify areas which could not be viewed from the driver's position either by direct line of sight or by use of the mirrors. This process included liaison with the Department of Transport and Main Roads (DTMR), in order to establish the required minimum field of vision when using the external rear view mirrors.²⁰
37. A number of maps and diagrams were examined. First, a map indicating the blind spots on the bus in a neutral position, as follows:

38. The coloured areas were indicative of the following:
- (i) The green area represented that which was required by regulation to be able to be viewed by the external mirrors;²¹
 - (ii) The yellow area represented actual external mirror view when one looked through it;
 - (iii) The red represented the external blind spots for the driver of the bus;²²
 - (iv) The black areas or the areas without the cross-hatching represent where the driver can see unaided or without obstruction.²³

- 110. RECOMMENDATION 3: I recommend that the Brisbane City Council and Translink Services install in its full fleet, technology of the type described as "mobile eye" and "camera mirrors" to assist bus drivers identifying hazard awareness training for pedestrians and cyclists.**

1. The existence of multiple blind spots preventing Mr Rudnicki from becoming aware of Max's position behind and at the left-hand side of the bus. Ancillary to this cause was the lack of training of BCC bus drivers in respect of these blind spots.
