CORONERS COURT OF QUEENSLAND

CITATION: Non-Inquest findings into the deaths of Ashley Pangana MORRIS, 2016/4191 and Humbereto Ferreira LEITE, 2016/4194

CATCHWORDS: Coroners: Inquest, Work, Health and Safety Fatalities, Reckless practices by contractor, two workers crushed by overhead concrete slabs lowered into a pit; Inadequate safety strategies in place; Mental Health Court ruling contractor permanently unfit to plead to manslaughter charge.

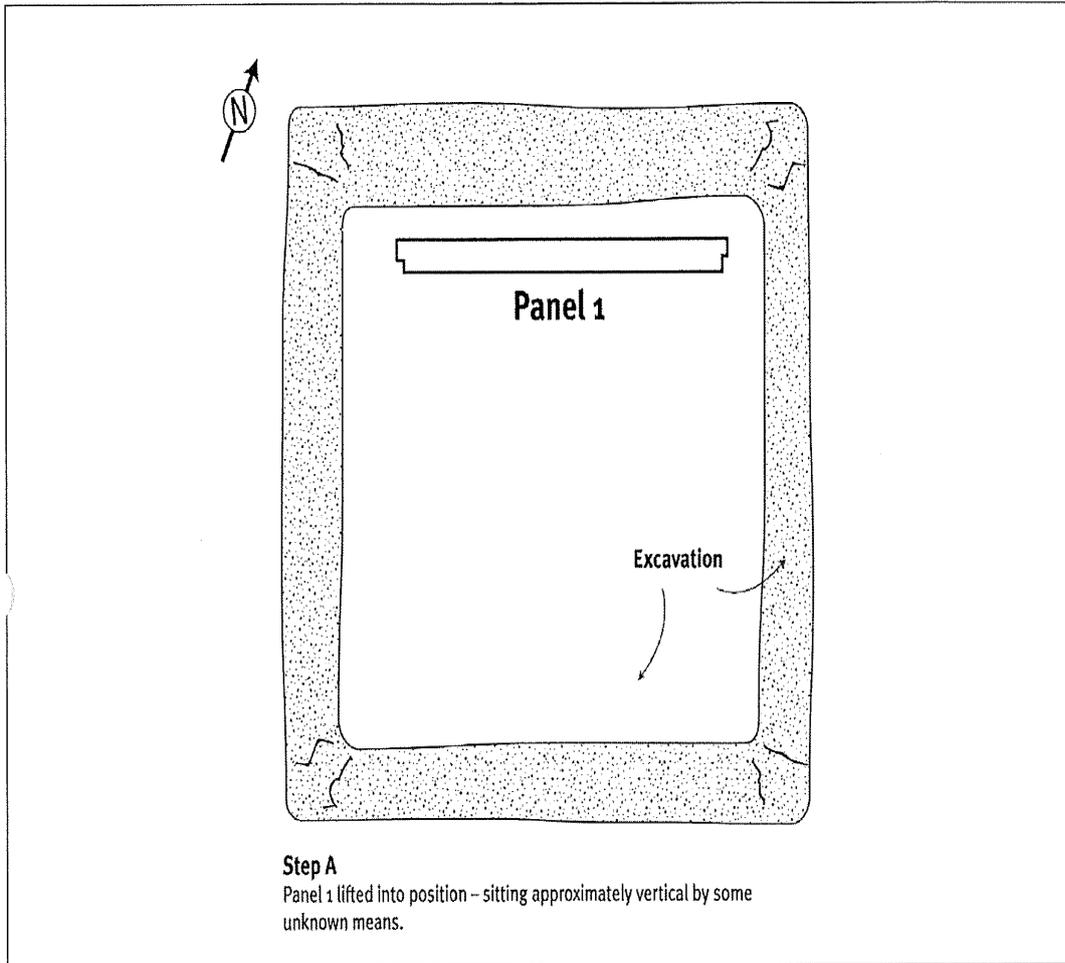
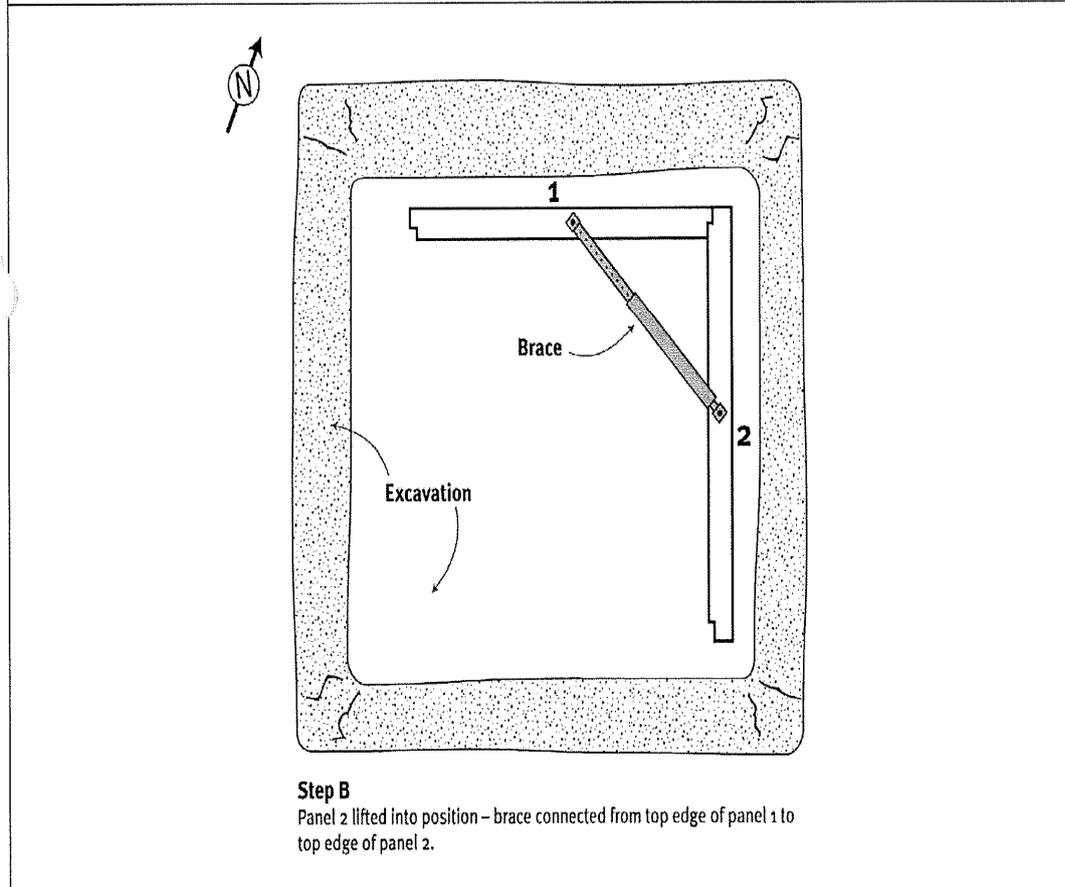
Appendix 2 – Diagrams showing likely sequence of events associated with the incident

50. The following diagram which was Annexure 2 to the WHSQ Final Report graphically outlines this tragedy in steps "A" to "F":

49. From WHSQ's assessment of the incident, it was considered likely that the fourth panel contacted the other panels with enough force to cause one or more of the braces to panel connections to catastrophically fail. With the braces no longer ensuring the panels remained vertical, the panels became unstable. An unsuccessful attempt appears to have been made by Mr Morris and Mr Leite to vacate the pit using the ladder scaling the walls and they were both fatally crushed by the panels, instantly.

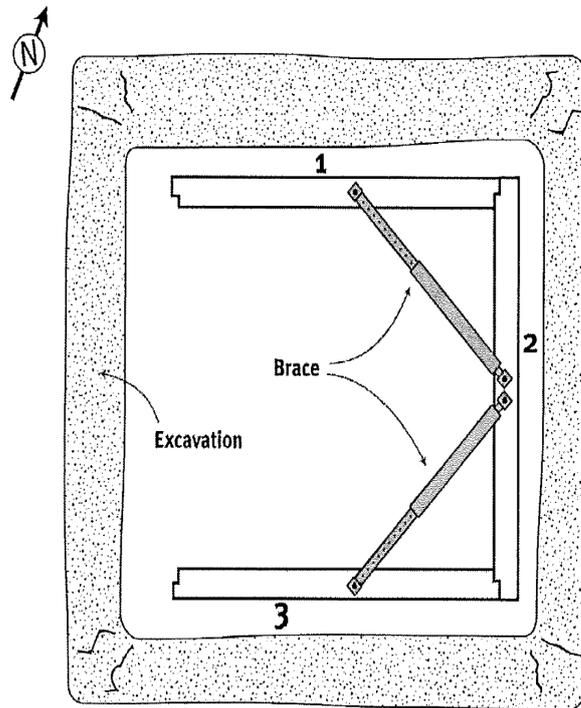
Step C
 Panel 3 lifted into position – brace connected from top edge of panel 2 to top edge of panel 3.

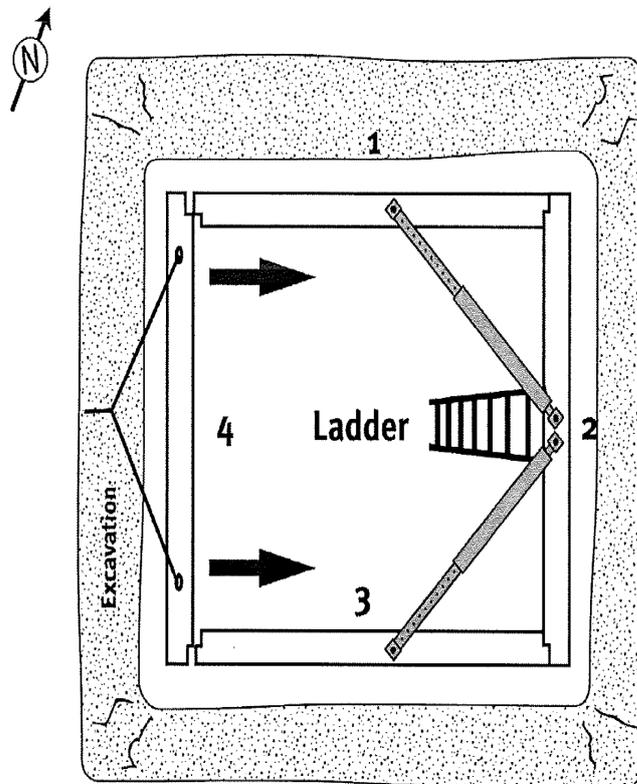
Step D
 Panel 4 lifted into trench. Attempt to line its edges up with panels 1 and 3. Forces from panel 4 cause one or more brace connections to fail. Workers attempt to escape with ladder up panel 2.

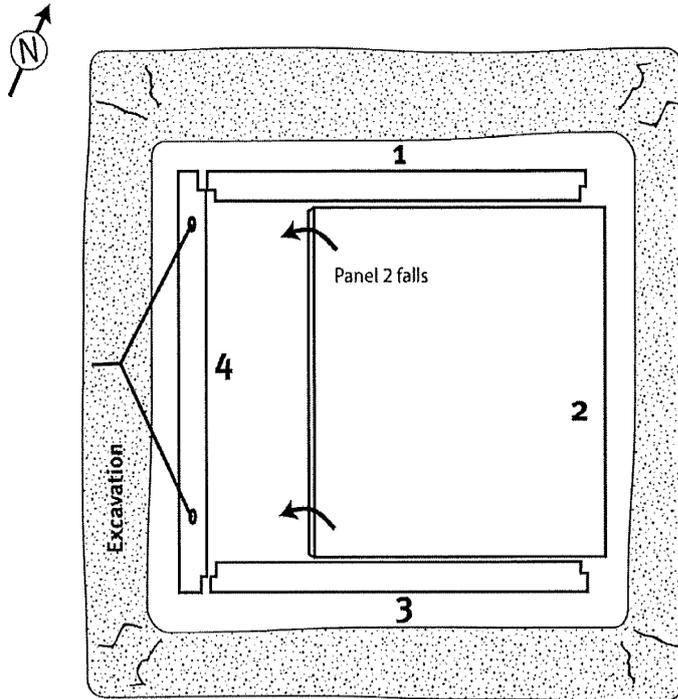
Step E

Panel 2 falls into the excavation. Ladder and workers flicked off. Workers and ladder end up on top of panel 2 when it falls flat.

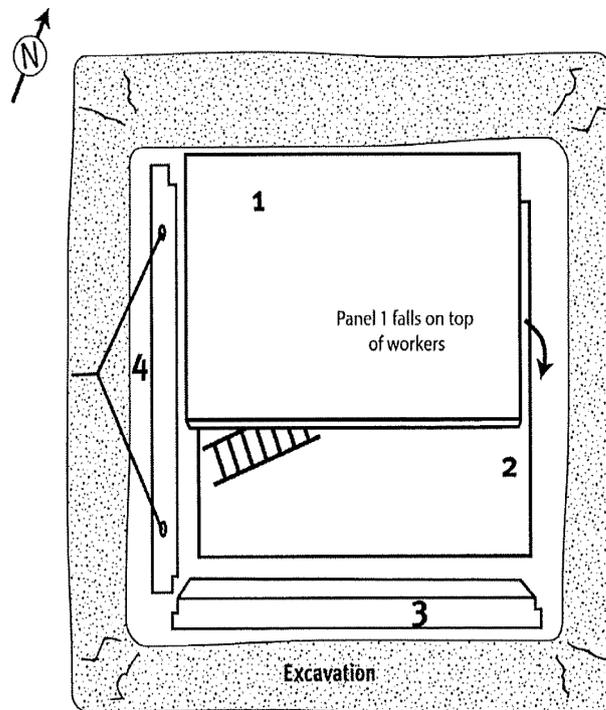
Step F

Workers are on top of panel 2. Panel 1 becomes unstable and falls on top of them. Panel 3 remains leaning against the excavation wall. Panel 4 remains near vertical on the crane hook.

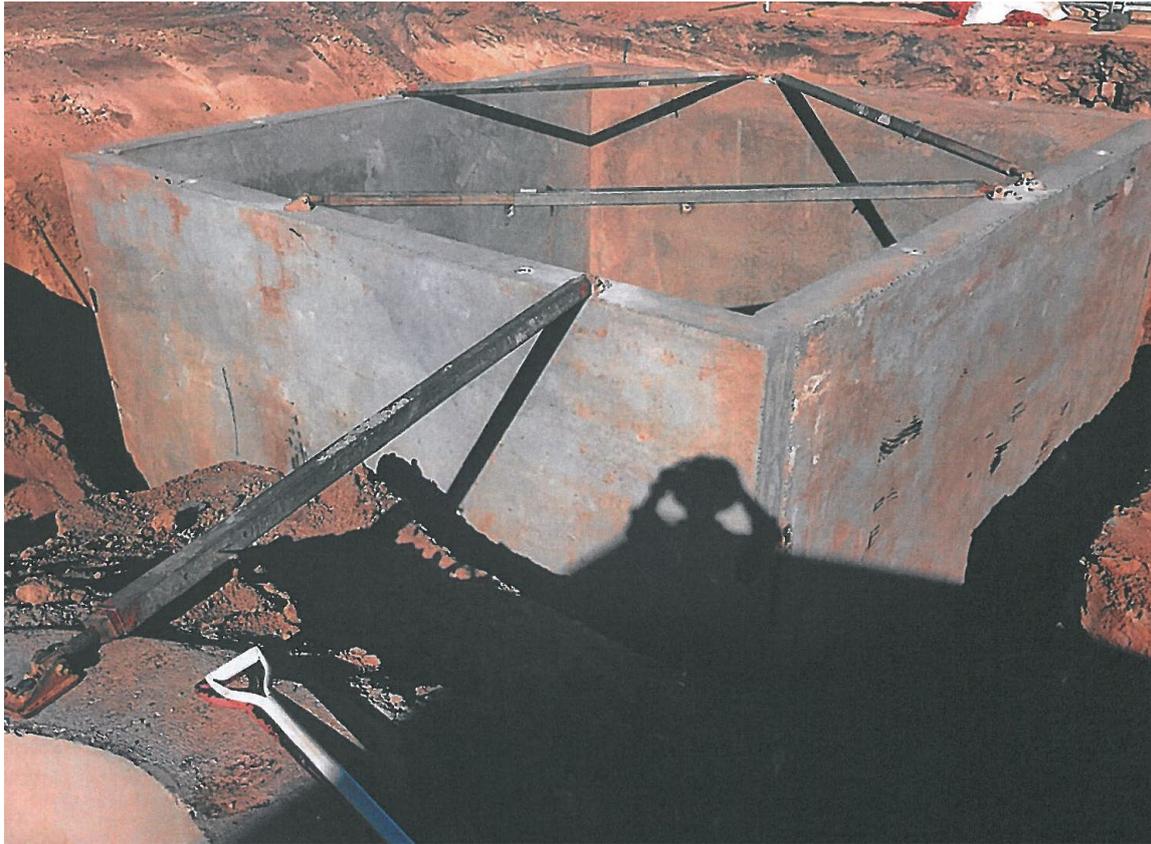
Image 2: A photograph taken of Tank 1 as successfully constructed by Mr D'Alessandro's team on 30 September 2016. This was the result hoped to have been achieved on 6 October 2016.

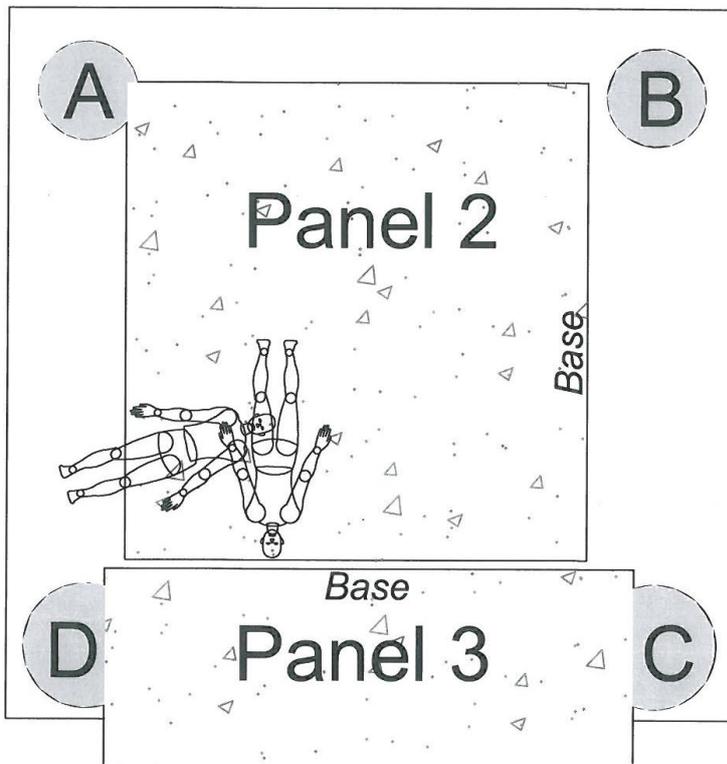
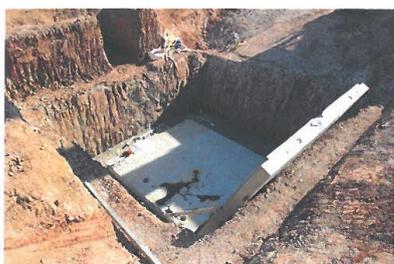
Pit Plan

Eagle Farm Race Course Redevelopment
Foul Water Drainage Settling Tank Site

Image 3: A plan and photograph of the pit following the extraction of the deceaseds' bodies. The photograph does not accurately depict the pit prior to the fatalities occurring because items and ground fill was removed in the extraction process.

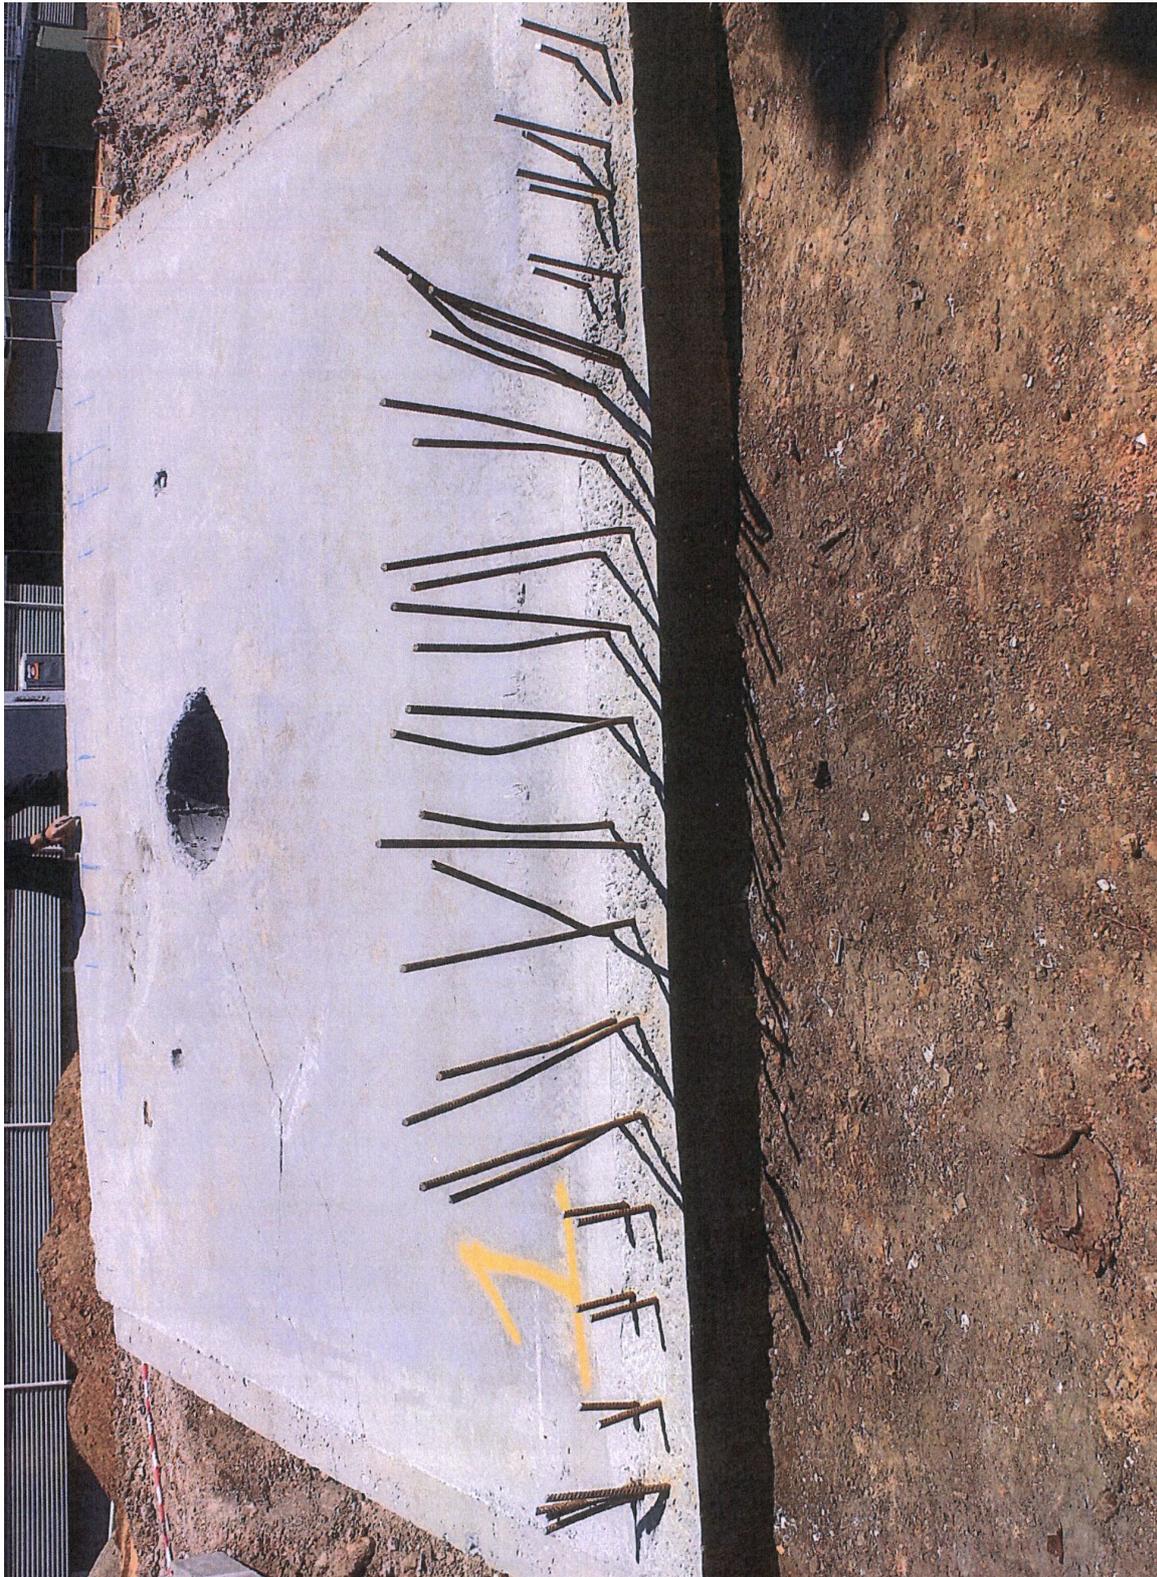
Image 4: Panel 1 having been removed from the pit taken on 12 October 2016.

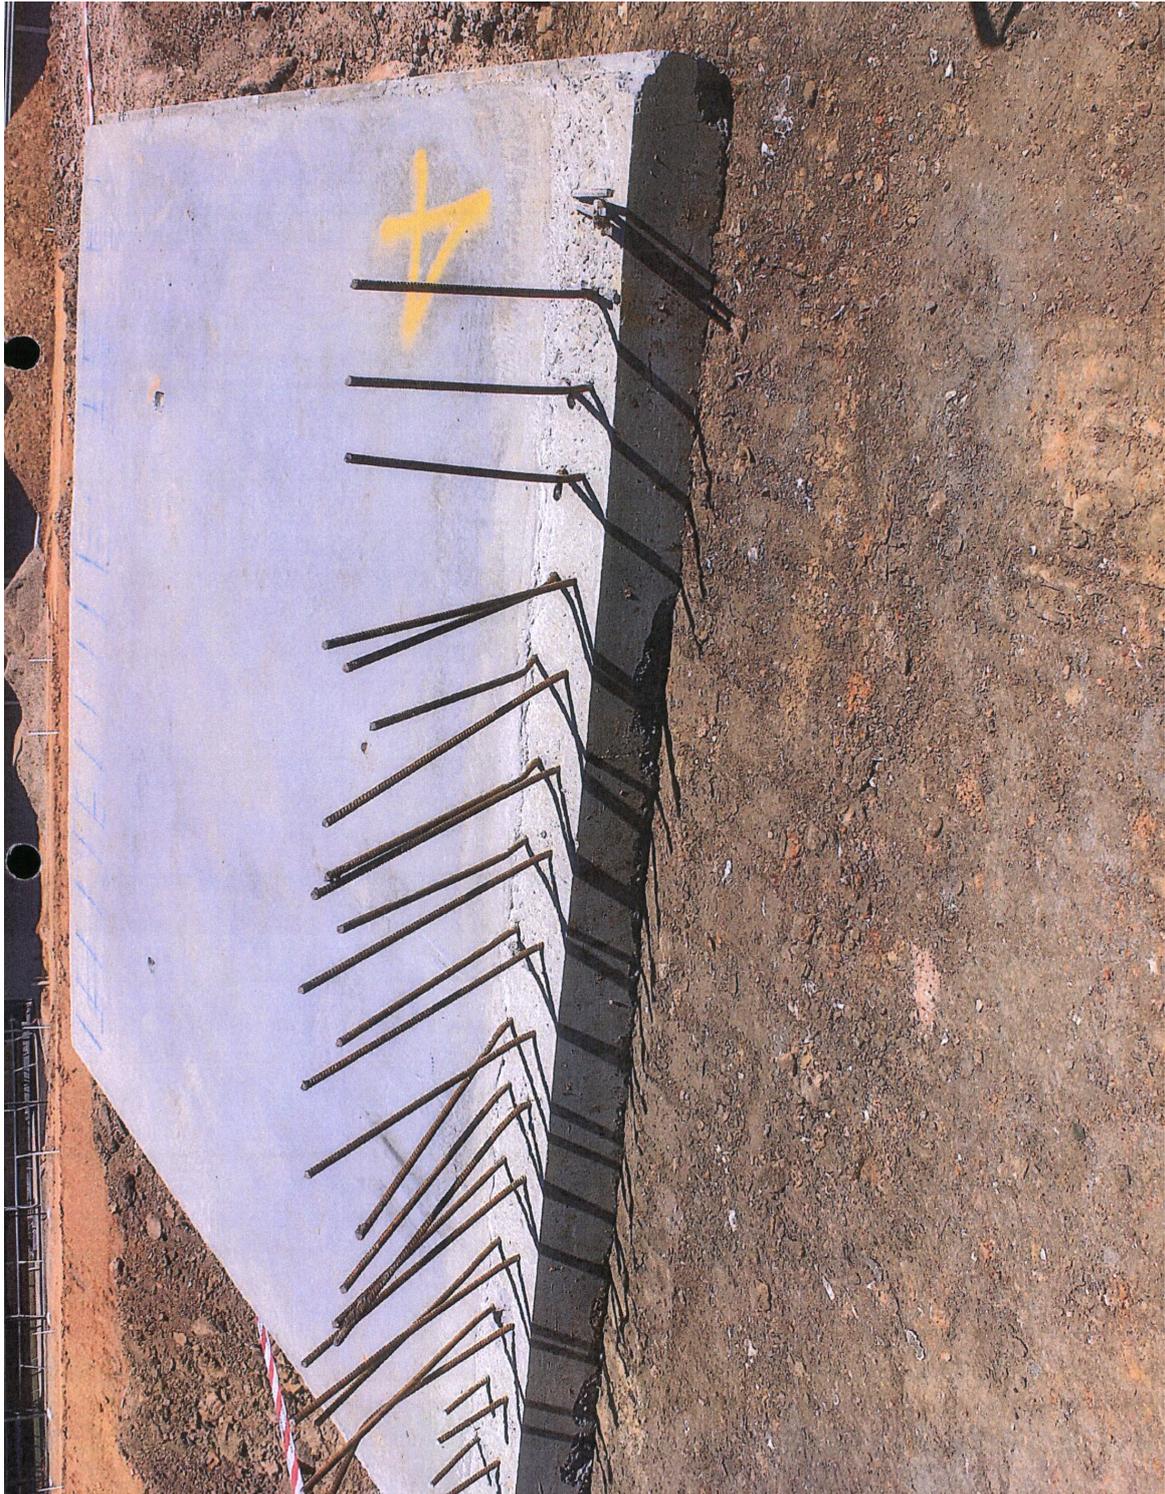
Image 5: Panel 4 having been removed from the pit taken on 12 October 2016.

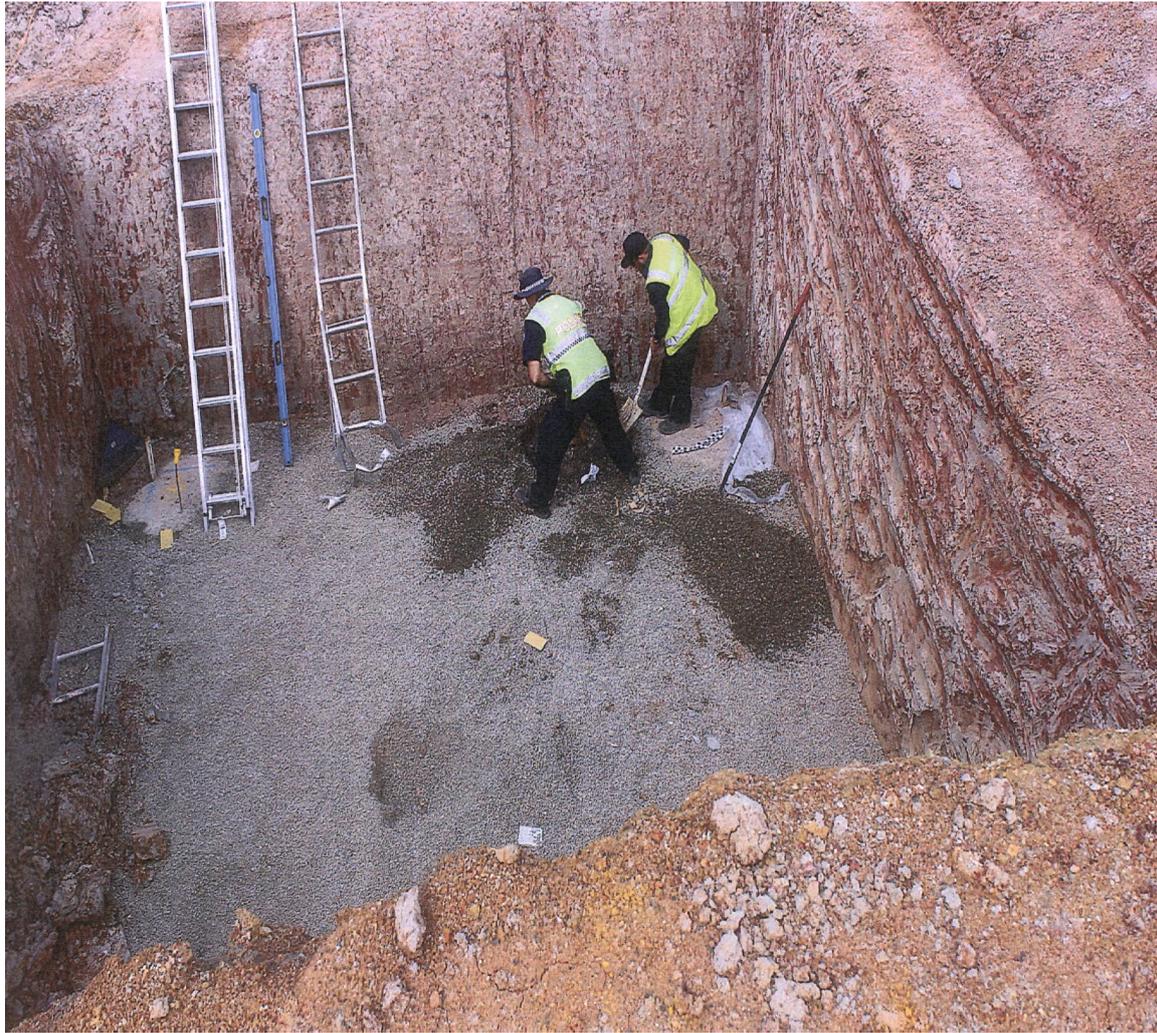
Image 6: Photograph of investigators searching for evidence on 12 October 2016 indicating the depth of the pit in comparison to the height of the deceased.

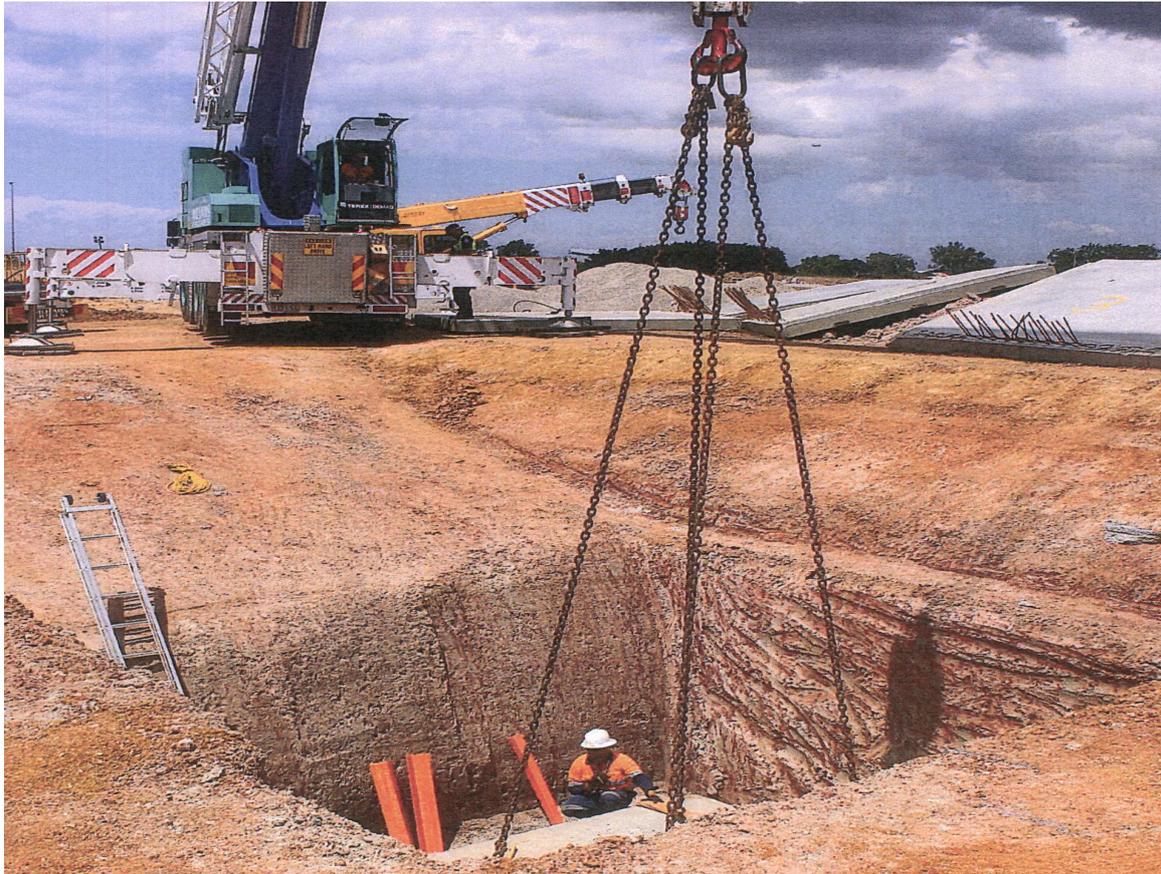
Image 7: A photograph taken on 12 October 2016 after reconstructing the crane lowering a panel to the ground as Mr D'Alessandro's team did on 6 October 2016.

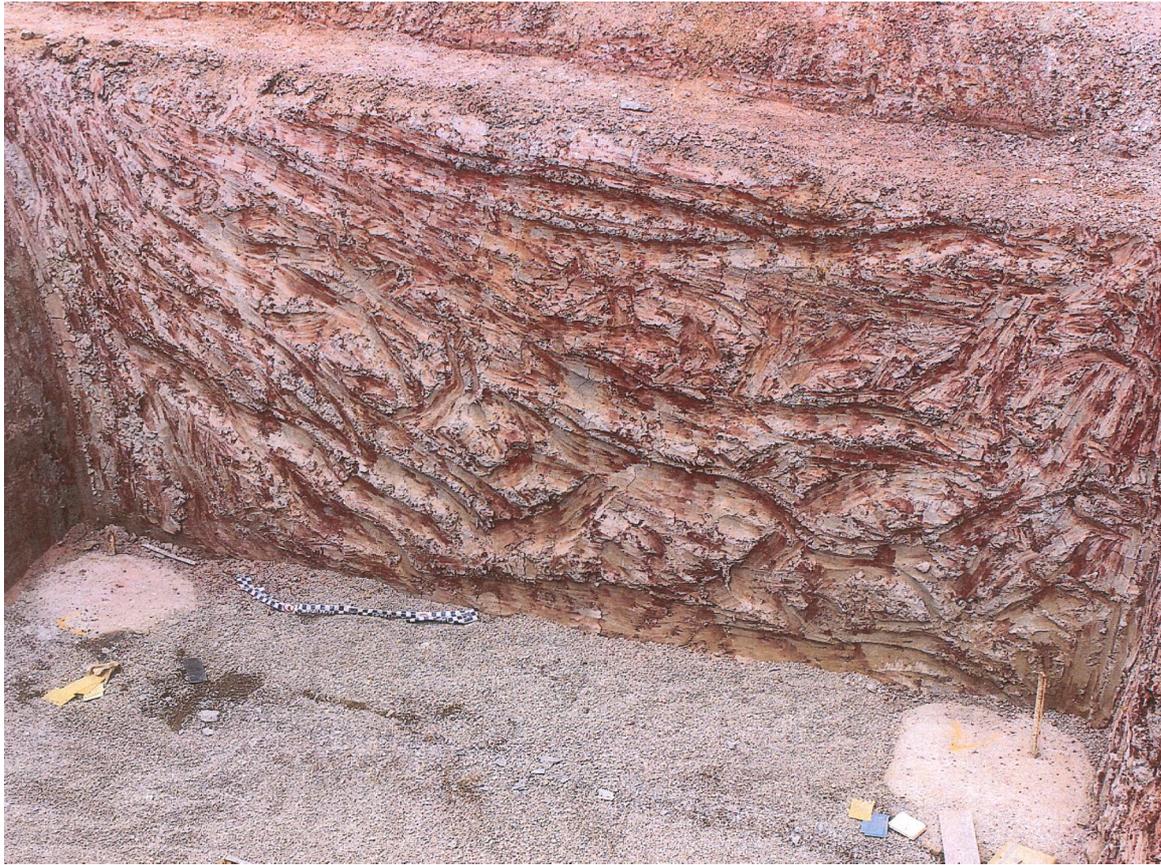
Image 8: A photograph taken on 12 October 2016 noting the absence of a concrete furrow into which the panels could have been lowered thus preventing a falling over.

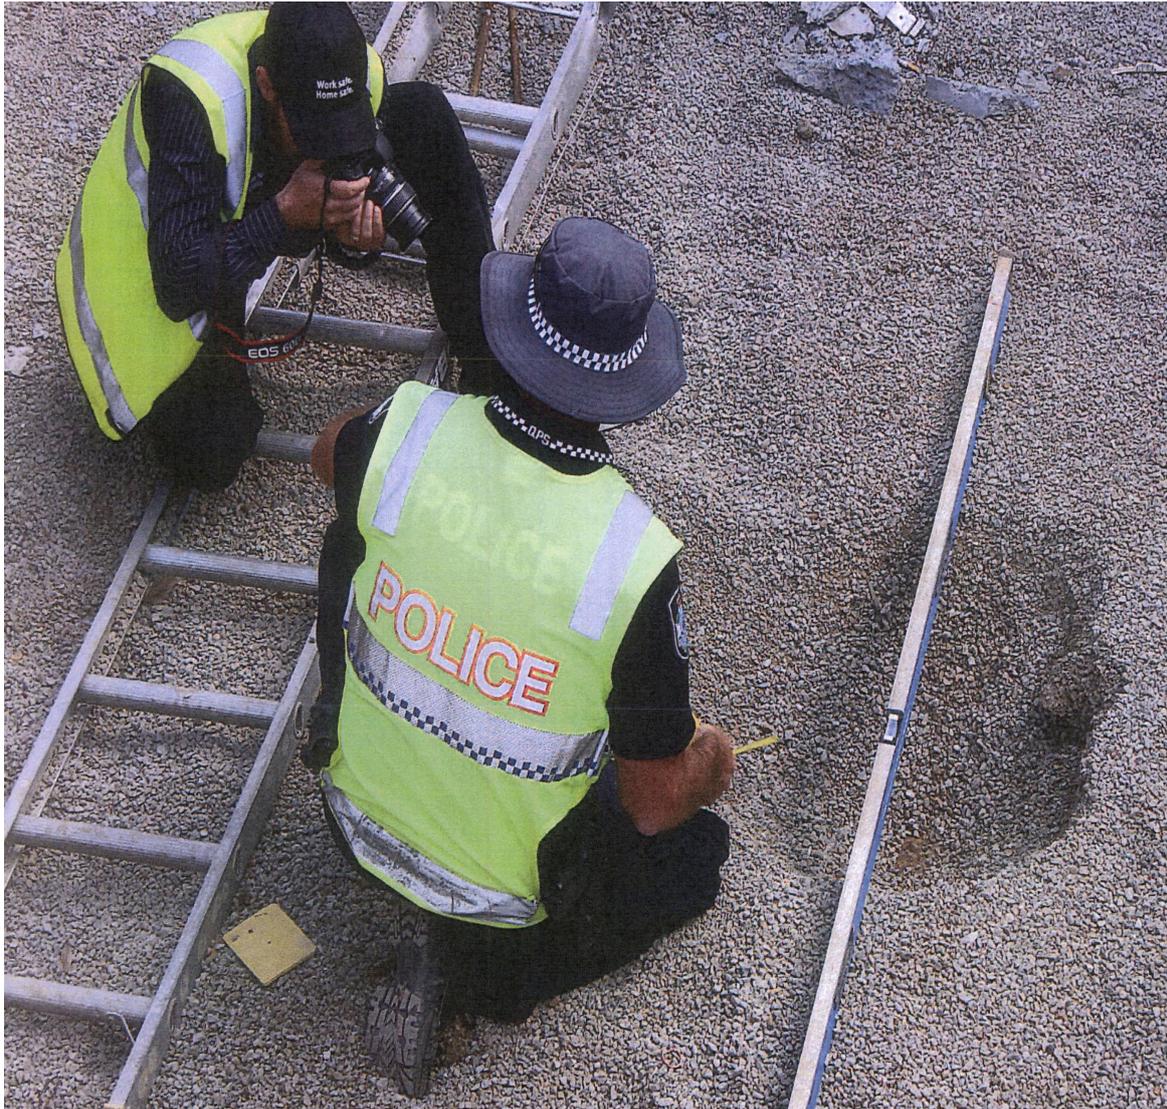
Image 9: QPS Photographing the unlevel gravel floor of the subject pit. The unstable gravel contributed to the panels' insecurity.

62. *The lack of restraint at the bottom of the panels also contributed to the instability of the panels, allowing the panels to move, resulting in failure of one or more of the brace to panel connections. Without lower lateral restraint, the lower panel edges were free to "kick out" as a result of the erection loads. There appears to have been little, if any consideration, of how lateral movement of the bottom of the panels could have been minimised.*

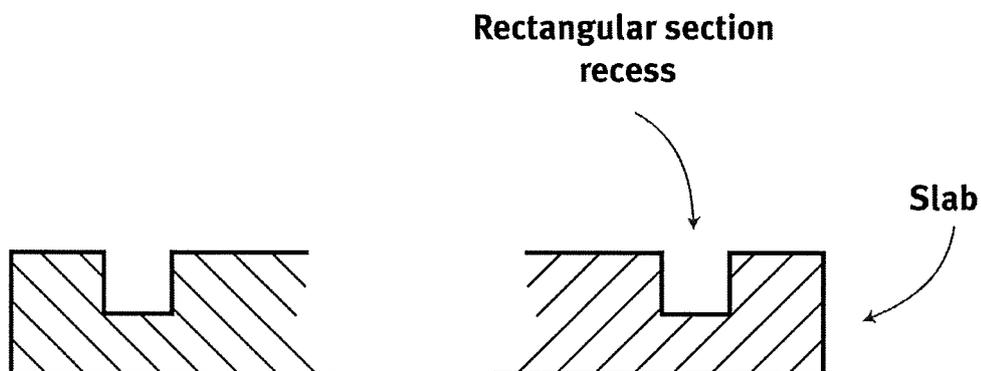
Diagram 5 – Sectional sketch of rectangular recess for panel - not to scale and for illustrative purposes

- Initially make an excavation with adequate benching and or battering to control the risk of collapse of the walls.
 - Pour a concrete slab, of adequate strength and depth, at the base of the pit that is larger than the base dimensions of the final structure and includes rectangular recesses that the wall panels can be slotted into (refer Diagrams 5 and 6). The slab and recesses are to be constructed level so that levelling shims under the panels are not required. These recesses are designed to provide lateral restraint for the bottom of the panels during erection. The slab is left for adequate time to cure (i.e. typically at least one week).

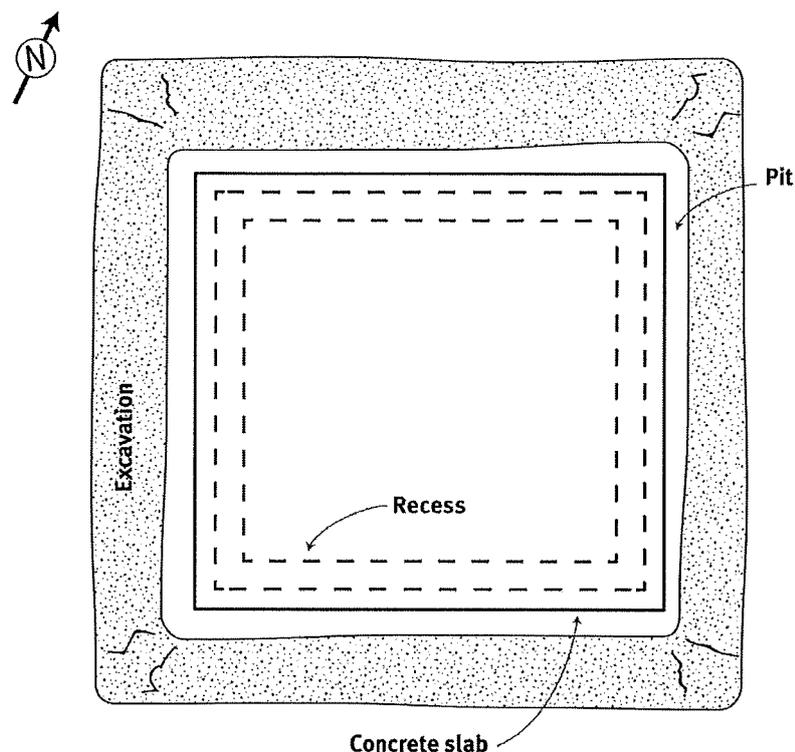
Diagram 6 – Plan sketch showing rectangular recess - not to scale and for illustrative purposes

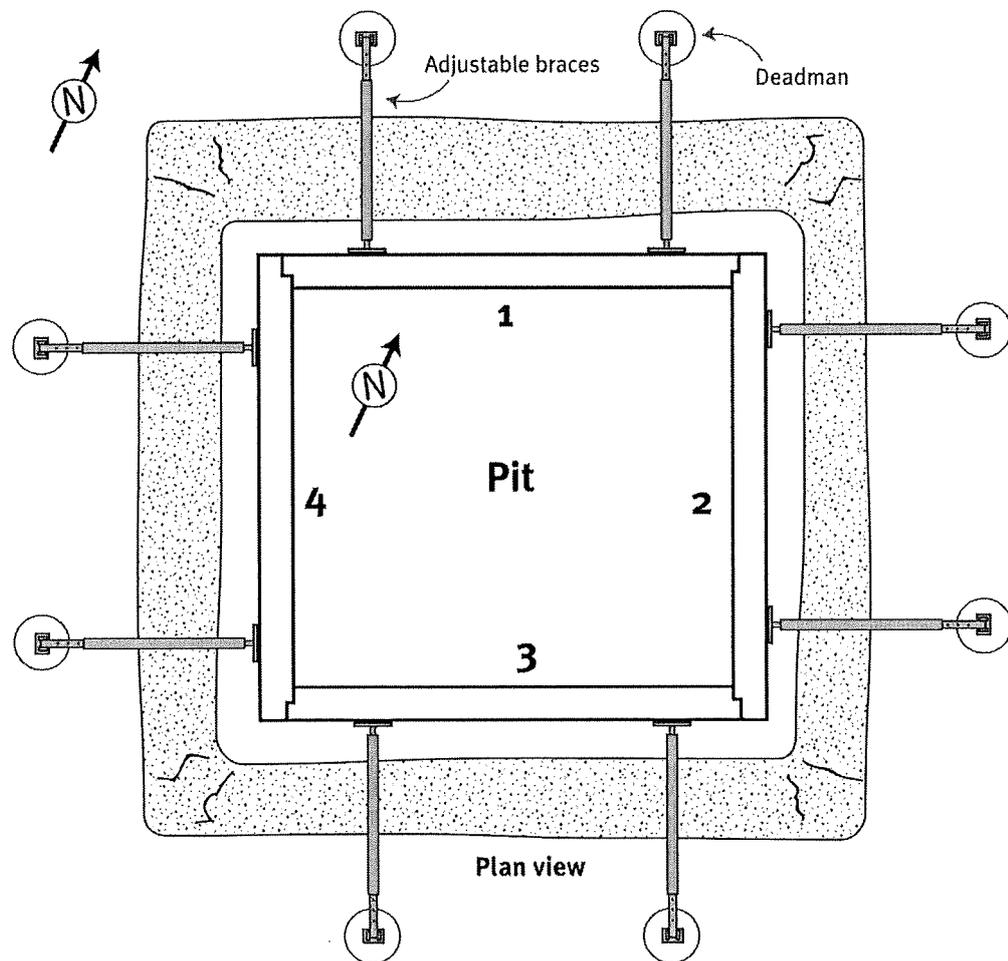
Diagram 7 – Plan view of excavation showing relative positions of panels, braces and deadmen

- f) Once a panel is sitting in a recess, with the crane still supporting the top of the panel, the end of the brace is bolted to the top of it's deadman by the Rigger(s). Once attached the position of the top of the panel can then be moved inwards or outwards using the screw adjustment on the brace (Diagram 7 shows a view from above once all braces have been attached).
