CORONERS COURT OF QUEENSLAND

FINDINGS OF INVESTIGATION

CITATION: **Non-inquest findings into the death of Pedro Miguel Ventura Enes**

CATCHWORDS: Coroners: Heavy Vehicles; Dual Tyres; High Velocity Rock Projectile into Windscreen; Regulatory Oversight; Industry Wide Risk Mitigation

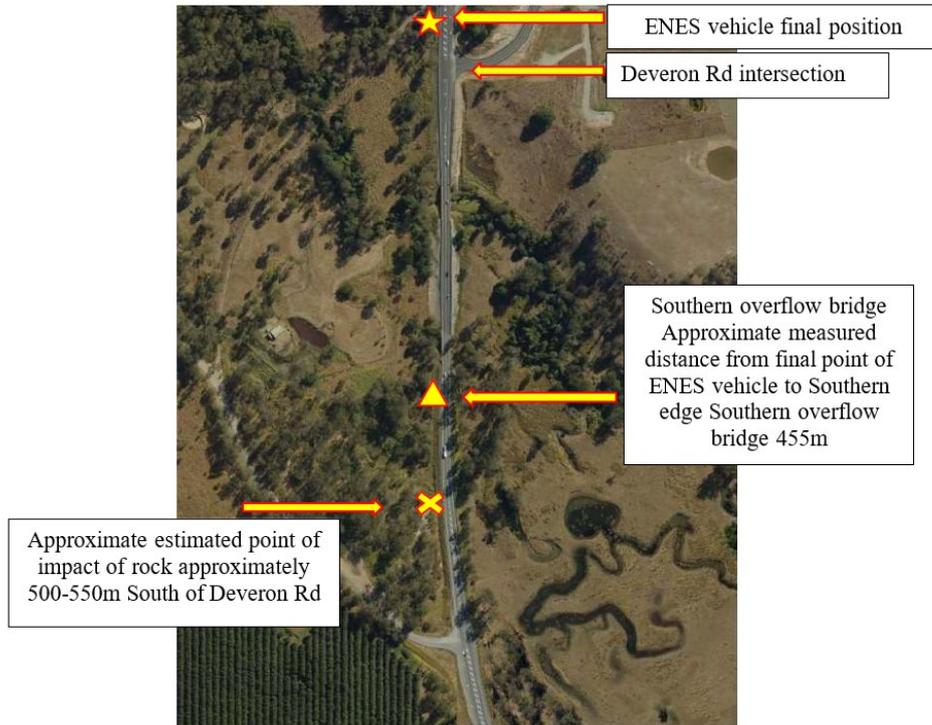
Crash scene overview

4. The site is a straight stretch of relatively new sealed bitumen surface in good condition with no apparent physical damage, defects or obstructions to the surface that would contribute to this incident. The road is a single lane in either direction approximately 3.5 metres wide with a painted double centre line separating.
5. A solid continuous fog line exists between 30-100cm from the edge of sealed surface or raised Armco railing. The Armco railing is continuous except for bridge sections where it becomes a solid poured concrete barrier post with an elevated steel horizontal railing slightly higher than the Armco rail.

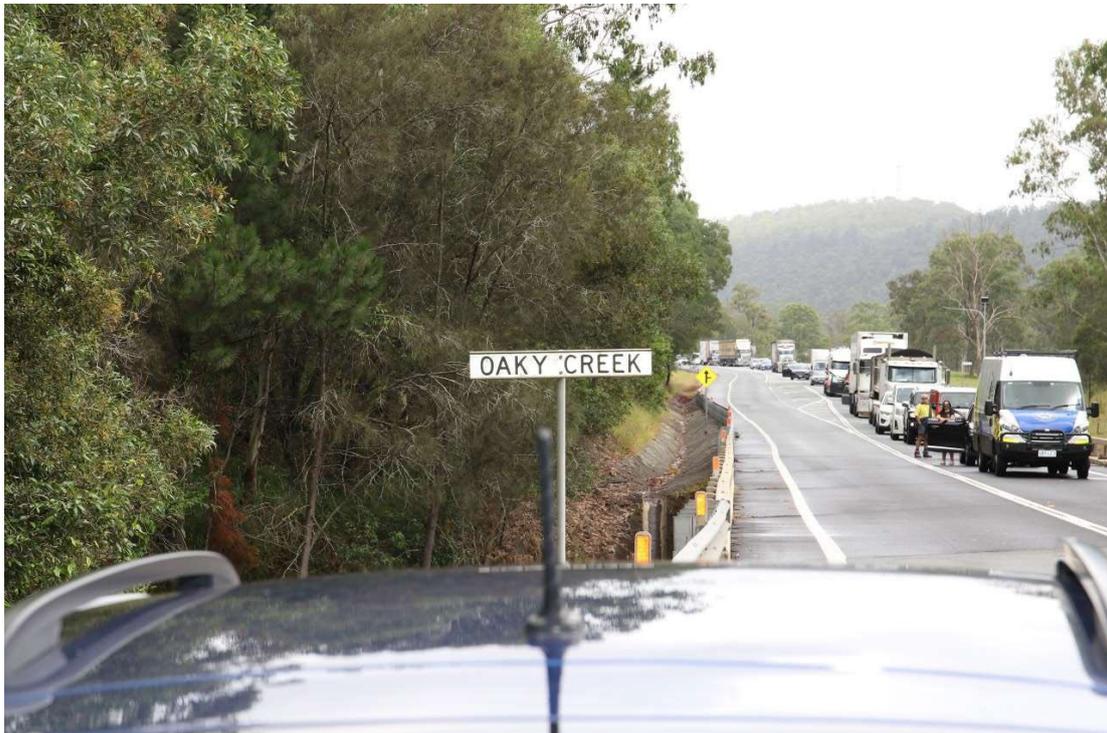
View North of T-Cross on Bruce Highway Oaky Creek

10. It is possible that any minimal trace evidence of contact between the rock and road had potentially been lost due to the rains that morning and the sheer volume of heavy and light vehicles travelling through the area at the time of incident.
11. There were no overpasses or cut slopes for the rock to have fallen from or been thrown from.

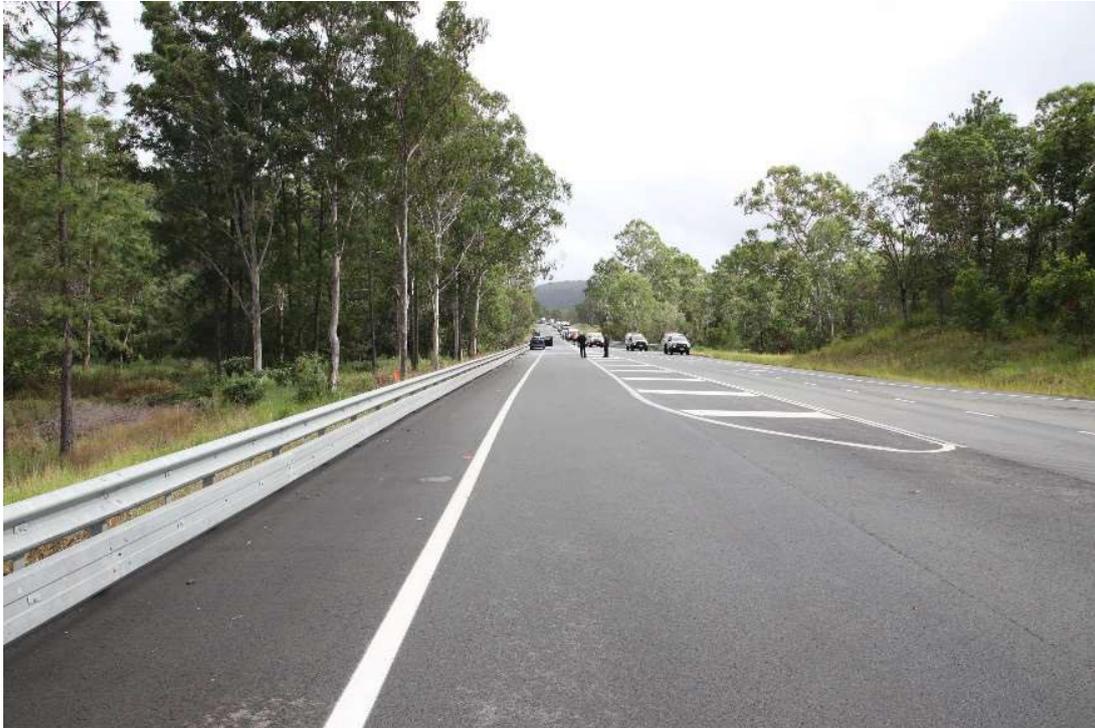
T-Cross against guard rail looking Northbound Bruce Highway from Deveron Road intersection

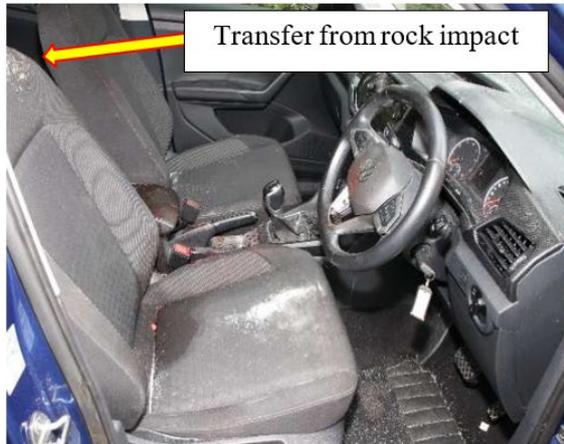
18. The dispersal pattern was indicative of an impact with the left side of Pedro around head height, accounting for seat position and the approximated size of Pedro whilst seated.
19. There was transfer on the left upper shoulder backrest area of the driver's seat consistent with the rock glancing off the upholstery.
20. There was further transfer on the rear passenger seat headrest consistent with the rock striking the headrest (causing it to raise in height from the lowered position) before the rock bounced forward and came to rest near the centre of the floor well behind the driver's seat.

Image of front driver & passenger seat

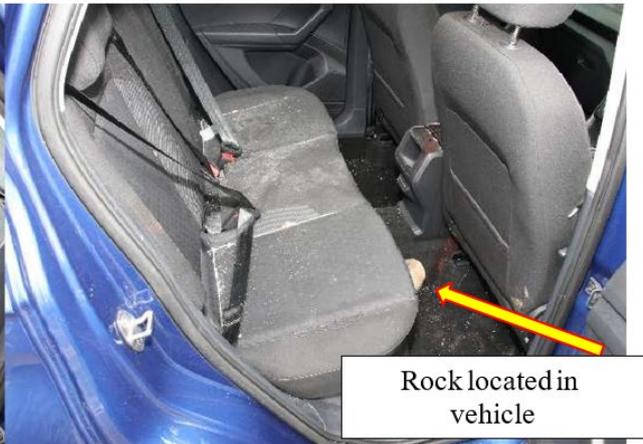
Image of rear seat

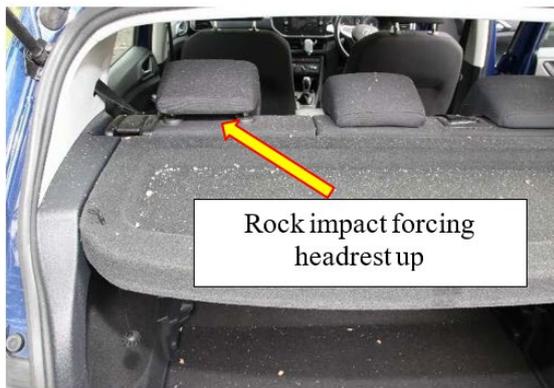
Image of rear seat head rests and parcel shelf

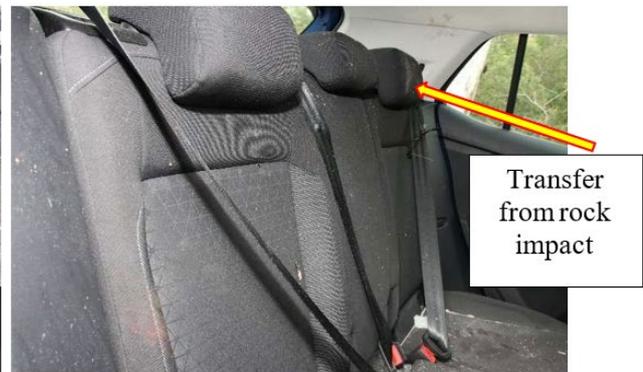
Image of rear seats

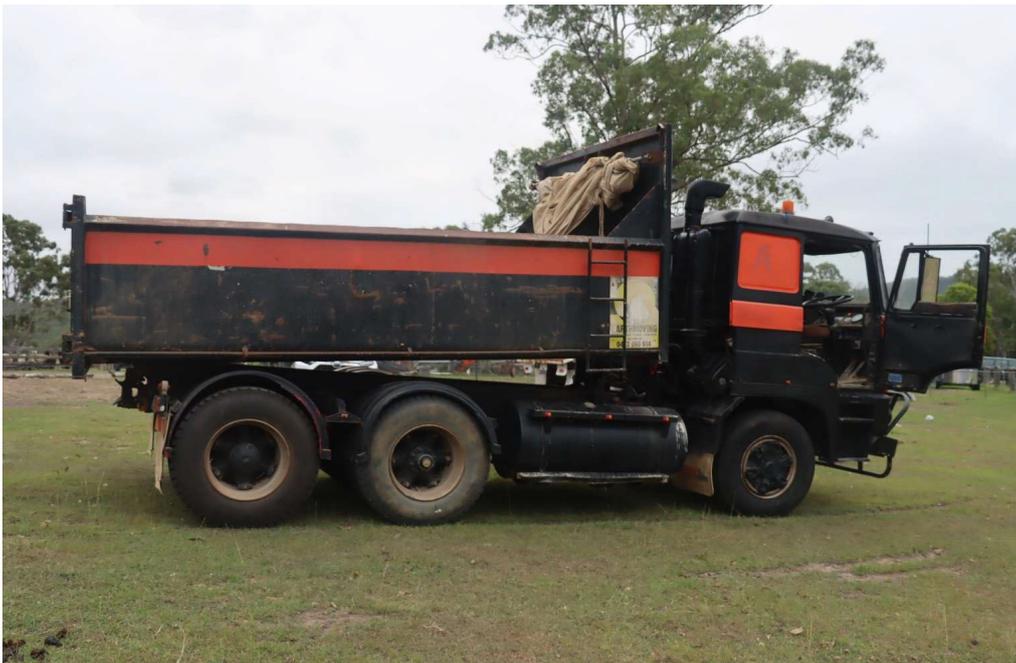
Image of 1990 DAF 3600 Prime mover truck with hydraulic tip tray (Unit 1)

24. A visual inspection was conducted on the truck in situ. General wear and tear was observed as expected in a vehicle of this age and type.
25. There was no evidence observed of rock strikes or indications of damage to the tyres, undercarriage or frame of the vehicle.

26. There was no significant damage observed between the tyre walls, although some evidence of transfer was present on opposite inner sides between the duals indicating that foreign/organic matter had been between the tyres.

29. The tyres appeared in reasonably good condition for a work truck. Mud guards were fitted and undamaged on the rear of the slave axle, with wheel guards present on all wheel arches. The truck has minor cosmetic damage in multiple areas including the wheel arches, however these appear to be historic, with nil physical evidence at the scene to suggest the damage occurred on the date of incident (no plastics or other related materials or debris observed at scene).
30. Damage was observed to the rear right slave axle wheel arches rim, and a slight deformation to the drive axle wheel guard on the driver's side at the rear of the arch. The owner was of the

opinion this was historic damage and not recent. No plastic or other fragments were found anywhere at the scene to indicate the damage occurred on the date of incident.

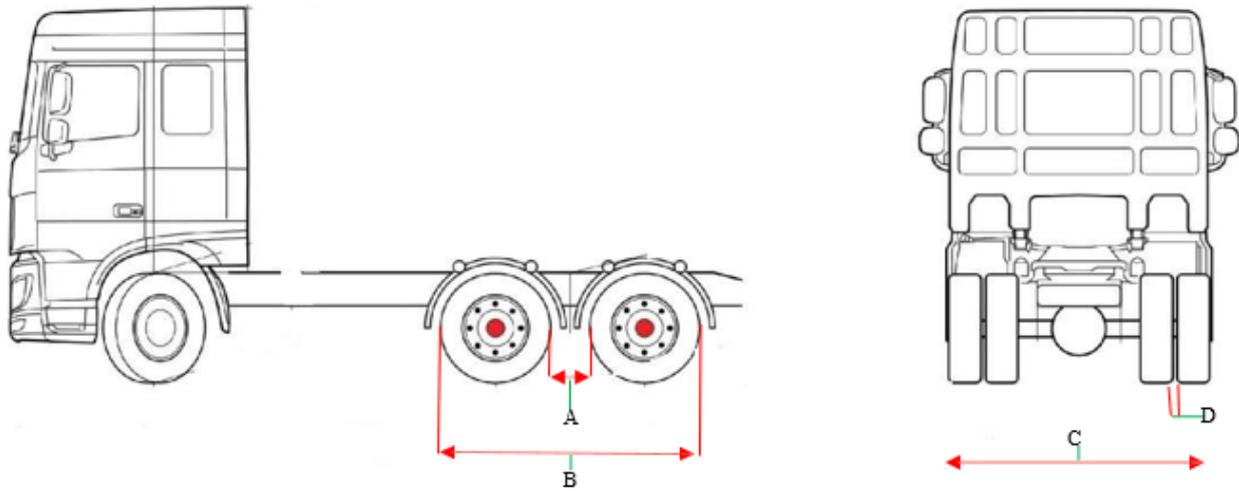
TRUCK MEASUREMENTS

A: 30cm depending on tread wear

B: 2380cm outer tread front tyre diameter to outer tread rear tyre diameter

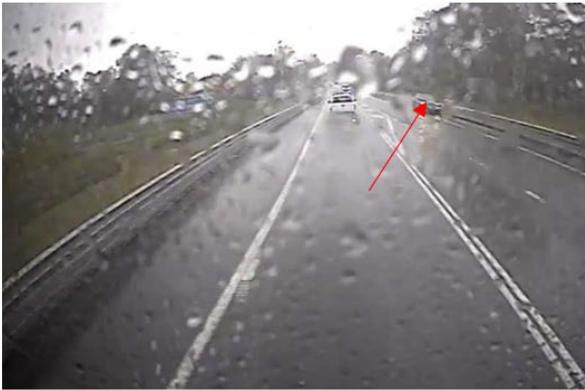
Queensland Health Truck dash cam passing T-Cross on railing Deveron Road 06:41 hours

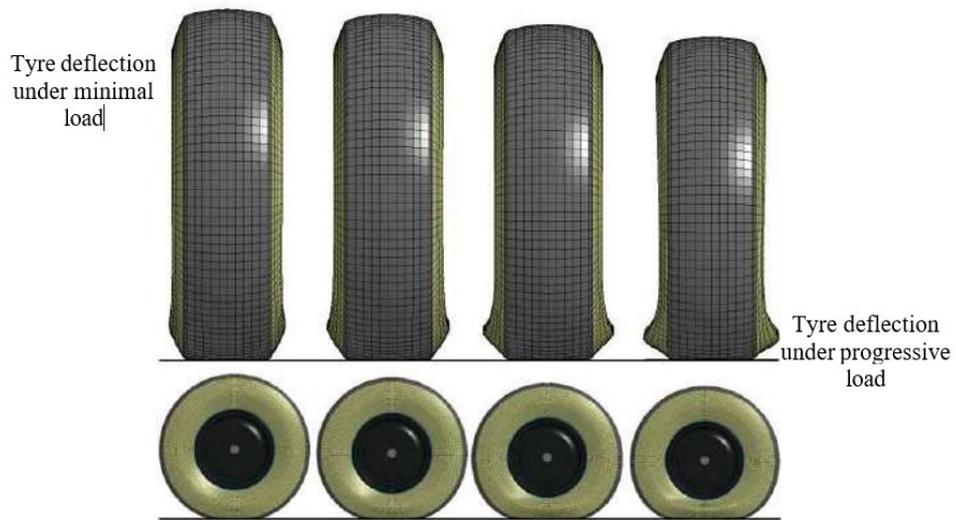
41. He stated that in his opinion as an experienced truck tyre fitter, elements such as the rain, the cold tyre pressure increasing from the truck accelerating, and the amount of tyre deflection (the amount of 'bulge' the tyre lowers under load as the weight or torque is applied to the tyre by the equipment axle) present from the load being carried by the truck could all have contributed to the rock being dislodged in the circumstances present on the morning of the incident.

Tyre deflection from the beginning of the test to maximum deformation presented in two views: one from the side of the tyre and second from the rim surface side

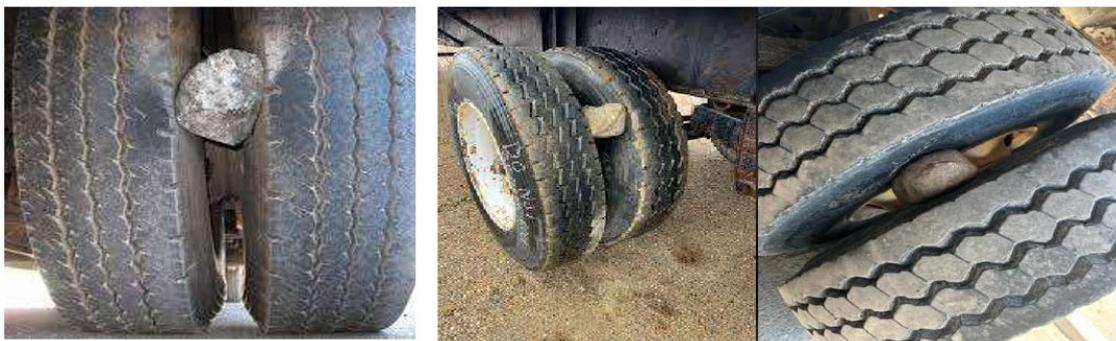
37. The manager/tyre fitter stated that in their line of work they regularly encounter instances of rocks stuck within dual tyres on trucks. He stated this was most prevalent on quarry trucks and logging trucks, with a frequency of about once or twice a month, 'give or take'. He brought to light the most recent example from the previous month where a truck experienced a 'puncture' which upon investigation by his staff was actually found to be a rock wedged between the duals wearing a hole in the inner tyre walls.

Examples of large rocks of similar size wedged in dual truck tyres

38. Standard practice when they locate a rock wedged in the duals is then to loosen the wheel nuts to manoeuvre the wheel and increase the spacing of the duals and allow the rock to fall out.

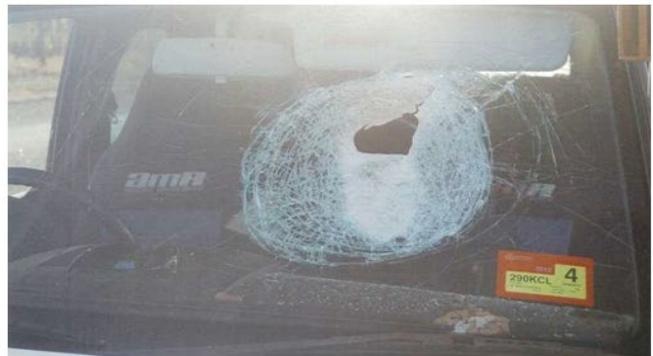
O'Neill vehicle front windshield strike

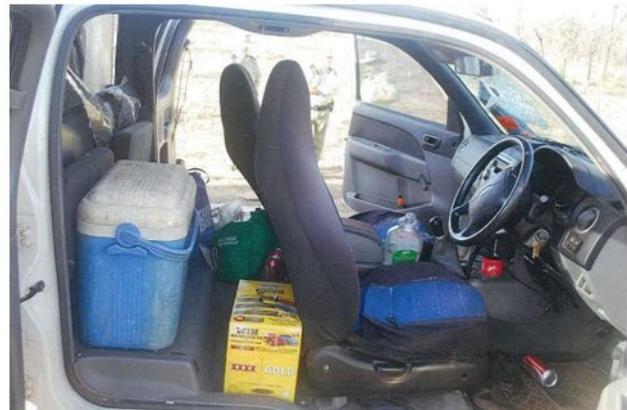
O'Neill vehicle windshield penetration

54. In the above images, it is possible to see the O'Neill rock continuing through to the rear of the cab where without contact with any further objects to reduce its speed before striking the back wall causing further damage. Radial fractures of almost identical size and form spread from the initial point of impact in both instances, with the rocks penetrating through the delaminated glass surface slightly above the impact point, consistent with a vehicle moving forward at speeds of 80-100 kilometres per hour.
